## Arborist Impact Assessment

Gosford Waterfront Precinct Revitalisation

Grahame Park, Waterfront Park & 6 Dane Drive, Gosford, NSW 2250

**AEP Ref: 6061**

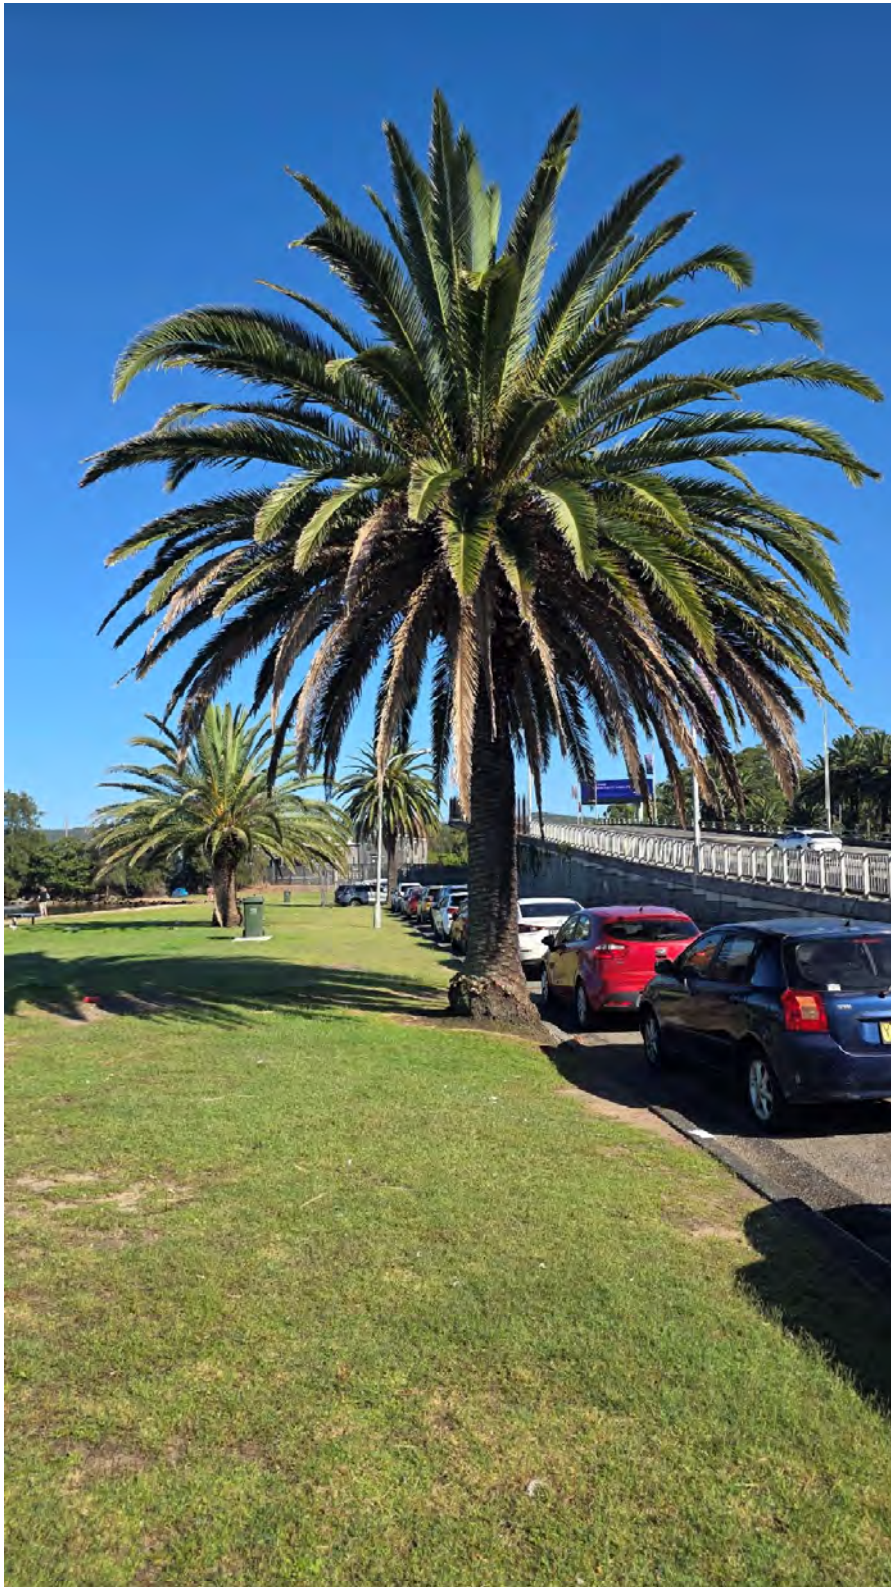
**Plate 1 - Tree 3. The current parking arrangement is to be modified and will encroach this palm significantly.**

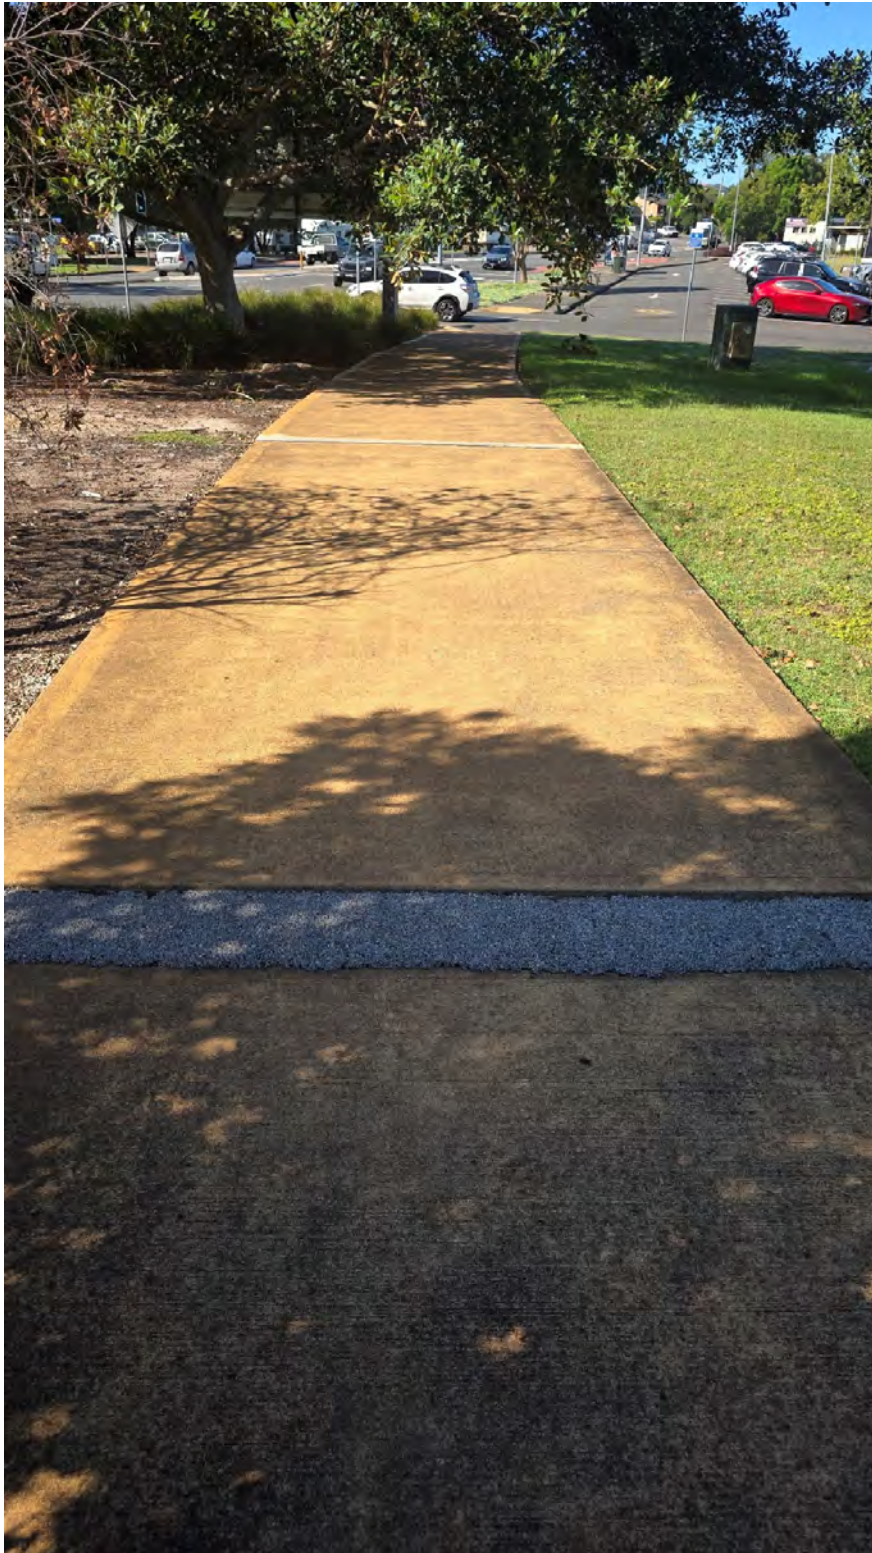
**Plate 2 - Tree 6 on the left and the proximity of the roots to the current path. Grinding and ramping are already used to manage risks. landscape design should address this problem.**

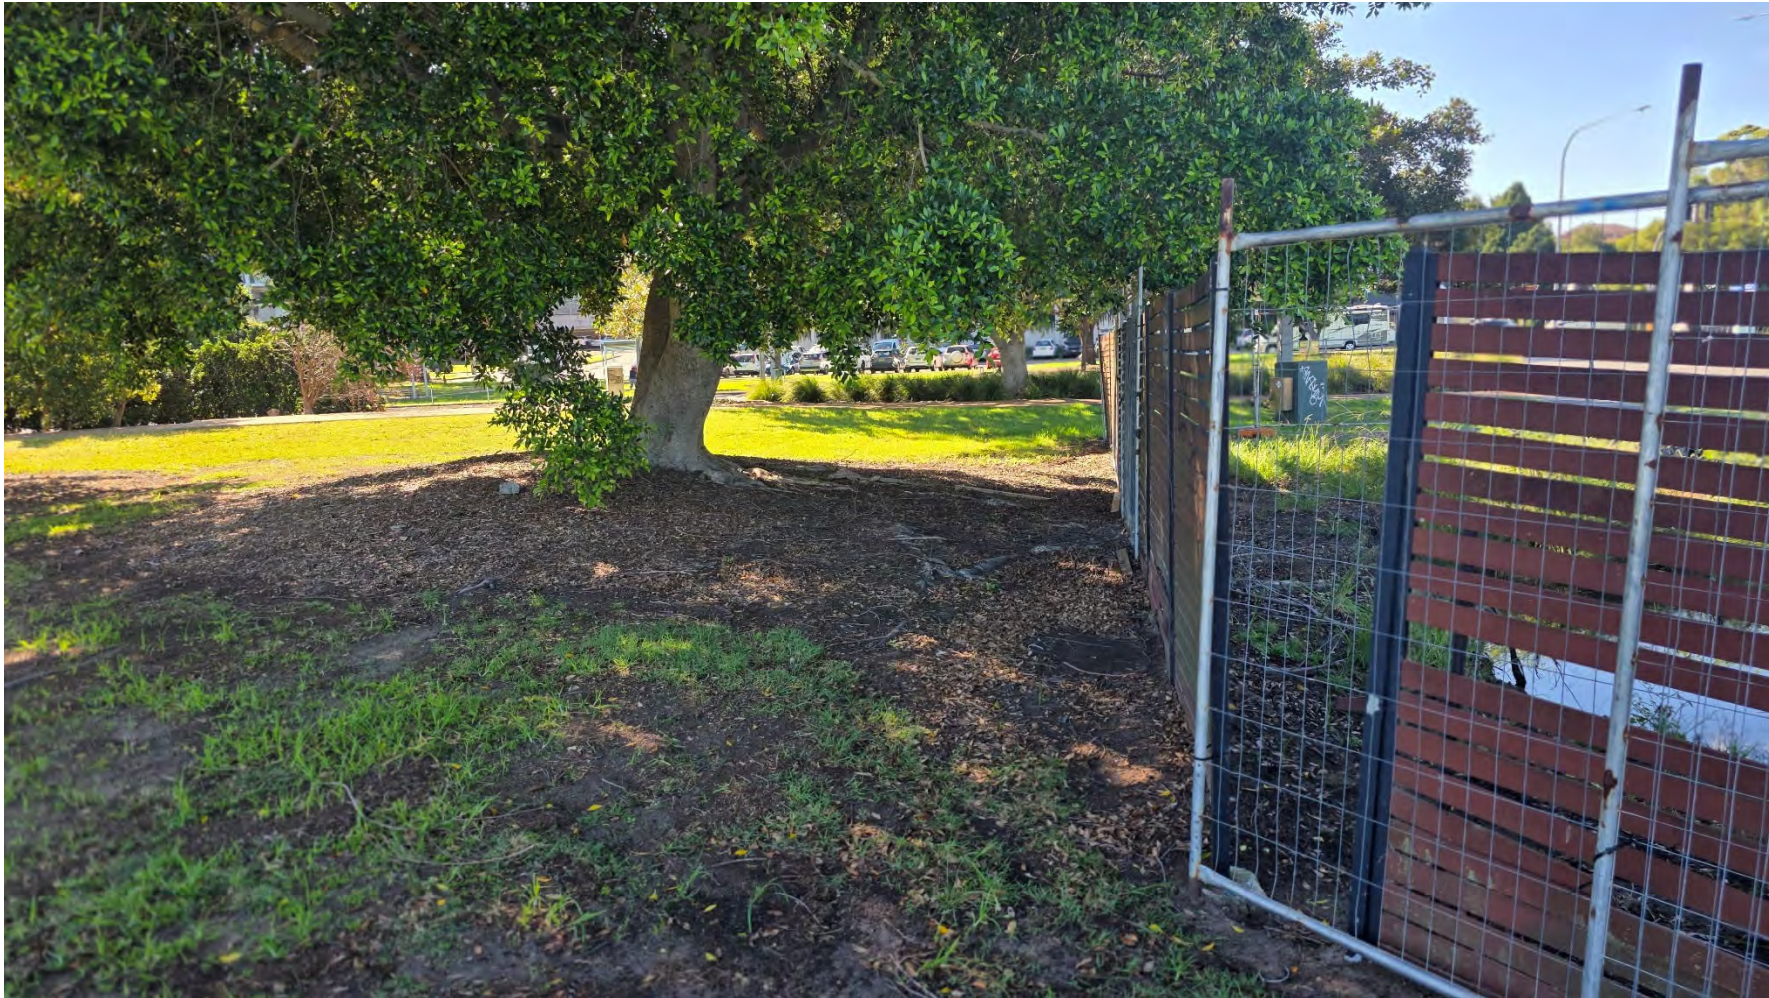
**Plate 3 - Tree 5 looking east. The current temporary fence is sufficient to protect this tree and the previous excavation on the site. The tree has a large NRZ area however no further encroachment to that present will occur.**

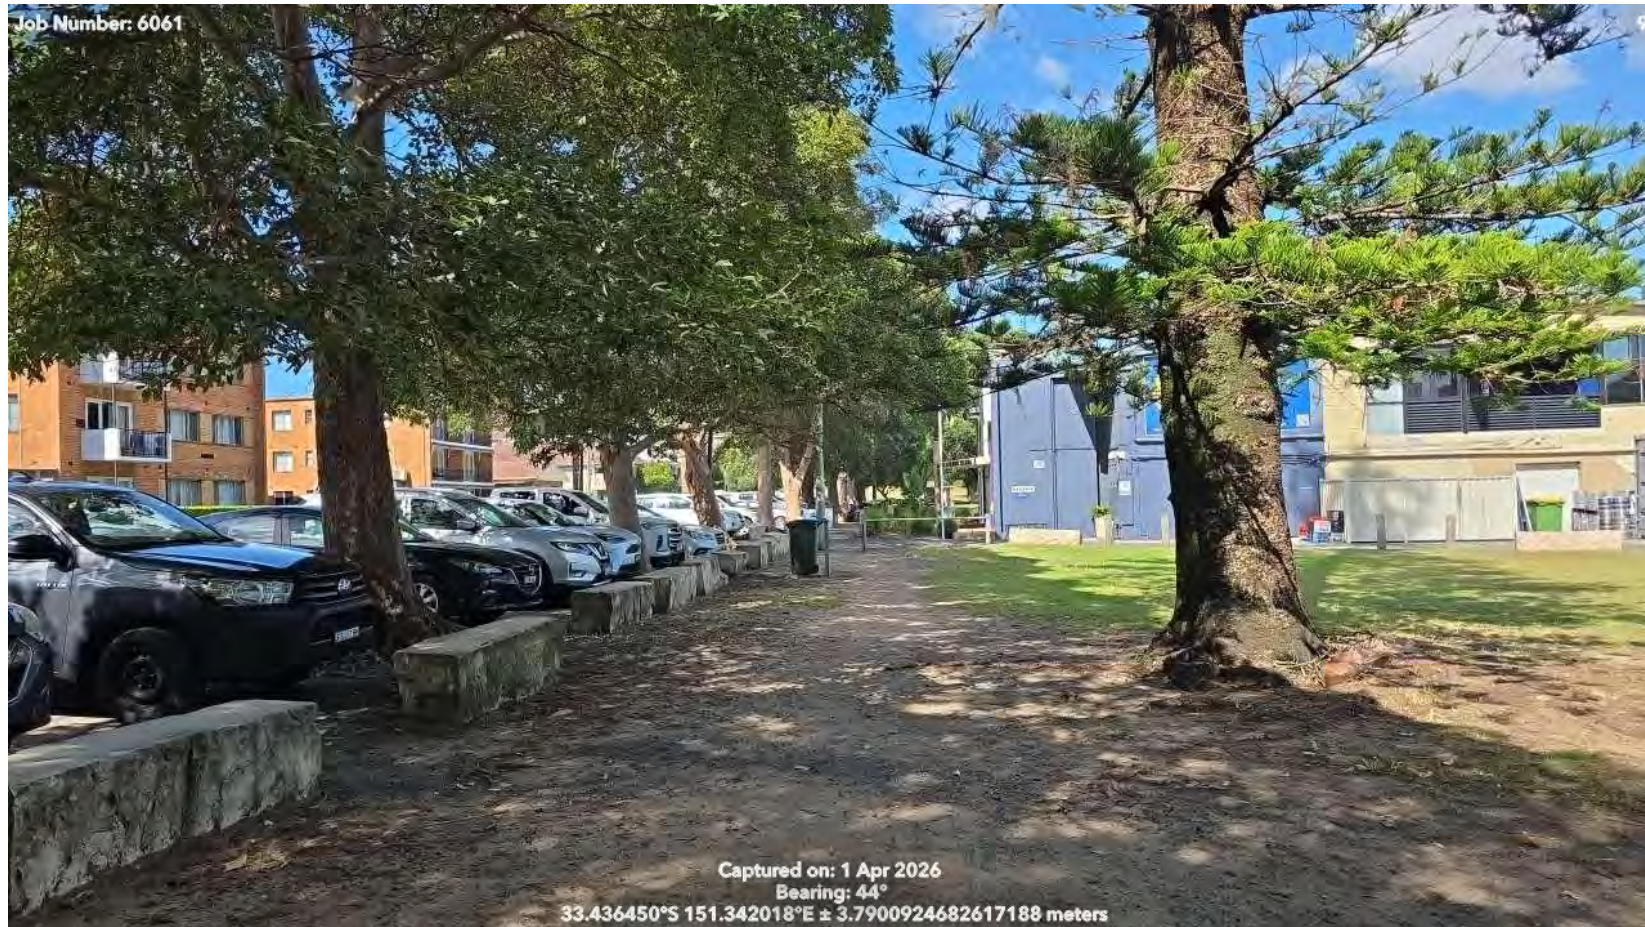
- Trees 10 – 18 (*Lophostemon confertus* – Brush Box) these trees have extensive damage to surface roots and, in some cases, mechanical damage to the base of the trunks from parking vehicles. The shaded area under the tree provides cooler parking for users of the site, particularly the Sailing Club users. The soil about these trees is heavily compacted.

- Trees 10 – 7 already suffer the impacts of compaction and physical damage to roots and the trunk. The proposed walkway/cycleway will encroach within the NRZ areas of these trees likely to exceed 20%. As in Tree 9 above, alternative methods of construction will significantly reduce the extent of root damage and allow retention of the trees. Additionally, improving the growing conditions about trees 9, 10 – 18 by the use of mulch, nutrients and good water during dry periods will enhance the areas of roots unaffected by development.

**Plate 4 - Trees 9 - 17. The current informal pathway between existing trees is proposed to be upgraded. Tree 9 (on the right) has major encroachment within the NRZ and SRZ of this tree. Designs should not cause further damage and decline.**

- Trees 9 – 18 have the most critical design requirements. In reviewing the landscape design, the method of construction is not specified at this date. It is recommended that the construction method does not involve excavation deeper than 100 mm of the current levels. A light scrape to obtain suitable levels is critical. The pavement material recommended is [Porous Lane Pavement system](#) that is purposely designed for shared user pathways.

- The current vehicle damage and compaction about trees 10 – 18 is not addressed. This may be beyond the scope of the project but could be considered as this is critical to the retention of these trees in the long term.

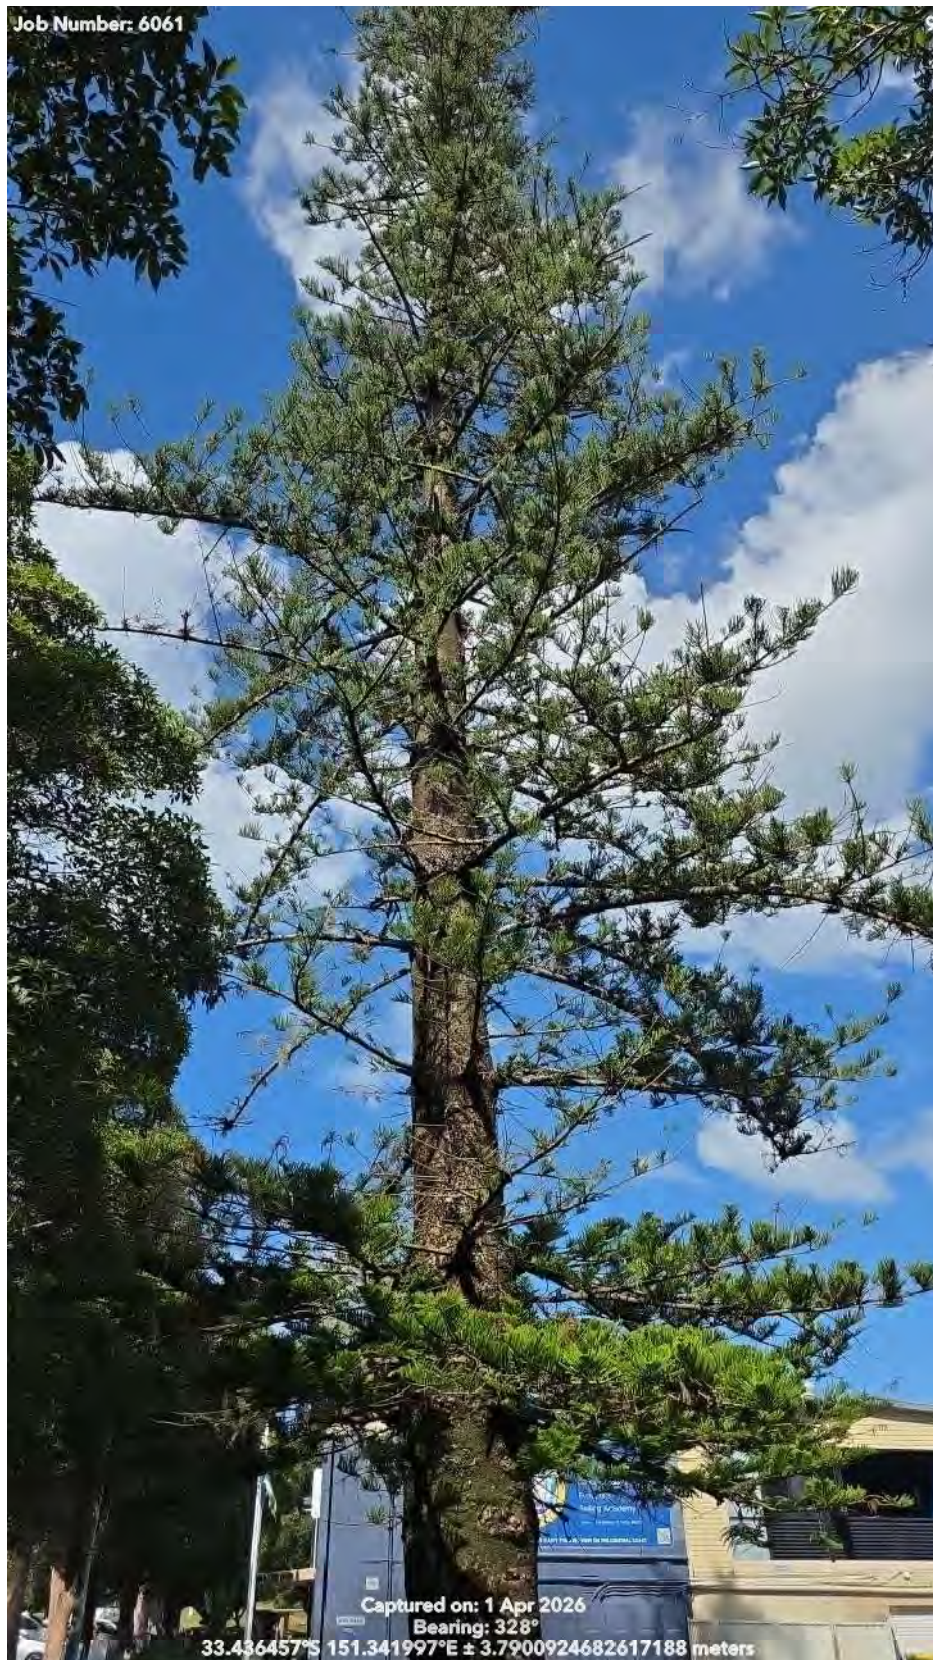
- Tree 9 (*Araucaria heterophylla* – Norfolk Island Pine) with poor canopy condition. This tall, old tree (measured at 31.5 m in height) has a very sparse canopy with stunted growth and very limited crown spread. The cause of the tree's condition is not known, possibly caused by bird damage or severe drought and storm effect. The root zone appears to have been compacted on east side and root crown has signs of a previous slab restriction over the roots.

- Trees 9, 10, 12, 14, 15, 16 & 17 have encroachment within the NRZ of greater than 20%.
- Tree 9 is a large tree with a substantial Notional Root Zone and Structural Root Zone. The proposed walkway/cycleway encroaches more than 20 % of the NRZ and encroaches within the SRZ distance. As this tree is currently in only Fair condition, the tree will be adversely impacted if conventional construction methods of a reinforced concrete pathway. The use of an elevated walkway, or a permeable pavement system would reduce the impacts of the encroachments. The tree also requires pruning to remove a large amount of deadwood that would be over the walkway and management of the remaining NRZ area to improve tree health.

**Plate 5 - Tree 9.** The tree has declined in health and the canopy is sparse for such a large, mature tree. the shared user pathway proposed under this tree should be combined with practical maintenance works that improve the condition of the tree's health.
