### ABOUT THE SITE

The Hunter Development Corporation (HDC), on behalf of the NSW Government, is undertaking a \$110M remediation strategy for the land on the former BHP Newcastle Steelworks Site at Mayfield.

### THE REMEDIATION STRATEGY

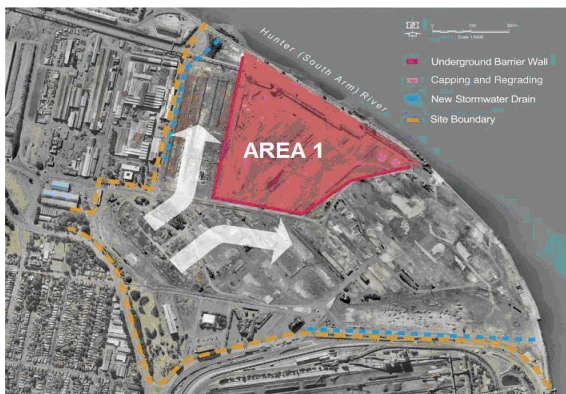
The contamination, which is common to steelworks sites, is largely confined to a 30 hectare area of the site identified as Area 1. However, remediation work is also required to the bulk of the remaining areas of the site as well.

THE SITE AND AREA 1

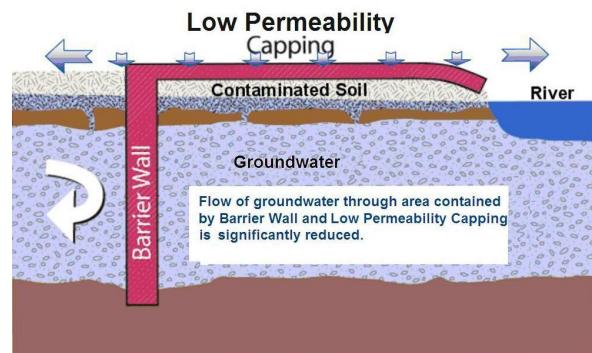
The wall is designed to slow down and effectively stop the contamination problems caused by the horizontal flow of groundwater through Area 1. The wall reduces the flow of contaminants leaching into the waterway. The underground barrier wall is about 1.4 km long and with an average depth of about 30 metres.

CROSS SECTION OF BARRIER WALL

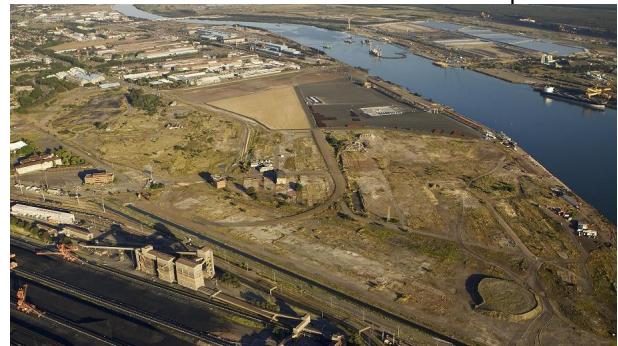
AERIAL VIEW AFTER STAGE 1 REMEDIATION
