# Mount Penang Infrastructure Works, Parklands Road Utilities and Related Works: Statement of Heritage Impact

FINAL REPORT

Prepared for Gyde Consulting

2 May 2022

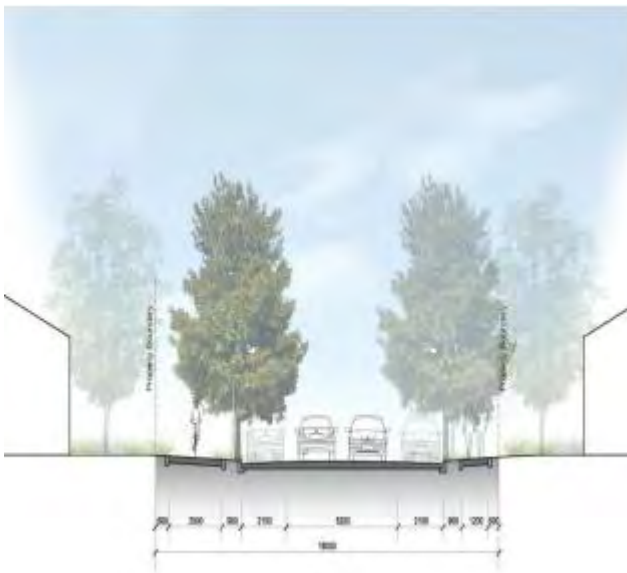
**Photo 2** Example configuration of a secondary road as per the GDCP (Source: (Central City Council 2018, pp. 5–32 Figure 2.6.2)

The roads which comprise the study area have been designated as follows:

- Parklands Road – Secondary Road / Access Road (designation alters according to access needed for to different precincts).
- McCabe Road – Secondary Road.
- Carinya Street – Access Road.
- The Avenue – Secondary Road.

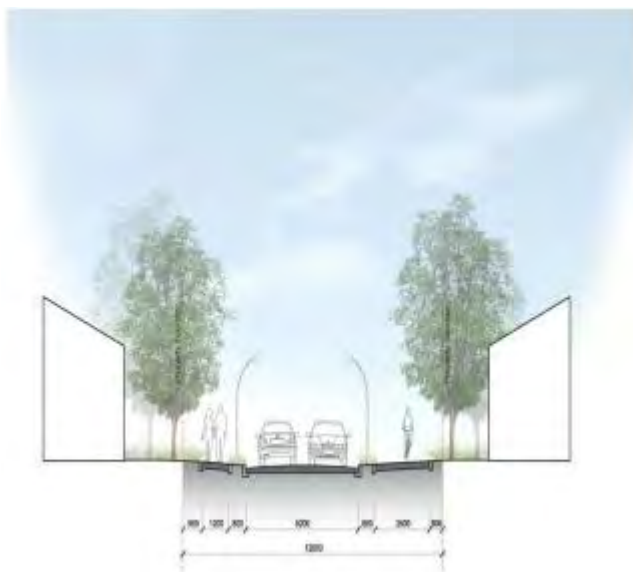
**Photo 3** Example configuration of an access road as per the GDCP (Source: (Central City Council 2018, pp. 5–32 Figure 2.6.3)

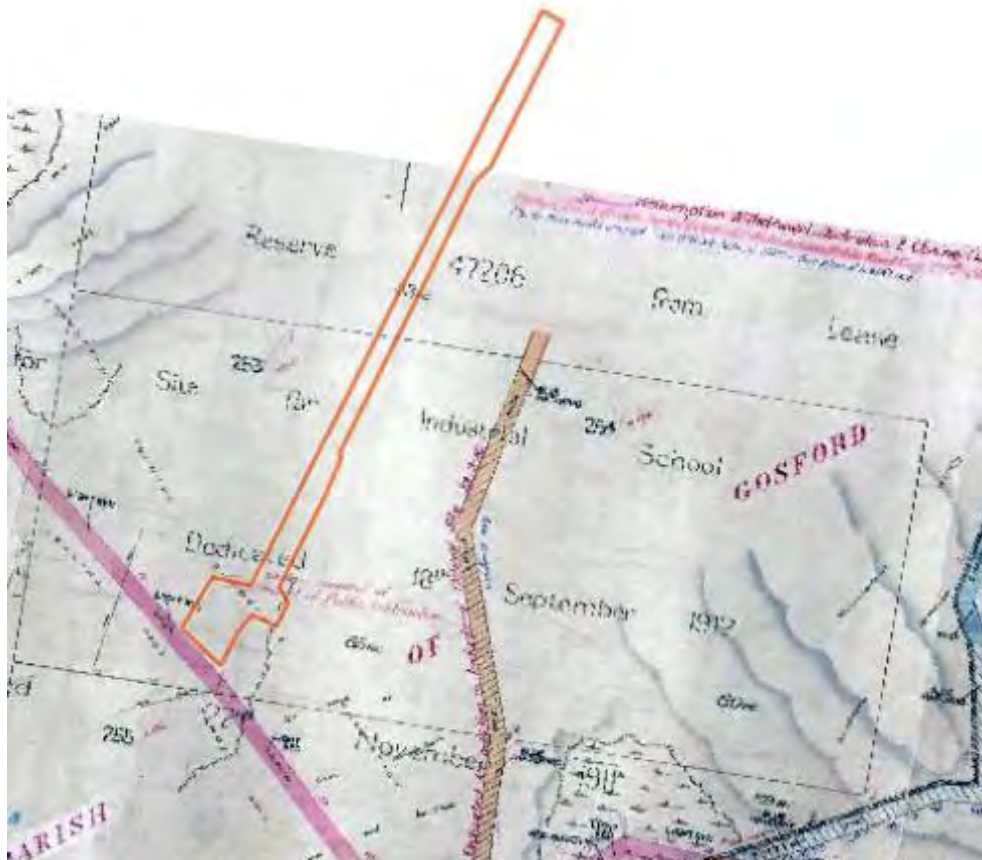
**Photo 4** 1917 Crown plan for lands to be resumed for a proposed deviation of the road from Gosford to Peats Ferry (Source: NSW Land Registry Services, R12467.1603)

Mount Penang Parklands is located approximately 5 kilometres west of Gosford, with the study area comprising 7.1 hectares of the wider park. The park sits on the lip of a reasonably flat summit of a sharp escarpment located within the Hawkesbury Sandstone geological unit. The study area is contained within the erosional Somersby soil landscape. A 1917 road map shows the landscape described at the time as “undulating country sandstone formation” with a “stony spur” to the west of the study area and swampy land to the south-east (Photo 4).

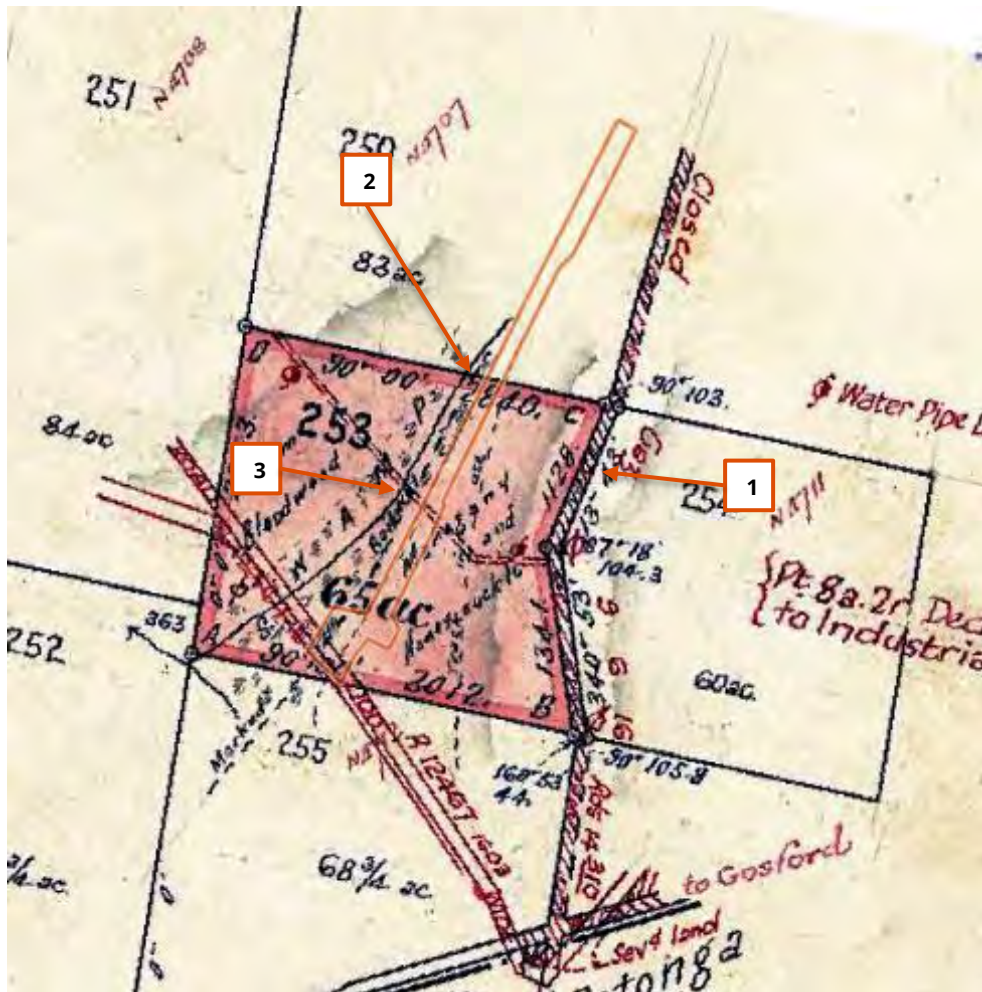
**Photo 6** 1911 Crown plan of Gosford parish portion 253, showing three roads or tracks [1] [2] [3], with the study area outlined in orange (Source: NSW Land Registry Services, Crown plan 4710.2111)

Parish portion 250, 253, 254 and 257 of Gosford parish was identified as the new site for the school, as indicated by a series of Crown plans dating to 1911 and 1912 (Photo 5, Photo 6, Photo 7, Photo 8). This combined land was dedicated as a site for the 'Industrial School' in September 1912.<sup>35</sup> The 1911 and 1912 Crown plans shows several roads and tracks [1] [2] [3], with swamps noted as running through the land, one of which is likely associated with the creekline to the north-west of the study area. Honeysuckle, Mahogany, Gum and Bloodwood trees are also noted, suggesting little to no development or clearing had occurred prior to this. Later annotations record a road cutting through portion 253, and also a railway line survey. No structures are recorded.

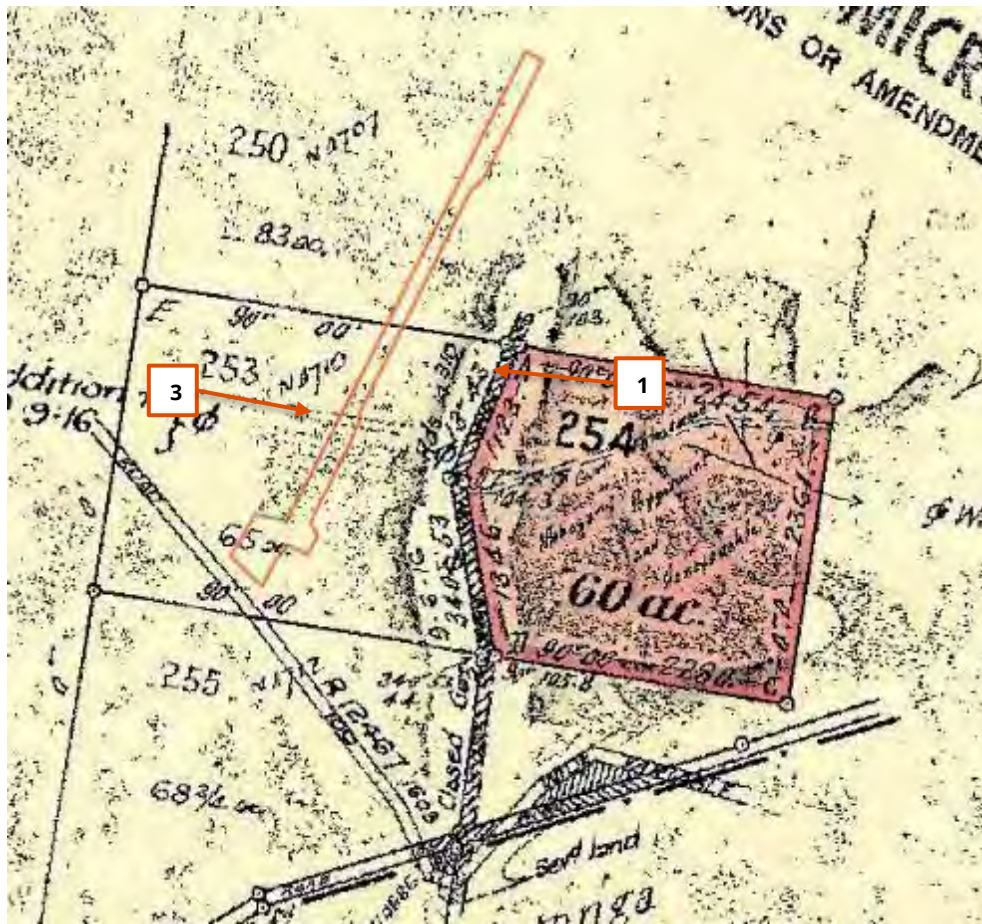
**Photo 7** 1911 Crown plan of Gosford parish portion 254, showing two roads or tracks [1] [3], with the study area outlined in orange (Source: NSW Land Registry Services, Crown plan 4711.2111)

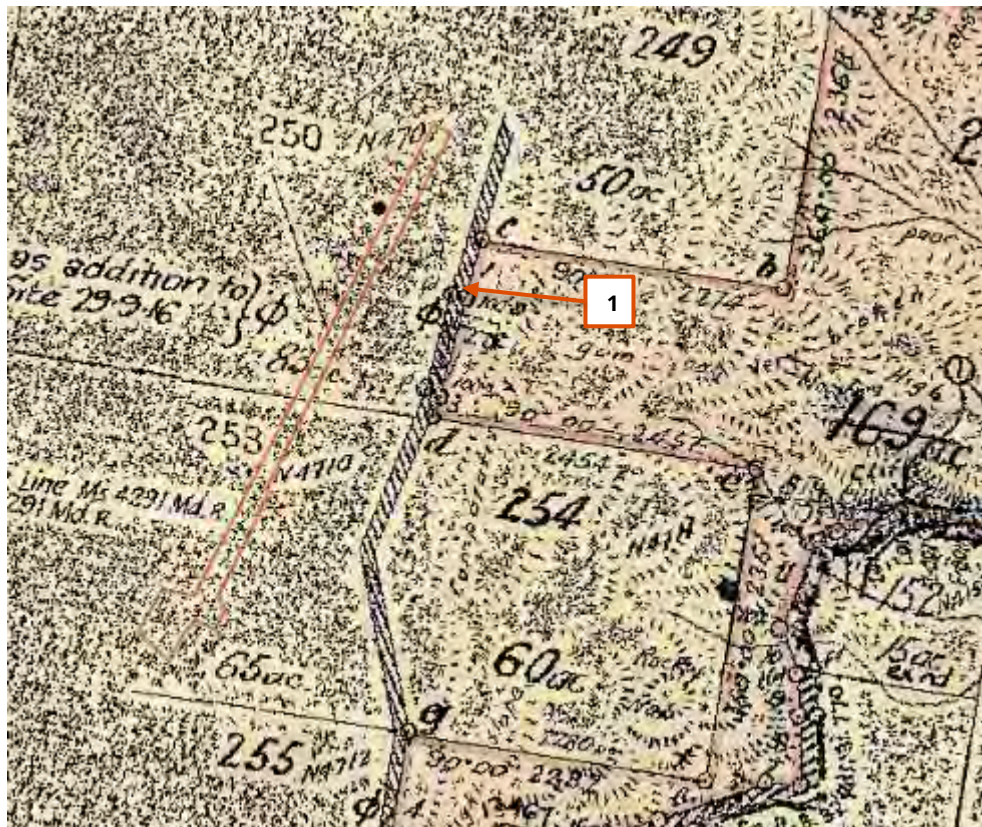
**Photo 8** 1912 Crown plan of Gosford parish portion 257, showing a road or track [1], with the study area outlined in orange (Source: NSW Land Registry Services, Crown plan 4775.2111)

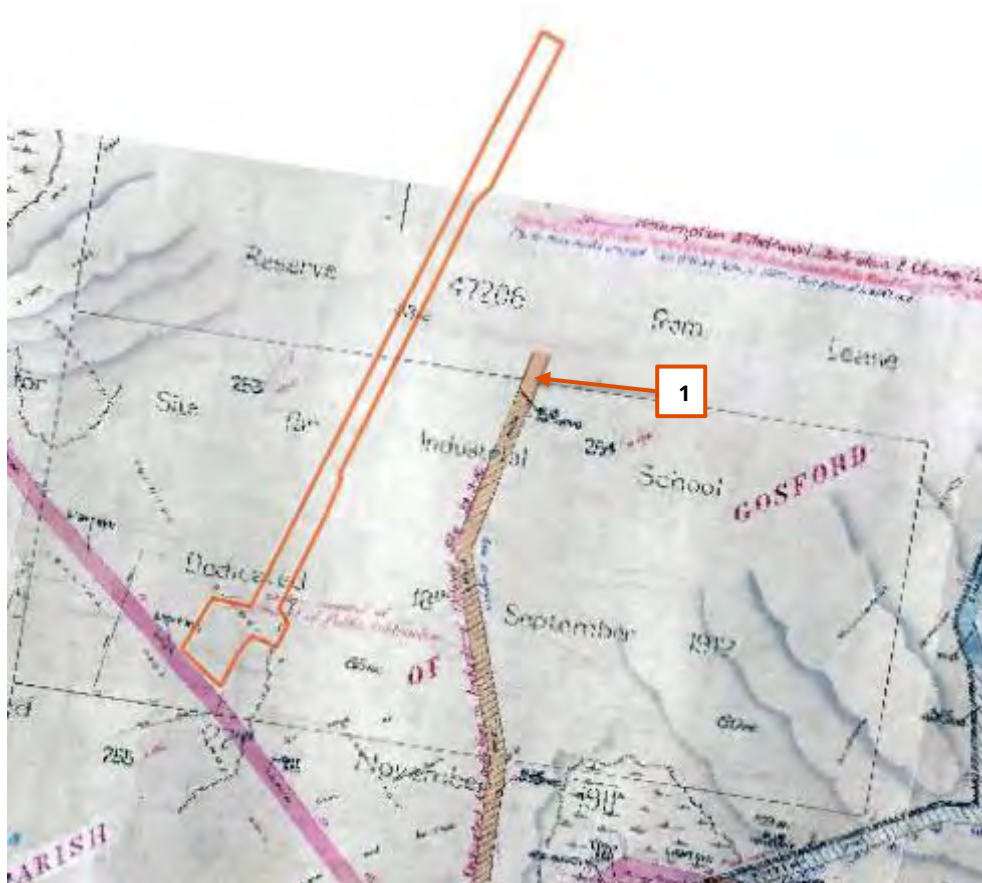
**Photo 9** 1915 Crown plan for the land to be resumed for the road from Gosford to Peats Ferry, showing the unused road [1], and the study area outlined in orange (Source: NSW Land Registry Services, Crown plan 12467.1603)

A 1915 Crown plan for the resumption of lands for the deviation of the road from Gosford to Peats Ferry shows the wider area containing the study area at this time (Photo 9). The unused road [1] previously identified is present, but the other two tracks [2] [3] have not been recorded. Topography and further swampy land in the vicinity of the study area is also noted, with vegetation described as low scrub of gum, stringybark, apple and banksia. No structures within or in the vicinity of the study area are recorded on the plan.

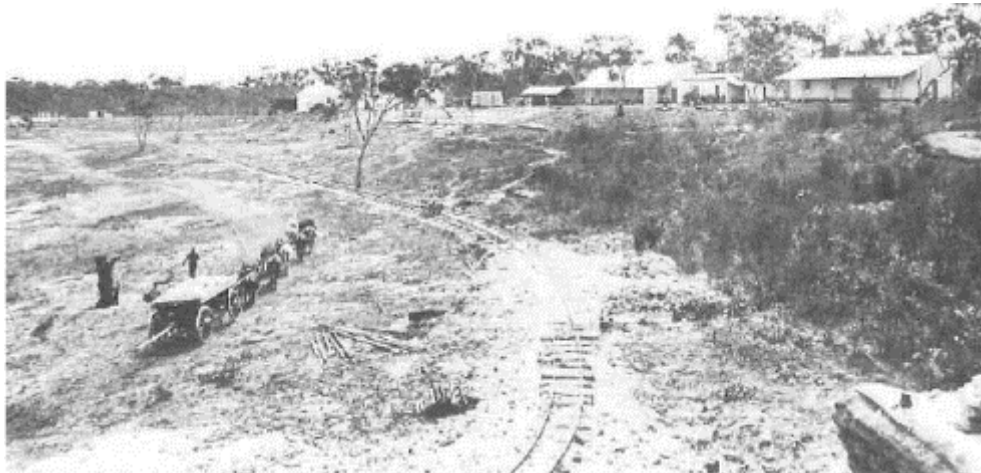
**Photo 14** 1912 photograph of one of the tramlines linking the quarries to building sites; temporary buildings can be seen in the background (Source: (Department of Community Services and Department of Juvenile Justice n.d.)

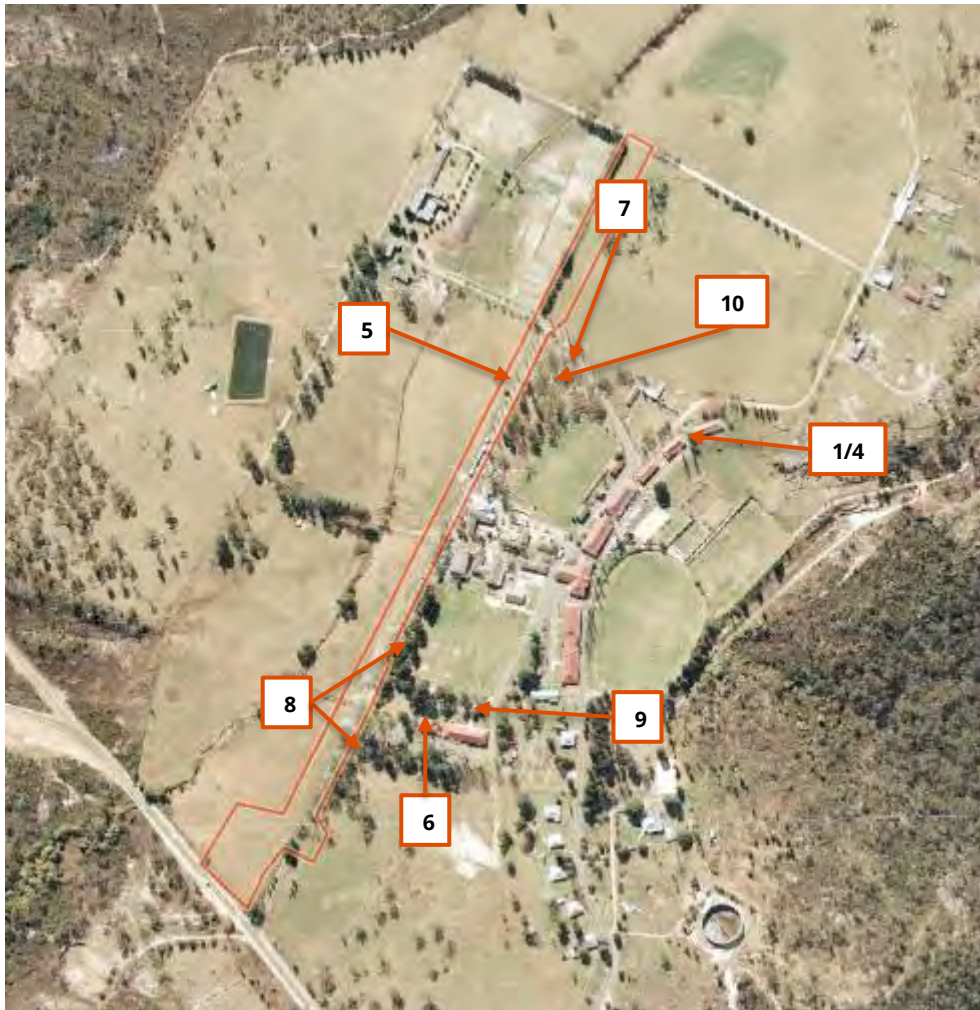
**Photo 29** 1976 aerial photograph, showing The Avenue [4] Parklands Road [5], Carinya Street [6], McCabe Road [7], Parklands Road plantings [8], Carinya Street plantings [9] and the Parklands/McCabe corner plantings [10] with the study area outlined in orange (Source: (NSW Spatial Services n.d.)

Aerial imagery from 1976 show visible changes in across the Training School since 1965 (Photo 29). New structures are visible on the southern edge of Carinya Street, and a waterbody has been constructed in the west of the site. The reservoir in the south-east appears to be empty and may have fallen out of use, though this could simply be due to the weather at the time of photography. The track leading out of the site to the north-east has fallen out of use, while the sports oval is still clearly visible in the east. There appears to have been some reduction in the plantings along Parklands Road [8].

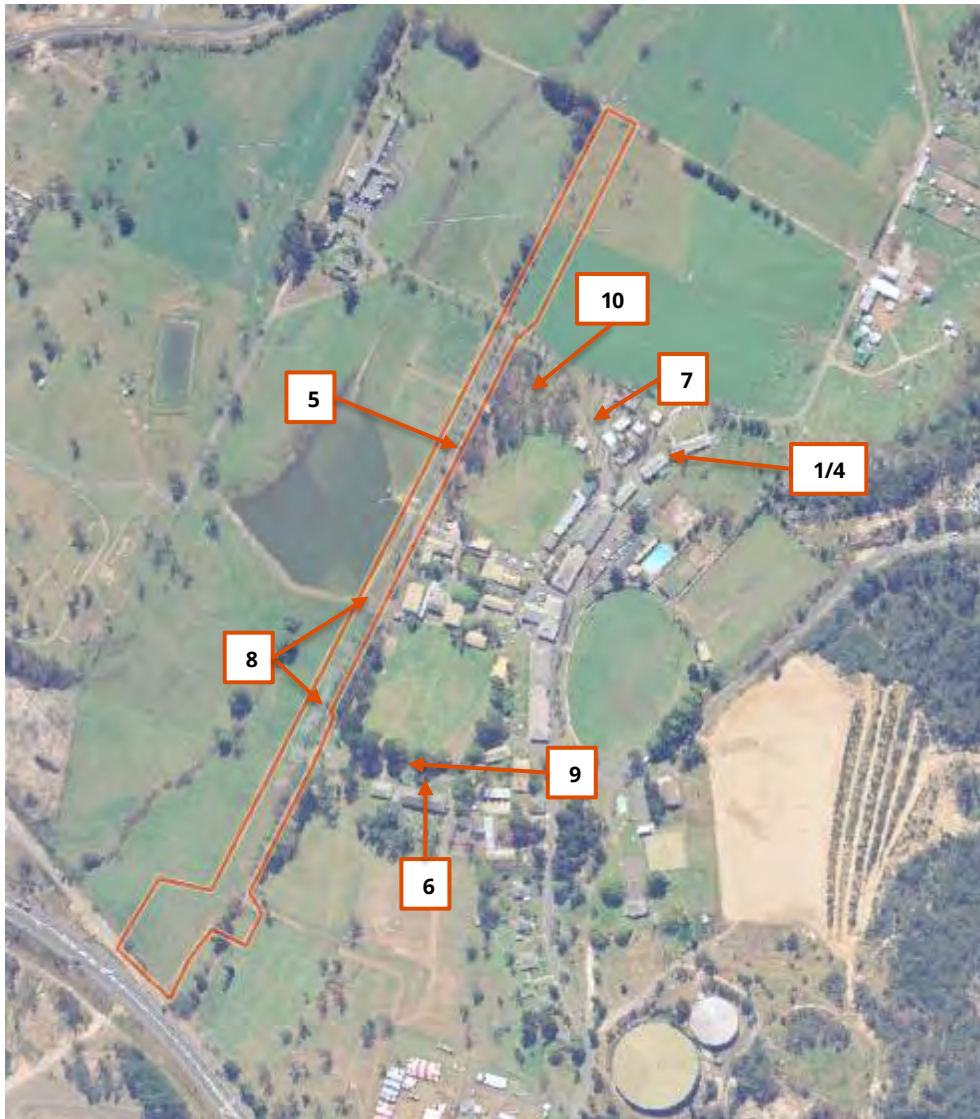
**Photo 32** 1994 aerial photograph showing The Avenue [4] Parklands Road [5], Carinya Street [6], McCabe Road [7], Parklands Road plantings [8], Carinya Street plantings [9] and the Parklands/McCabe corner plantings [10], with the study area outlined in orange (Source: (NSW Spatial Services n.d.))

A 1994 aerial photograph shows dramatic change across the wider Mount Penang site, though there is little change within the study area (Photo 32). Extensive tree clearance has taken place to the east, and multiple structures have been erected, including multiple building complexes and an additional reservoir. There is new access to the site, with a road leading out from the north-easternmost area.

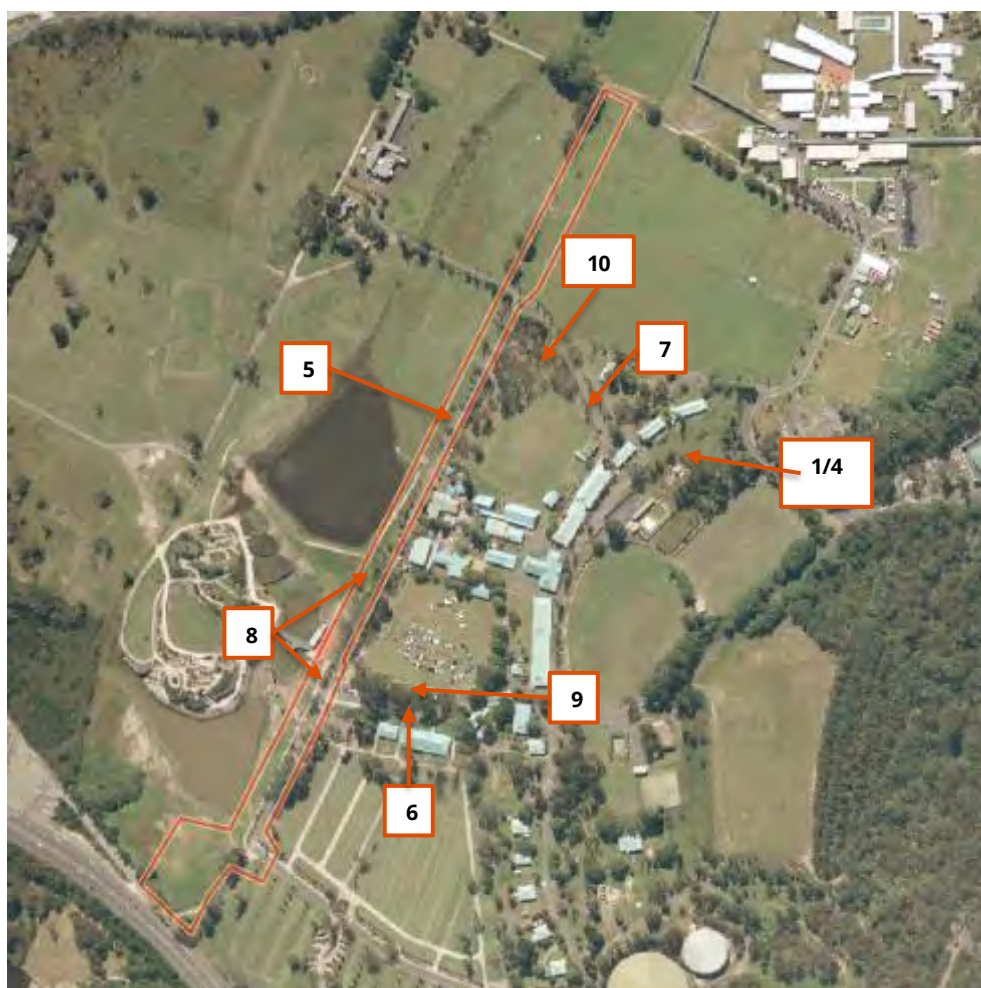
**Photo 34** 2006 aerial photograph showing The Avenue [4] Parklands Road [5], Carinya Street [6], McCabe Road [7], Parklands Road plantings [8], Carinya Street plantings [9] and the Parklands/McCabe corner plantings [10], with the study area outlined in red (Source: (NSW Spatial Services n.d.))

Aerial photography from 2006 highlights the rapid development across the wider Mount Penang site (Photo 34). Within/immediately surrounding the southern end of the study area at Parklands Road, access has been increased with the establishment of Festival Drive. In the same area, landscaping associated with the Gardens has taken place to the west with more structures erected, including the building currently holding the Waterfall Café. Previous building complexes in the north-east of the wider site have been massively expanded, with increased road access, car parking and a new fence added. To the west, down the road, additional structures have been built. To the south east, temporary structures have been removed and the area has been landscaped with lines of trees and access paths.

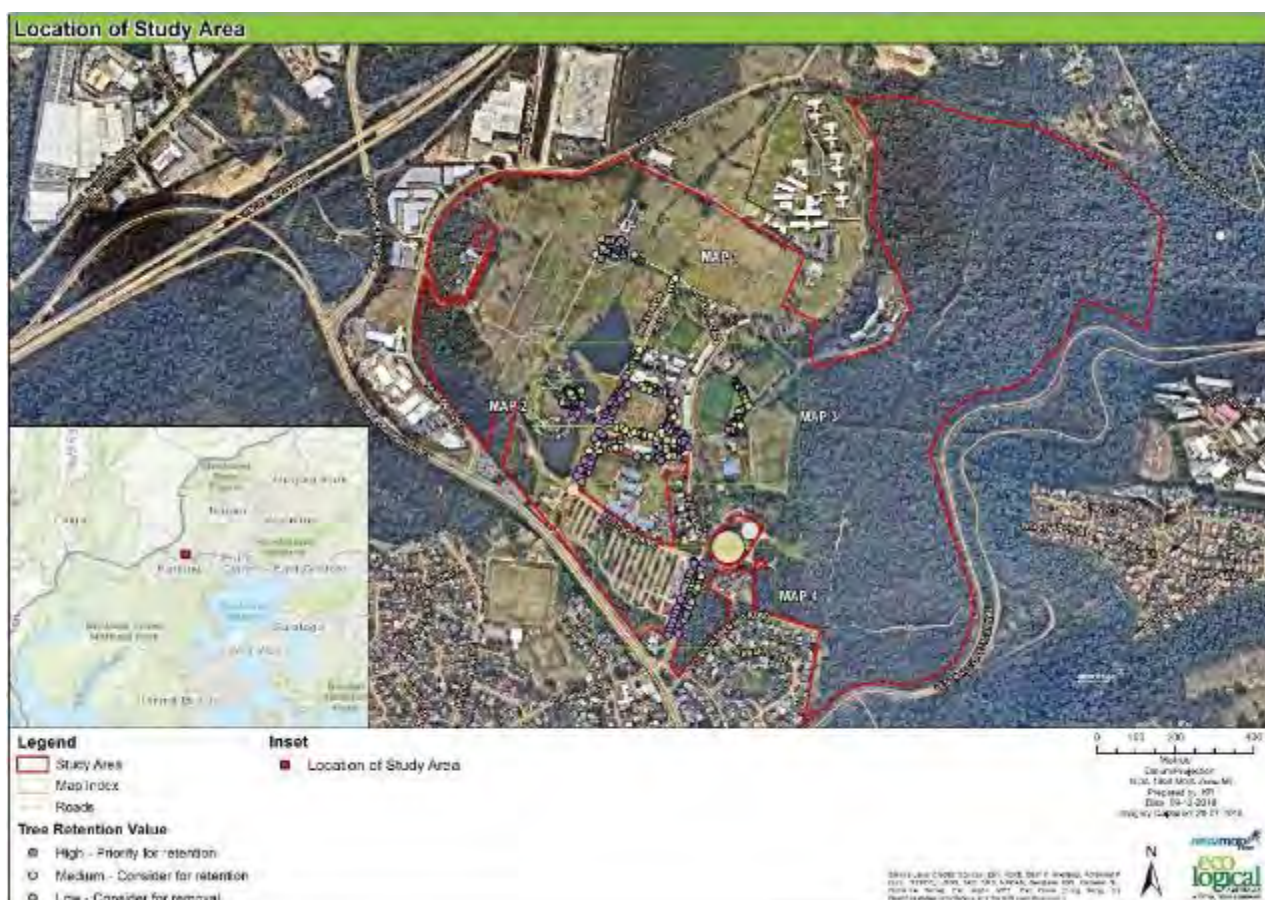
**Photo 36** Eco Logical study area at Mount Penang showing tree retention values (Source: (TKD Architects & Eco Logical Australia 2019, pp. 3)

retention value, and 63 low retention value.<sup>84</sup> Photo 36 shows the location of the trees identified, with many marked along Parklands Road within the current study area.

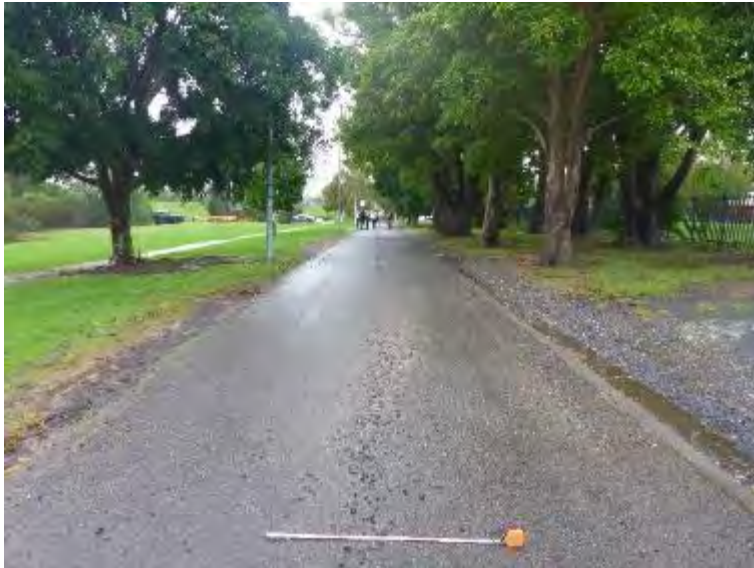
**Photo 37** View of southern end of Parklands Road and L5 Mature Cultural Plantings along Western Edge of School, facing north-east

Parklands Road is located to the west of The Avenue area, and is dominated by a road, open spaces and plantings. Parklands Road intersects with Festival Drive, Carinya Street, and McCabe Road. Parklands Road, Carinya Street and McCabe Road were established over time from the 1920s to 1940s (Photo 37, Photo 41, Photo 44, Photo 45, Photo 46). There are designated heritage planting groups along Parklands Road (L3: Poplar and Brushbox Avenue and L5: Mature Cultural Plantings Along Western Edge of School) (Photo 37, Photo 38, Photo 41, Photo 42, Photo 43) and Carinya Street (L4: Sports Field 1 Perimeter Brushbox and Eucalypt Plantings) (Photo 39, Photo 40); these are first noted in 1946 plan drawings. Some of the original plantings along Parklands Road (L3: Poplar and Brushbox Avenue) (including Lombardy Poplars) have been replaced (White Poplars), but the date for this is not known. There is also several clusters of Scribbly Gums at the corner of Parklands and McCabe roads (L2: Scribbly Gum Group) which may be remnant native vegetation (Photo 47, Photo 48, Photo 49).

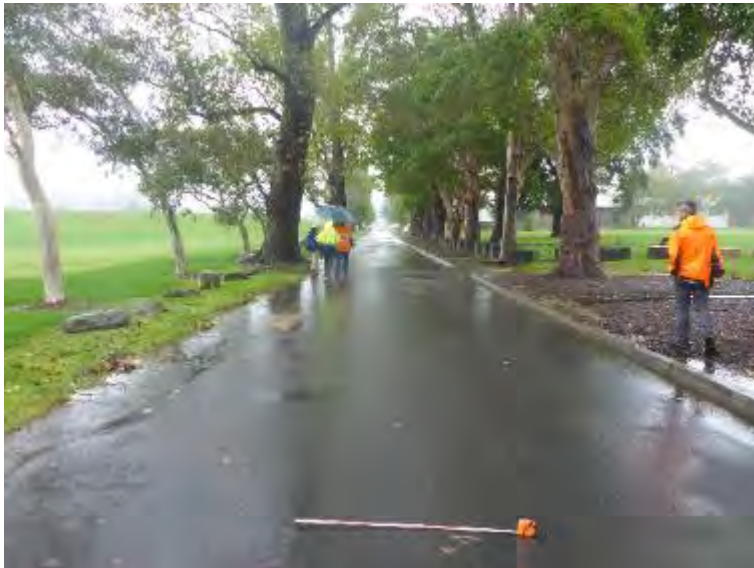
**Photo 41** View of central portion of Parklands Road and L3 Poplar and Brushbox Avenue, facing north-east

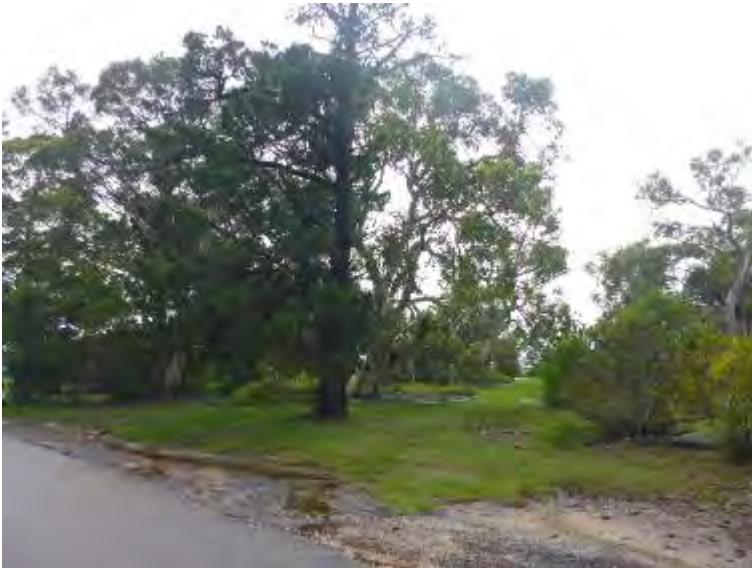
**Photo 47** View of L2 Scribbly Gum Group from Parklands Road, facing east

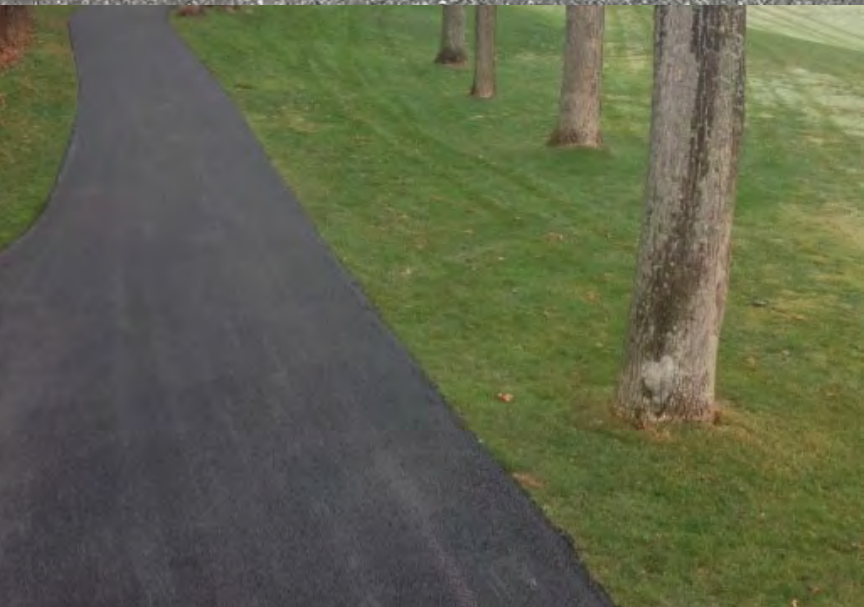
code	description	specification and finish	Precedence
PV1	Bitumen Location: Roadways to civil engineer.	to civil engineers.	 
PV2	Bitumen Location: Footpaths and shared paths on Parklands, The Avenue and Carinya Street.	Finish and size: AC10 over AC 30. Thickened sawn edge, galvanised steel edge in steeper cross falls.

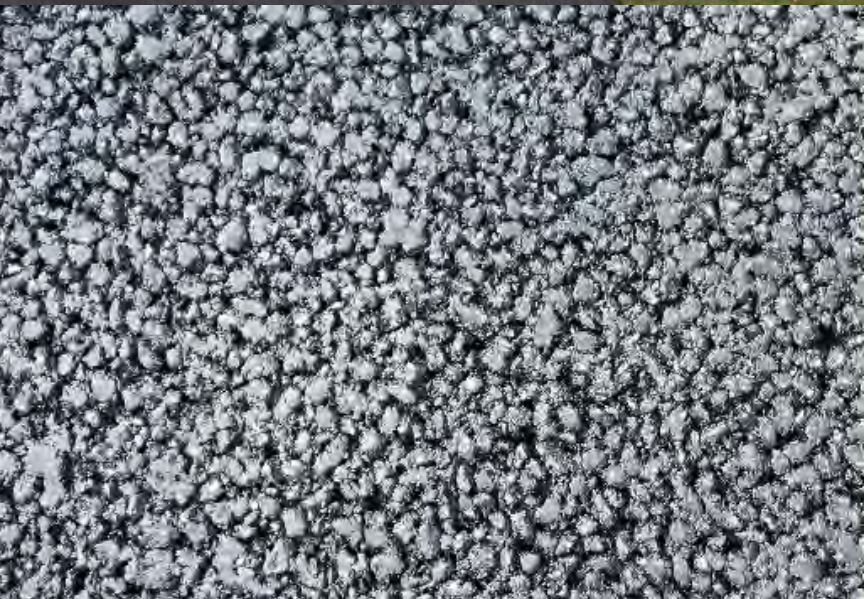
PV2A	Porous Bitumen Location: Footpaths on The Avenue beneath existing tree canopies.	Finish and size: No fines gap graded bitumen. Thickened sawn edge, galvanised steel edge in steeper cross falls.

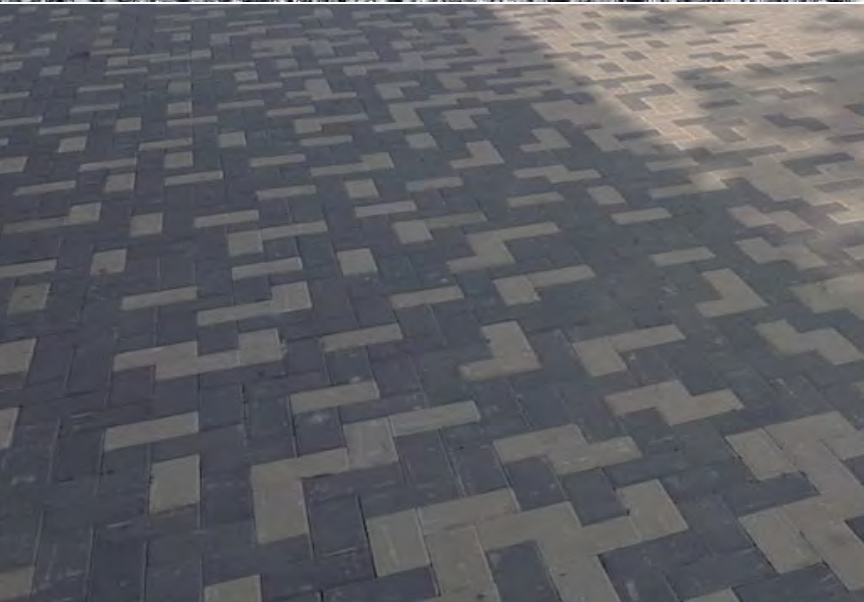
PV4	Shared Zone (Pedestrian Priority)	Product: Interlocking pavers (heavy hehicle loading). Colour: 60% natural grey/ 35% charcoal grey and 5% Almond. Pattern: Basketweave pattern, with colour distributed as a random salt and pepper pattern. Size: 230 x 110 x 80mm Supplier: Boral or similar

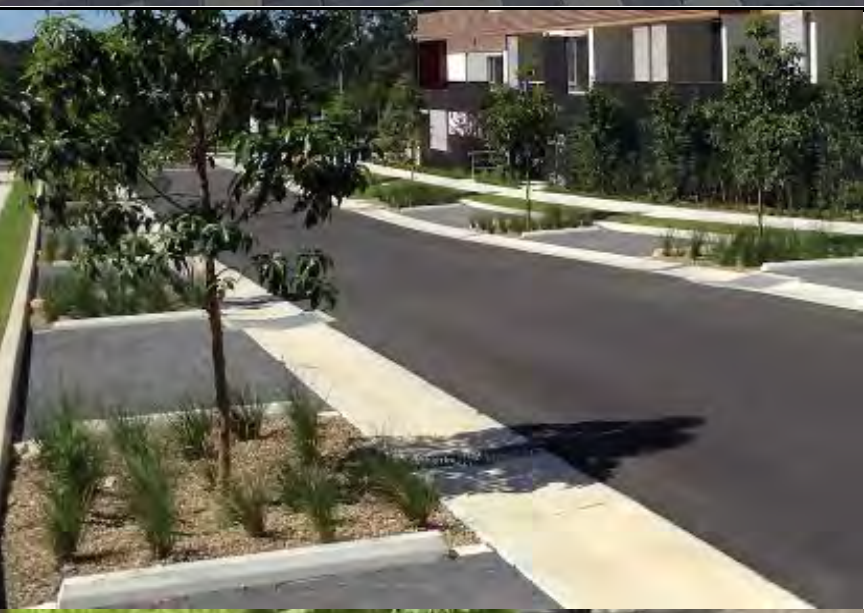
PV5	Porous Unit Pavers Location: Carpark bays	Finish and size: 80mm thick x 206 x 136mm Pattern: Basketweave Colour: Charcoal

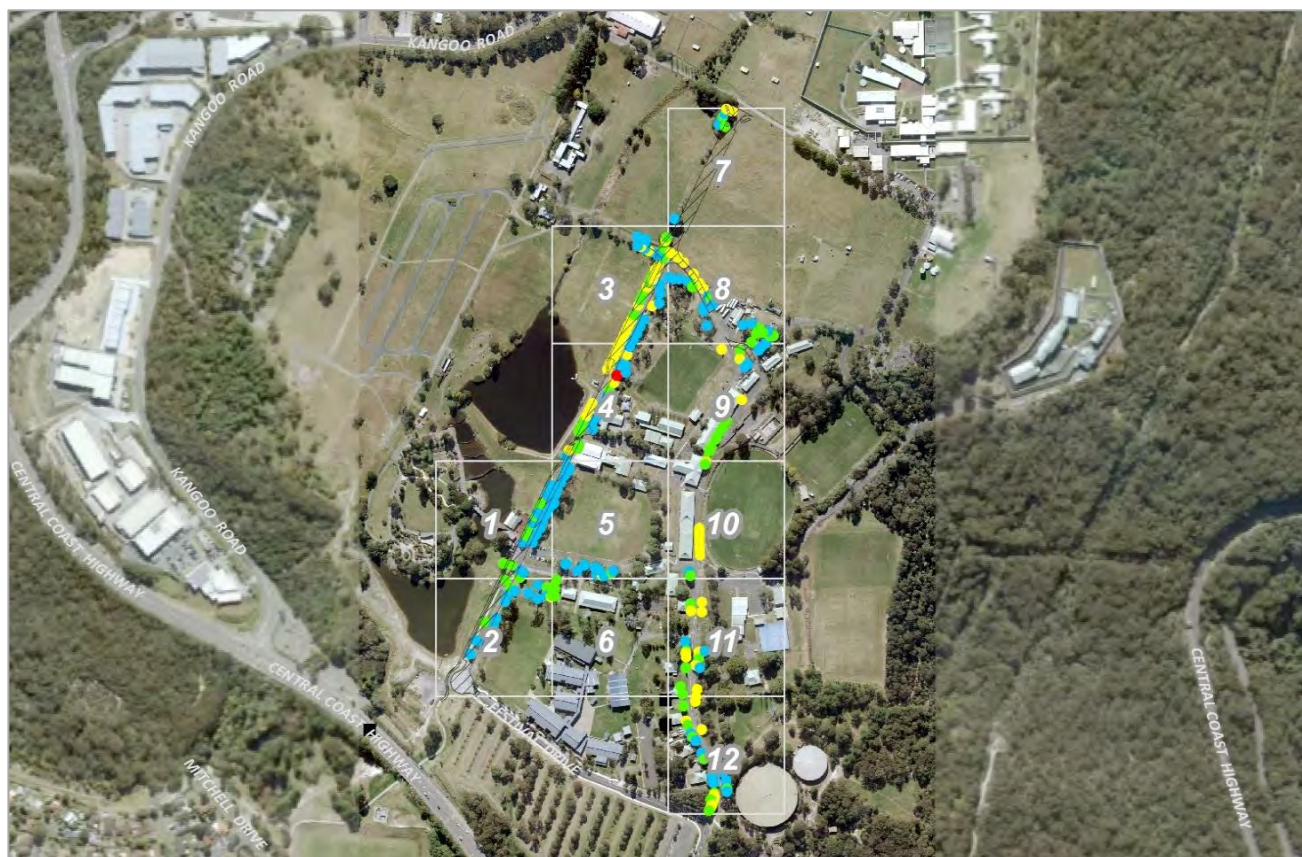
Image 2: Master Map for the Mt Penang Gardens Project

- i. Please find below a Master-map and Sub-maps with the indicative locations of the assessed trees.
- ii. For convenience the calculated Retention Values of the subject trees are colour-coded per the (STARS) *Tree Retention Value - Priority Matrix* which can be found in the Appendix.

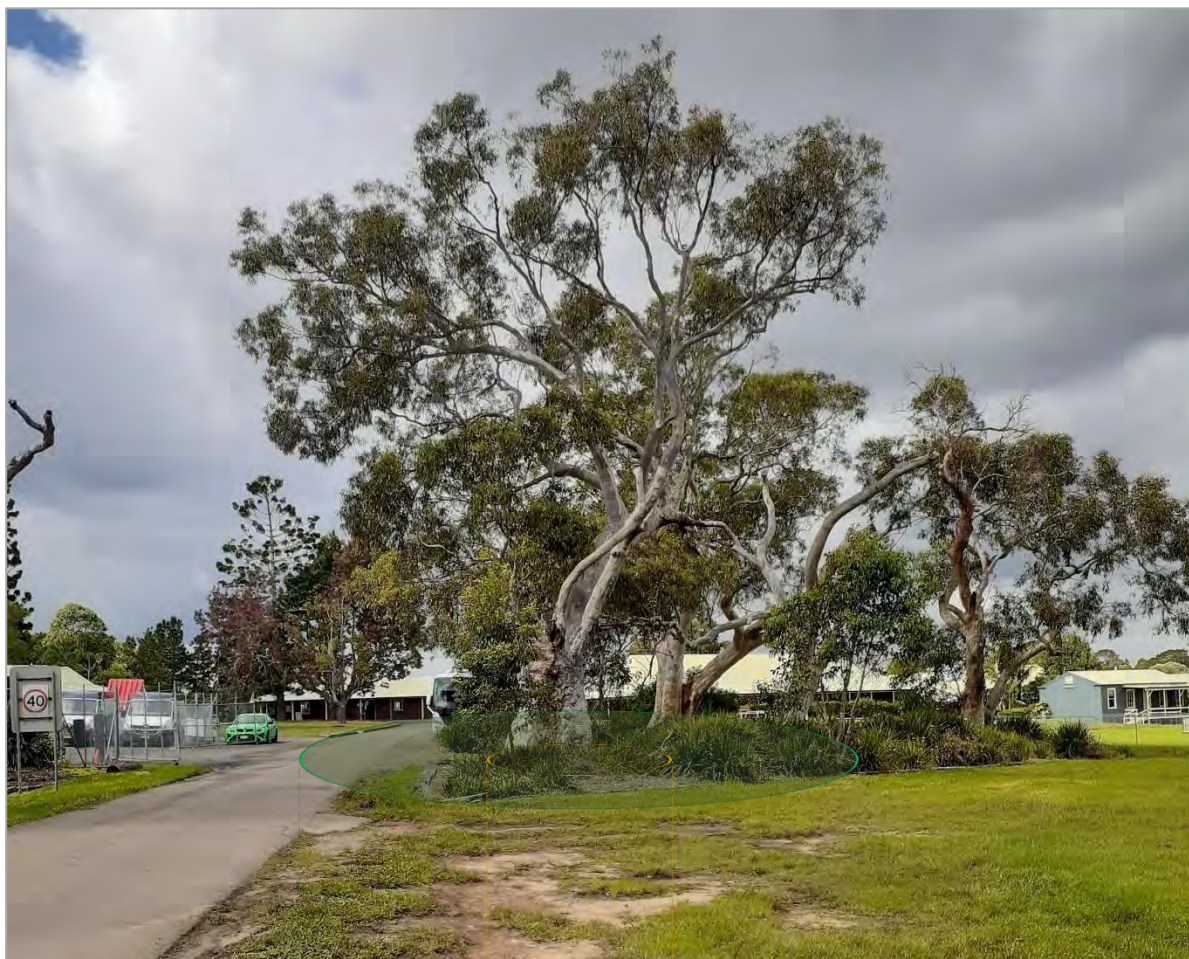
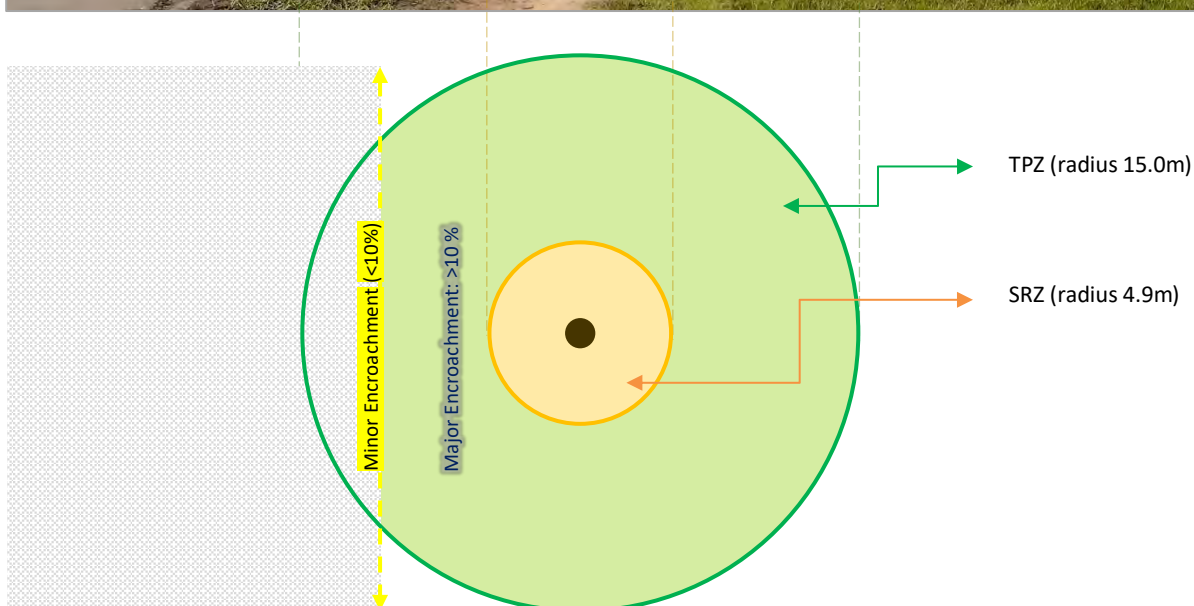
Diagram 1: McCabe Road (Tree 125) *Eucalyptus haemastoma* – Diagrammatical calculated zones

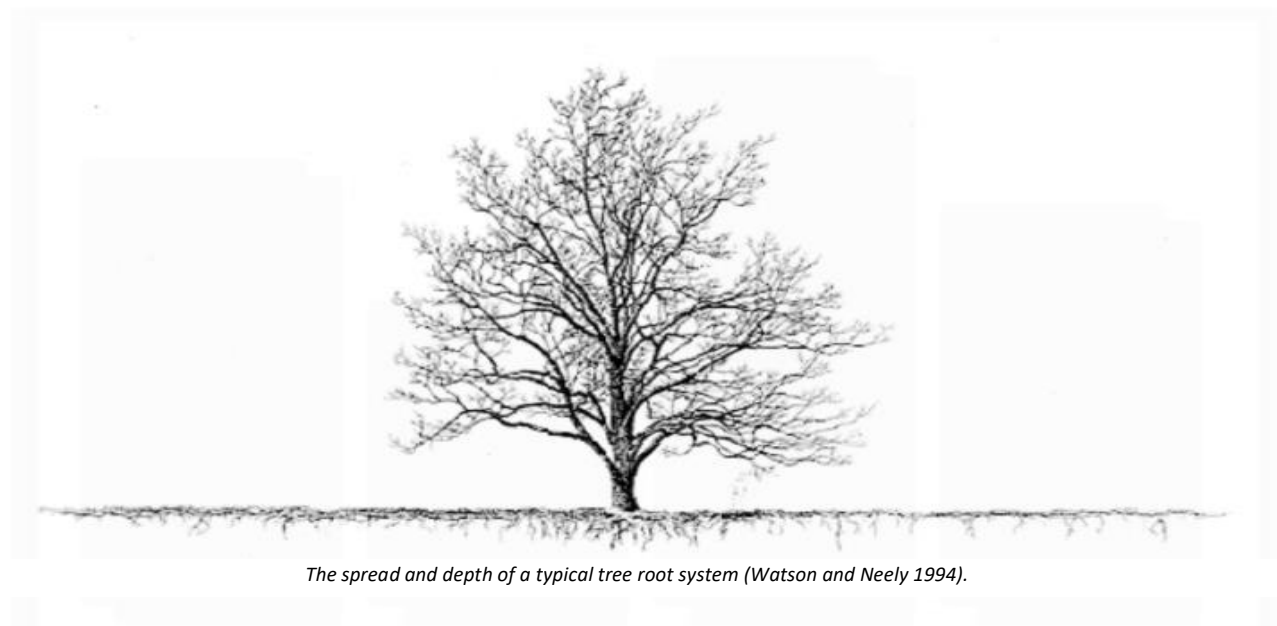
*The spread and depth of a typical tree root system (Watson and Neely 1994).*

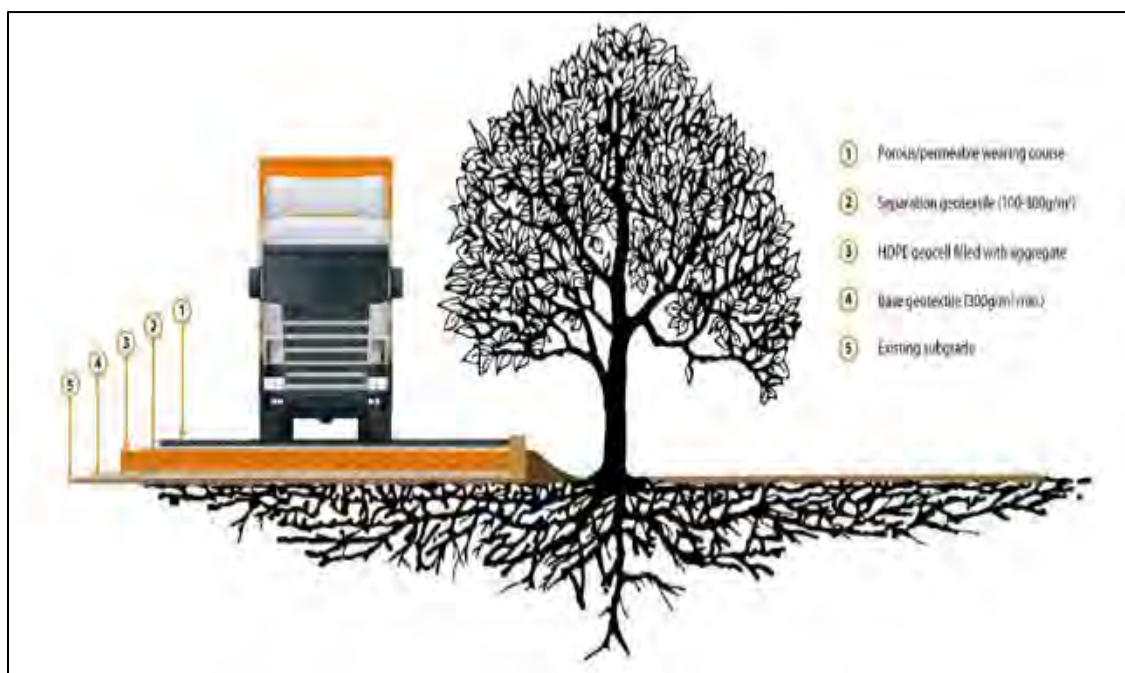
Figure 3: indicative representation of the use of a cellular confinement system over tree root zones.

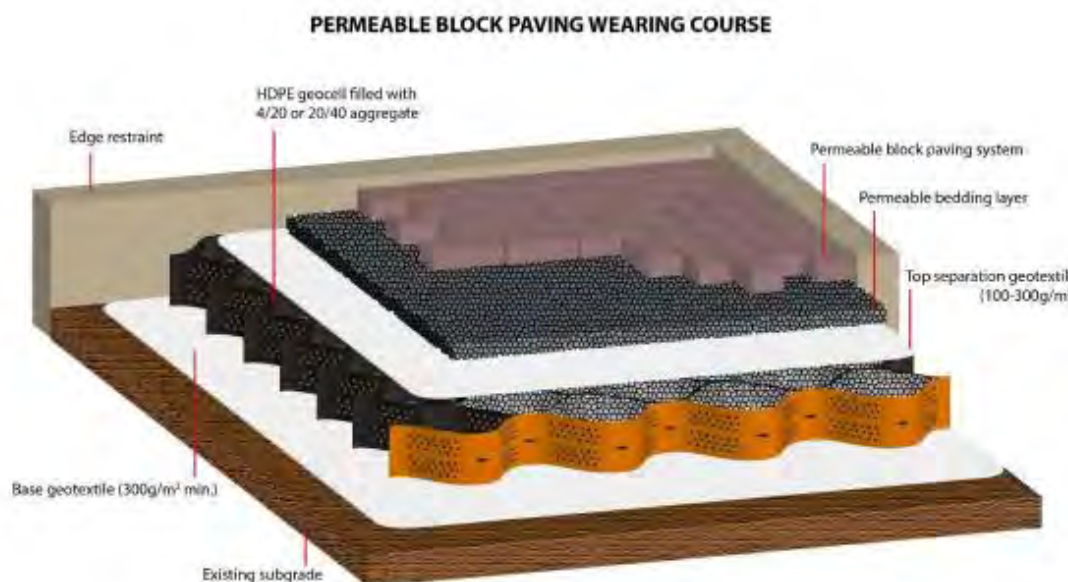
**Figure 5** The recommended specification when installing permeable block paving above a cellular confinement system [image courtesy of Core LP].

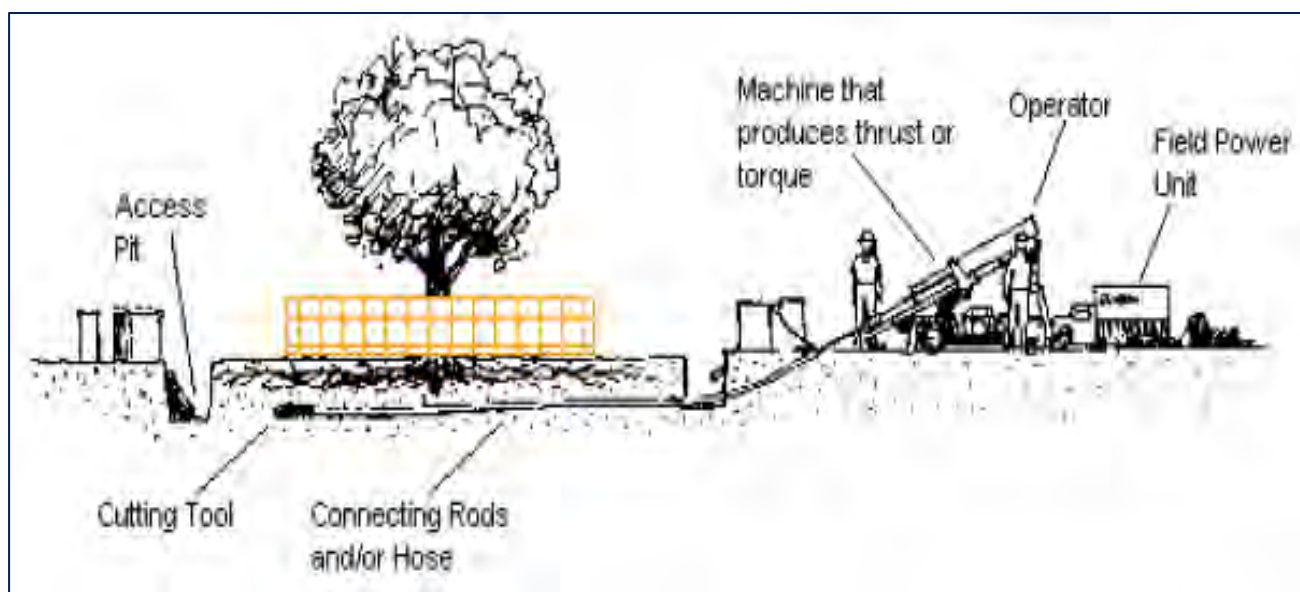
*Indicative Directional Drilling diagram.*

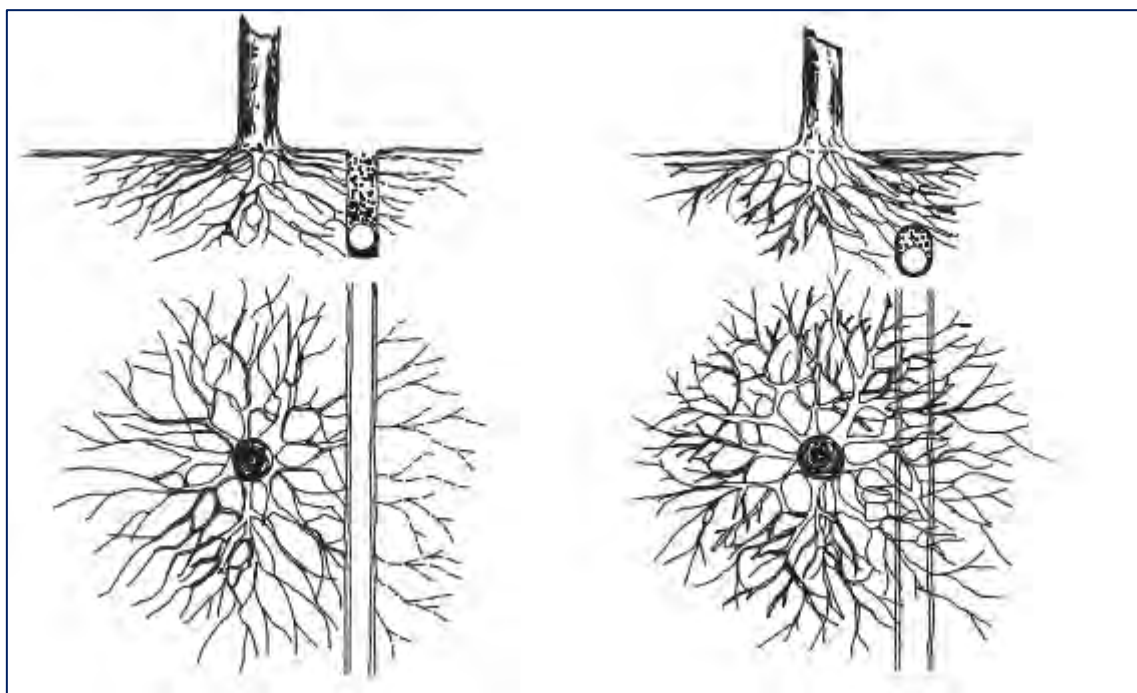
*(Left) Trenching causes major damage, whilst (Right) Thrusting minimizes damage.*
