# Mount Penang Infrastructure Works, Parklands Road Utilities and Related Works: Statement of Heritage Impact

FINAL REPORT

Prepared for Gyde Consulting

2 May 2022

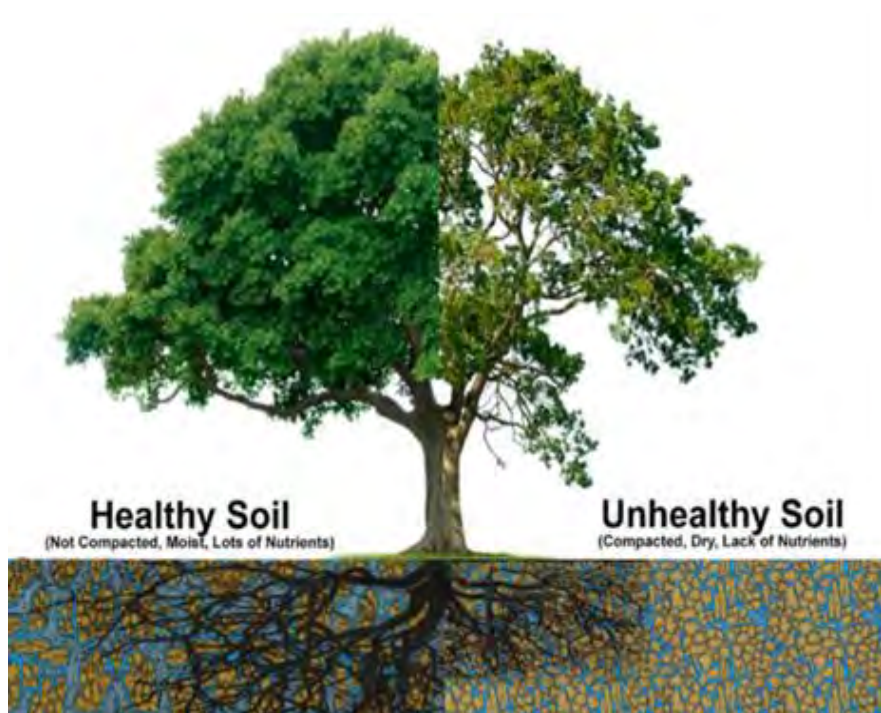
## Surface Openings Around Trees

Indicative tree root growth

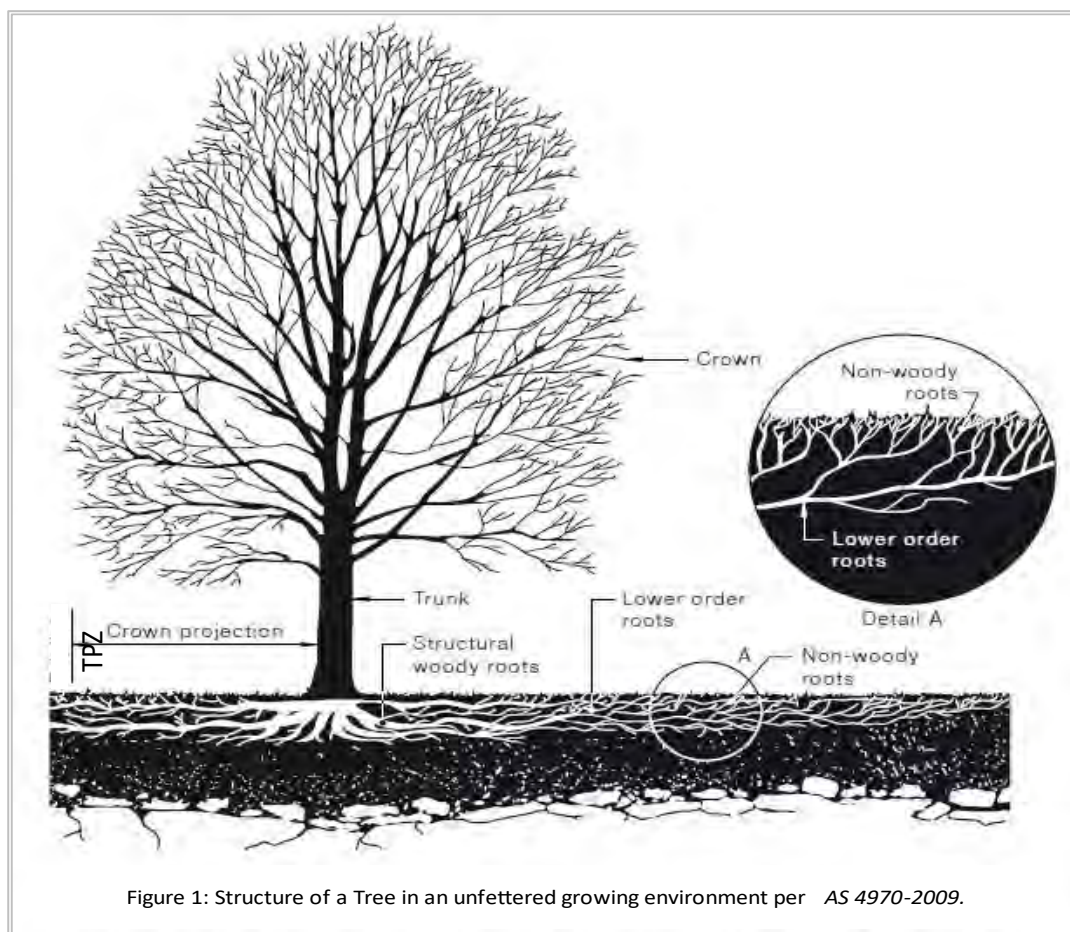
*Drawing 1: Indicative Root System and Rhizosphere of a Healthy Tree.*
