NSW DEPARTMENT OF PUBLIC WORKS AND SERVICES

Mt Penang Dam- Dam Safety Evaluation Prepared for the Festival Development Corporation

Report No: DC 02029

Date: May 2002

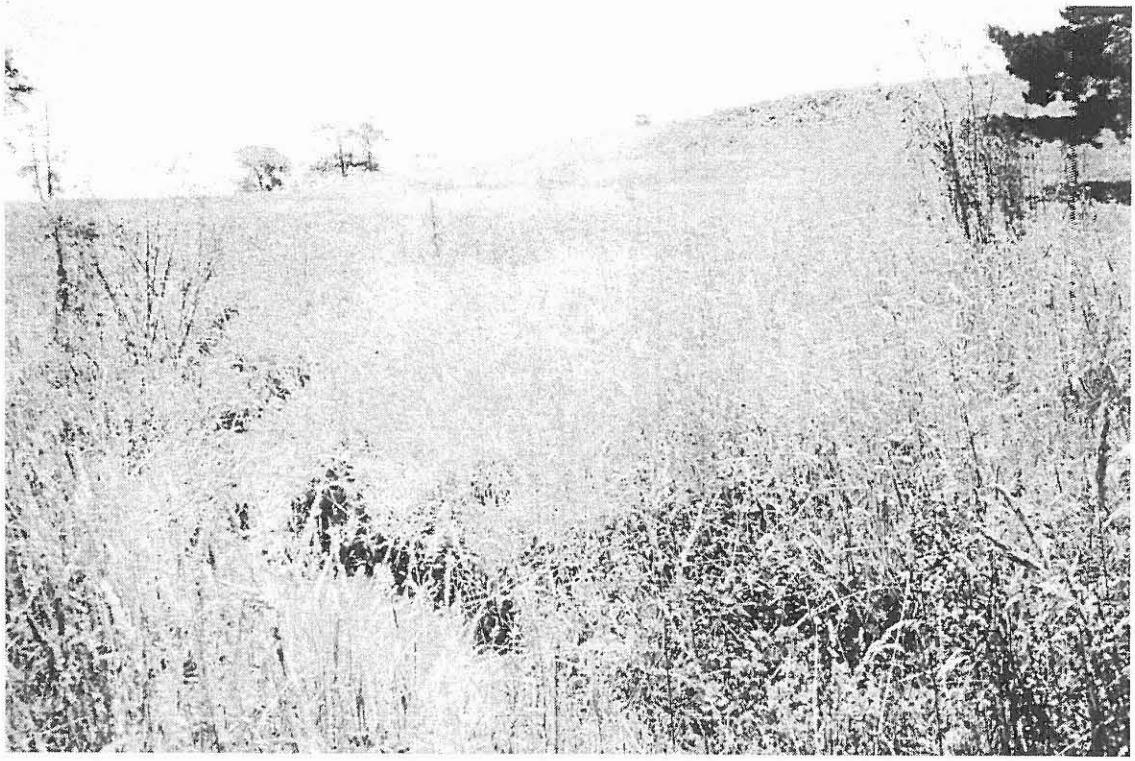
9. Location and extent of any cracks, slips, erosion, or subsidences in earth/rock materials:
An eroded gully/seepage area was observed to the south of the southern embankment toe section.

12. Describe any leakage/seepage through dam, foundations or abutments (give location, quantity, clear or coloured):
Evidence of seepage flow through the southern embankment and flowing along the eroded gully located south of the southern toe. There is no seepage measuring device on site but the seepage is clear and appears to be small.

Seepage gully south of the southern embankment

29. Is the dam considered to be in a safe condition? Indicate any measures necessary to make the dam safe.
The dam appears to be in a safe condition. Spillway and the discharge channel should be well defined and protected against erosion damage. Design and construction details should be perused and compiled for reference. Thick grass cover should be reduced to allow closer inspection of the embankment, seepage areas, feeder channel, spillway and the outflow channel.

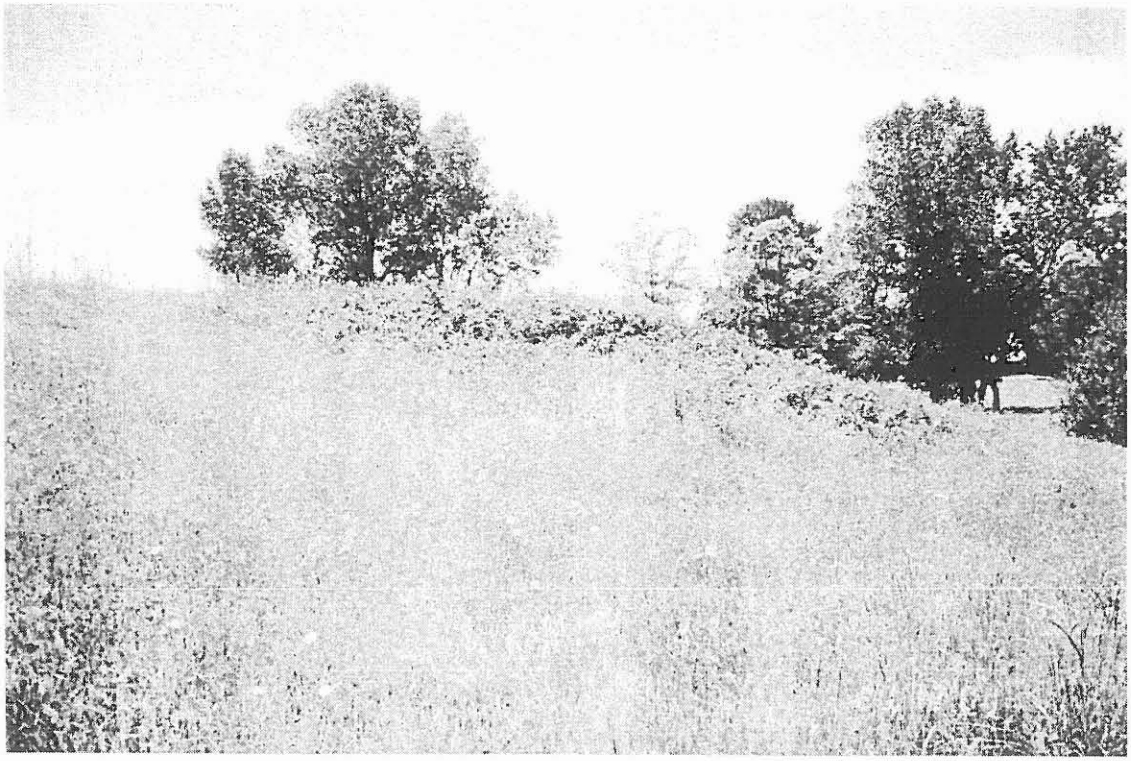
11. General condition of downstream face:
Thick grass cover is obstructing close observation. A seepage area was observed on the southern side of the embankment.

Lush vegetation on the southern embankment downstream face suggesting possible seepage area

Seepage in the gully south of the southern embankment toe section

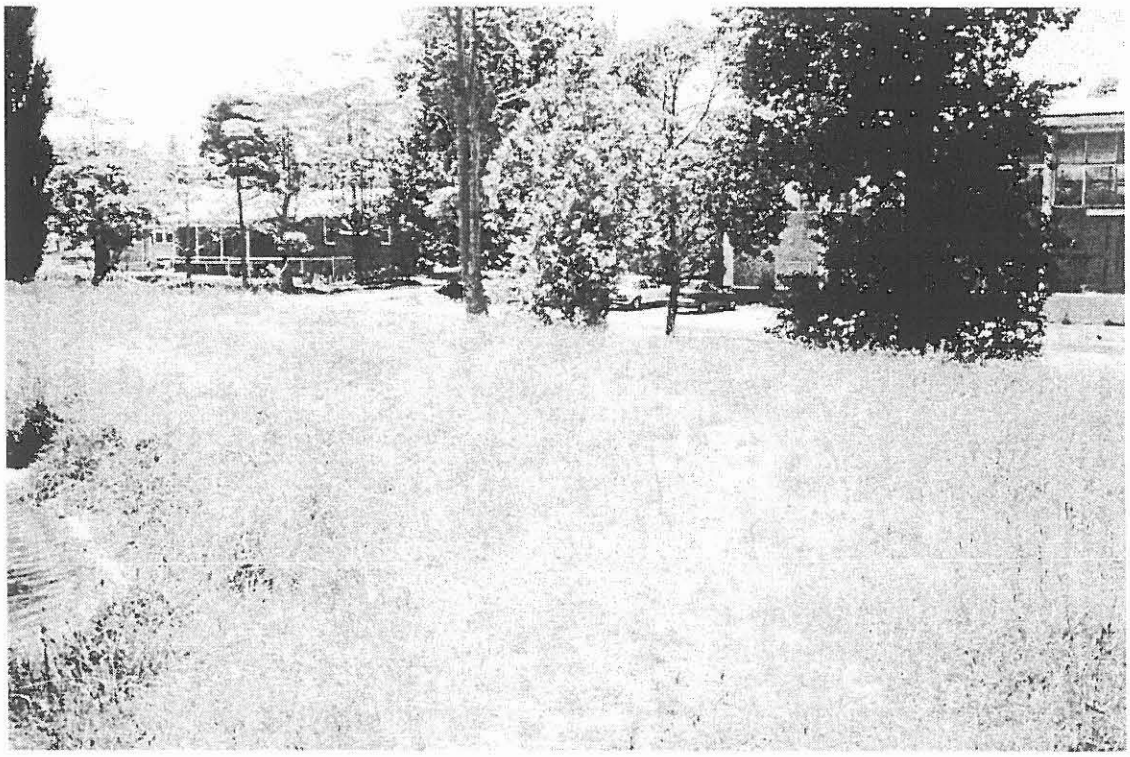
26. State the adverse consequences which justify the sunny day hazard rating.
A school and some buildings are located on the eastern end and there may be ample time to evacuate people. The damage to the buildings may be medium.

School and buildings on the eastern side
