Mount Penang Infrastructure Works Aboriginal Due Diligence Assessment

Prepared for Gyde Consulting 15 June 2022

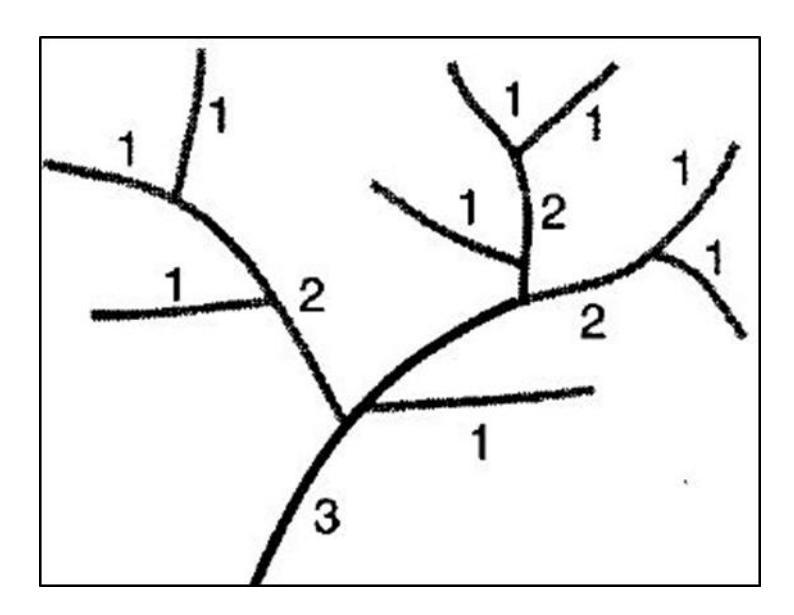
Photo 1 Diagram showing Strahler stream order (Source: Ritter, Kochel, & Miller 1995, pp. 151)

The stream order system used for this assessment was originally developed by Strahler (1952). It functions by adding two streams of equal order at their confluence to form a higher order stream, as shown in Photo 1. As stream order increases, so does the likelihood that the stream would be a perennial source of water.

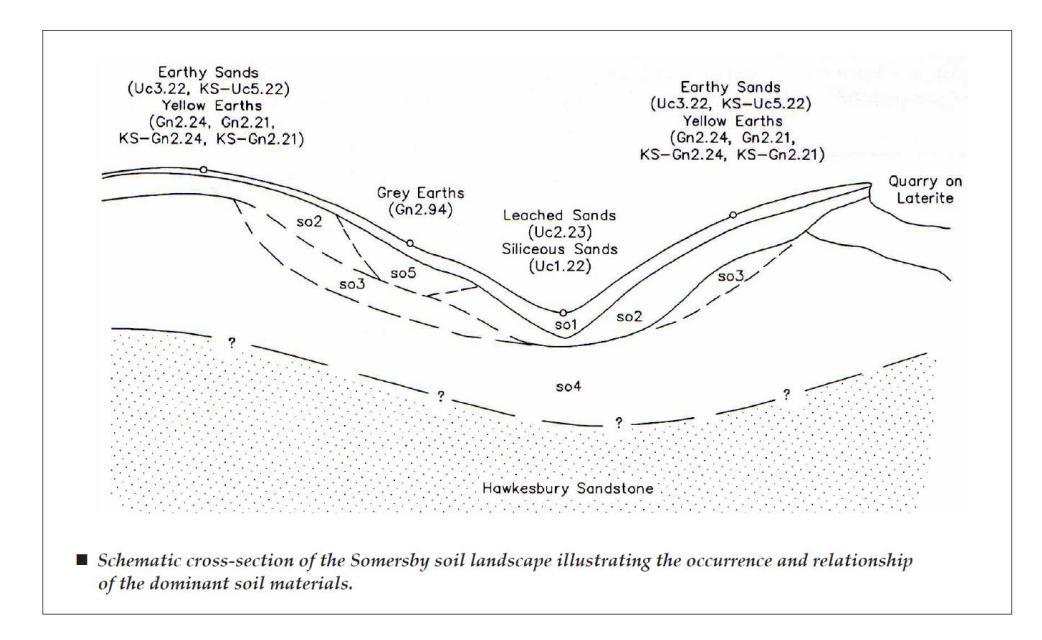
Photo 2 Cross section of the Somersby soil landscape (Source: Department of Planning, Industry and Environment 2020)

Somersby 4 <i>(so4)</i>	This is a strongly weathered sandstone with a distinct sugary appearance. It occurs as deeply weathered parent material. Texture is commonly clayey sand which often becomes sandier with depth. Structure is apedal and massive, and fabric is usually sandy or occasionally earthy. Colour varies from light grey (10YR 8/1) to dull yellow orange (10YR 7/2). It is readily disrupted by a moderate force. Disrupted particles have a feel and appearance similar to sugar crystals. The pH ranges from extremely acid (pH 3.5) to moderately acid (pH 5.0). Strongly weathered fragments of sandstone are commonly found at depth, and roots are few with minimal branching except where bedrock is approached. Rusty coloured piped mottles often follow root traces.
Somersby 5 <i>(so5)</i>	This is a pallid loamy sand to sandy loam to sandy clay loam with apedal massive structure and earthy porous fabric. It occurs as subsoil in wet areas. Surface condition is loose. This material is characterised by pallid soil colours such as greyish yellow brown (10YR 6/2) and dull yellowish brown (10YR 5/4). Rusty coloured piped mottles are present around root channels. The pH ranges from strongly acid (pH 4.0) to moderately acid (pH 5.5). Stone fragments and charcoal fragments are rare, and roots are few to common.

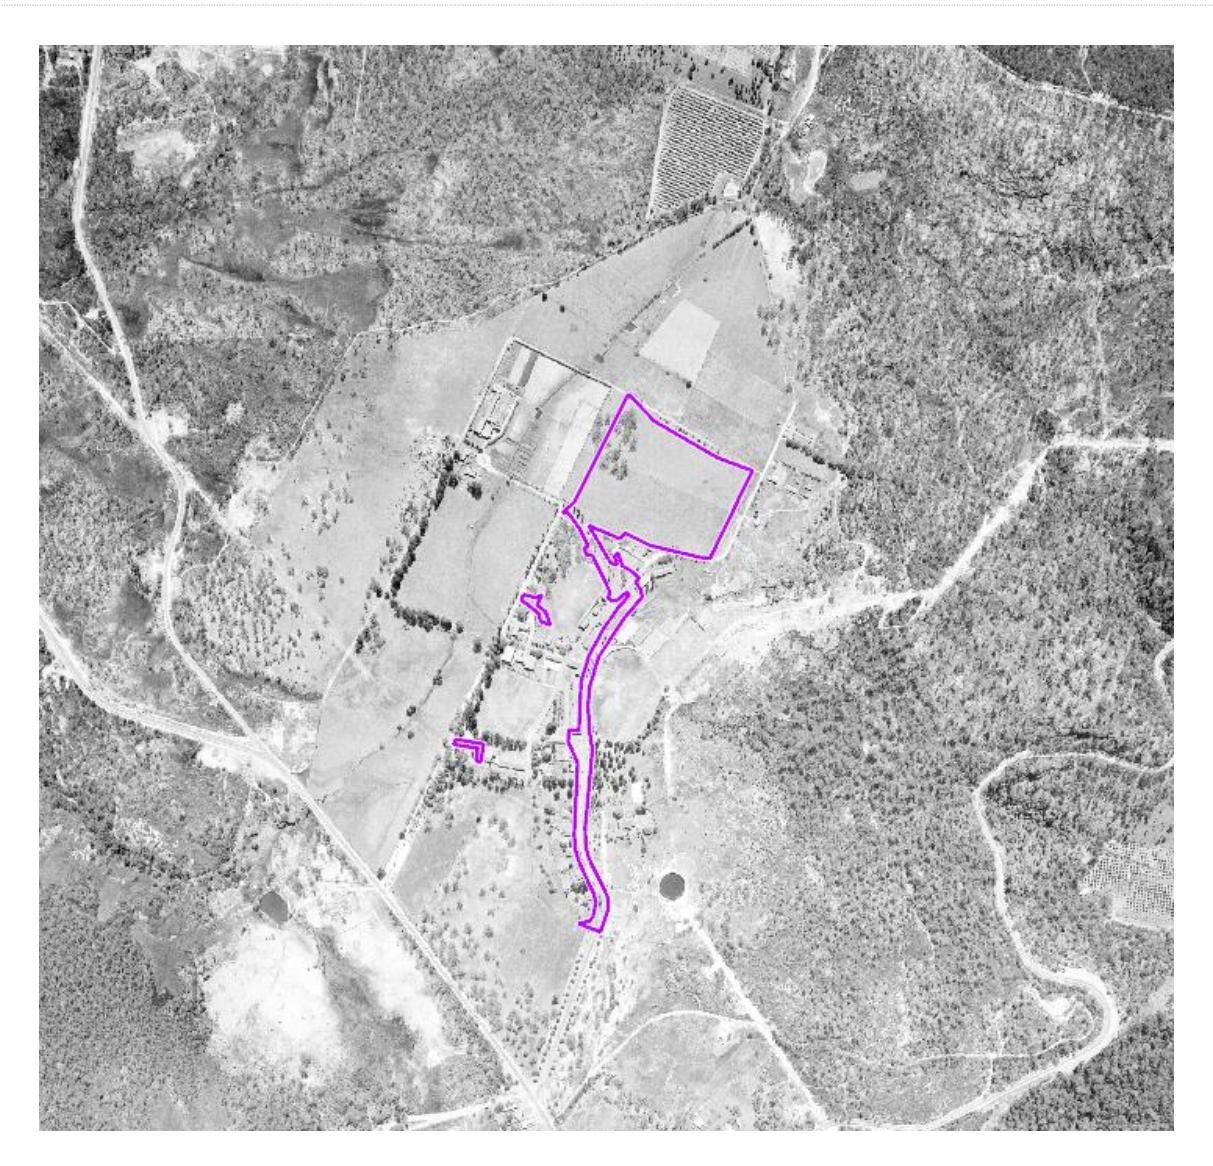
Photo 3 1965 aerial photograph, with the study area outlined in orange (Source: NSW Spatial Services)

Photo 3) shows extensive vegetation clearance for the parkland grounds and surrounding vicinity. By 1976 (Photo 4) there appears to be minimal change except for the construction of a dam to the west of the study area. In the 1984 aerial (Photo 5) it appears that a second dam to the west of Parklands Road has been constructed adjacent to the previous dam from the decade prior. In the 1990s, (Photo 6) major infrastructure developments occurred with residential dwellings seen to the south and industrial development to the north. However, minimal change can be seen to the study area itself. Lastly, in the 2006 aerial (Photo 7), development of the Penang Parklands can be seen to the south of the dam seen in the 1984 aerial. This is likely the development of the Waterfall Café and the surrounding gardens.

When reviewing the historical land use of the study area, it is clear that the site has been subject to increasing levels of disturbance since the early 1900s with modern development evident in the historical aerials from the 1960's. The 1965 historical aerial photograph (

Photo 3) depicts tree clearances within the site Mount Penang site and the established pre-existing roads and buildings related to the history of the previous occupation of the study area. By 1984, (Photo 5), a dam had been construction of to the west of Parklands Road. In the 1990s and mid 2000s (Photo 6 and Photo 7) extensive residential and industrial developments had occurred surrounding the Parklands Precinct and the Café, and gardens located to the west of Parklands Road were established. Although the study area was completely cleared of vegetation, significant disturbance had occurred surrounding the established roads within Mount Penang Parklands, including landscaping, development of the boys' school and subsurface infrastructure.

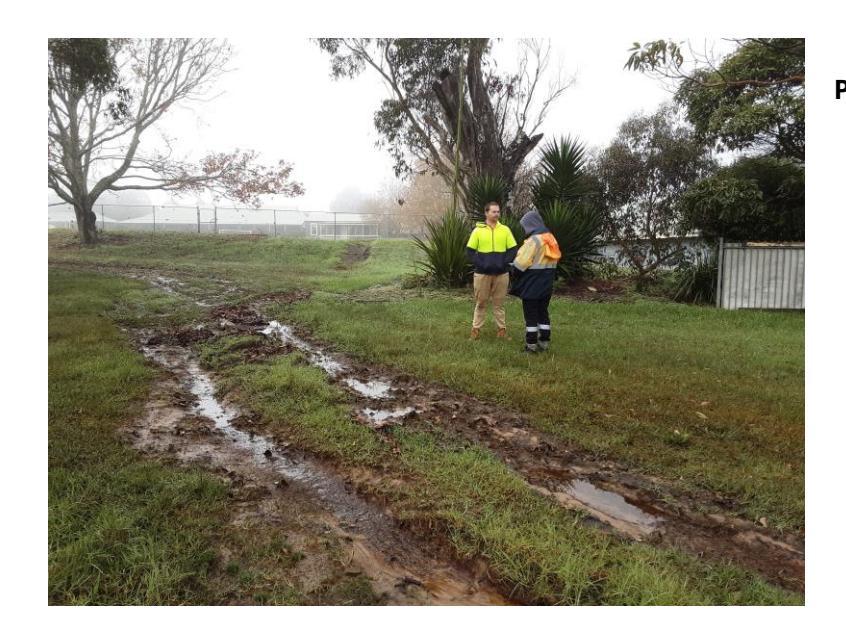
Photo 19 View of area proposed for electrical trenching on the eastern side of Parklands Road, featuring some ground visibility due to vehicle tracks in waterlogged soil, facing east

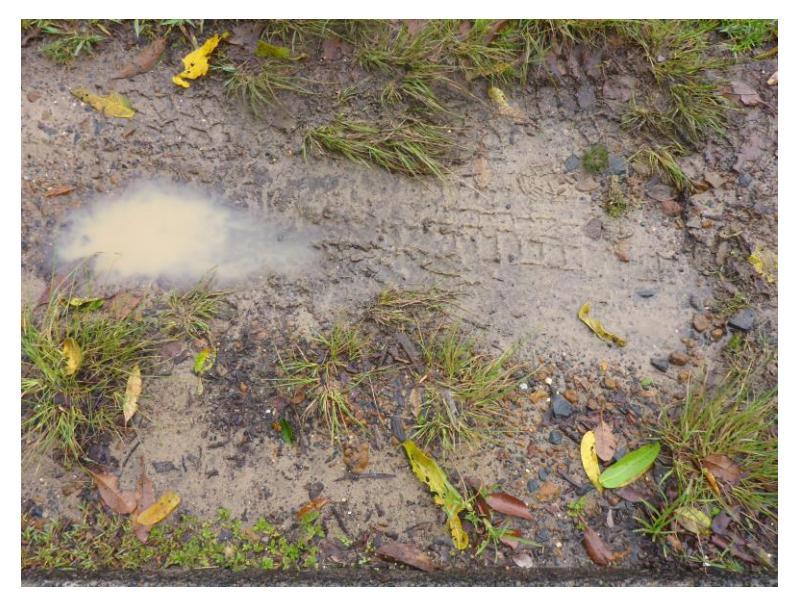
Overall, the study area displayed areas of low exposure (5-10%) around Parklands Road and in the northern paddock (Photo 20, Photo 21, Photo 22, Photo 23, Photo 24, Photo 25, Photo 26) and low to moderate exposure to the north of Parklands Road (5-20%) (Photo 27, Photo 28, Photo 29, Photo 30). Areas of exposure are increased around fence lines and in some areas around animal and ground disturbances.

Photo 20 Area of exposure located beside Parklands Road

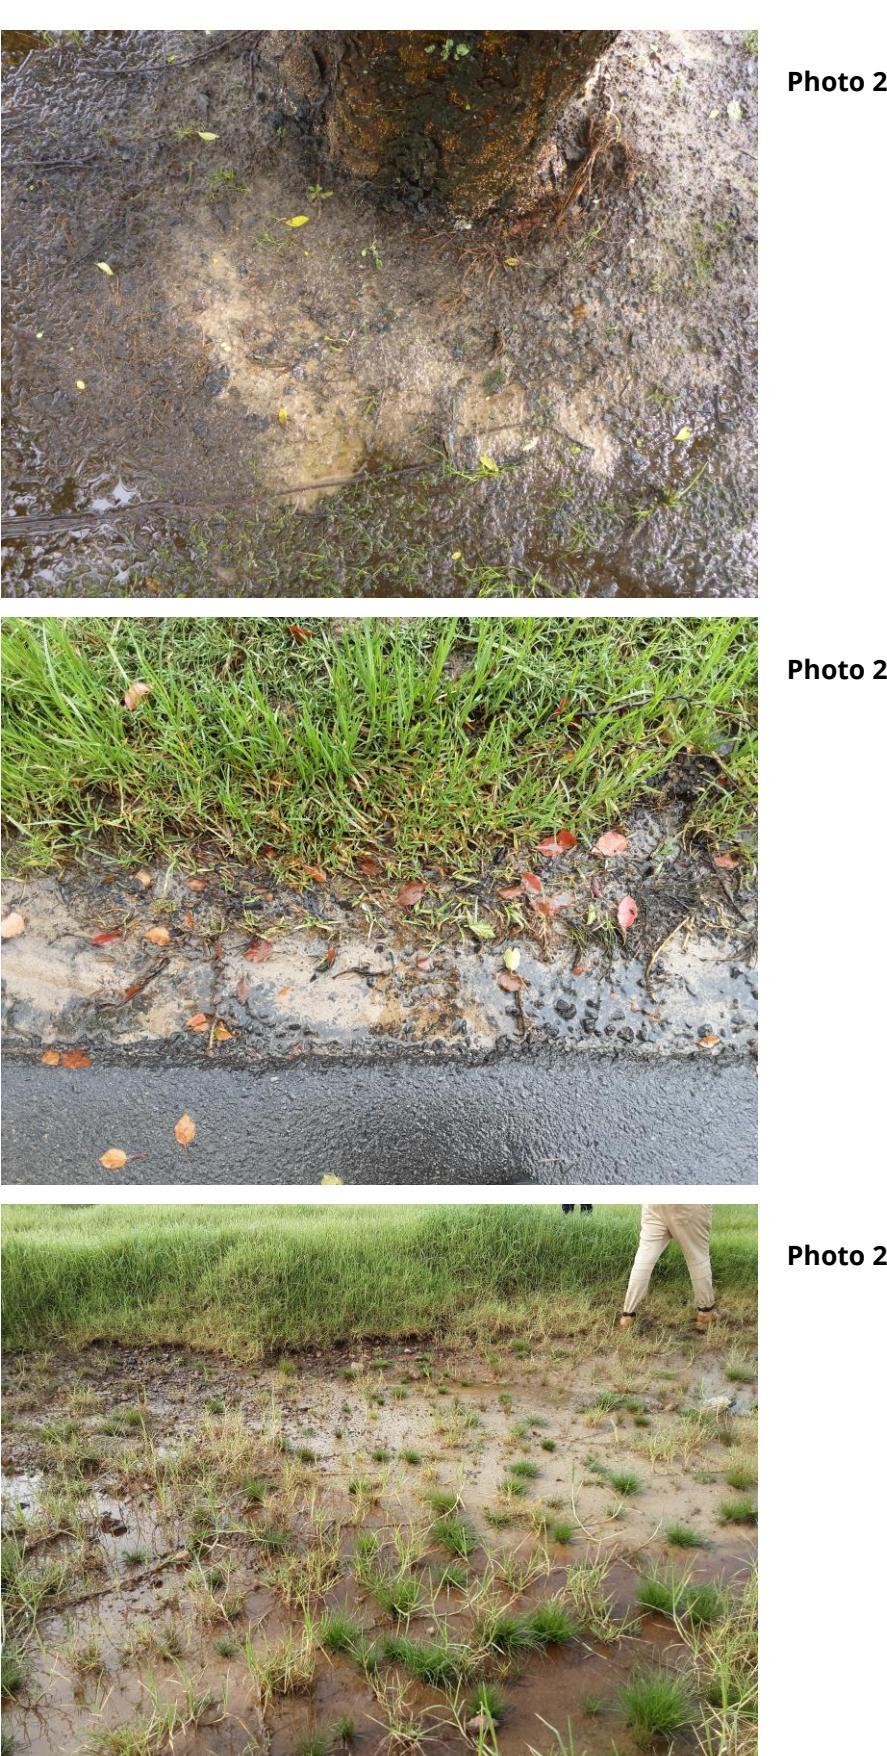
Photo 24 Area of exposure near Parklands Road at the base of a tree

Photo 25 Area of exposure to the east of Parklands Road

Photo 26 Area of exposure near an animal water /feed trough in the central portion of the paddock proposed for the northern ancillary area, facing north-west

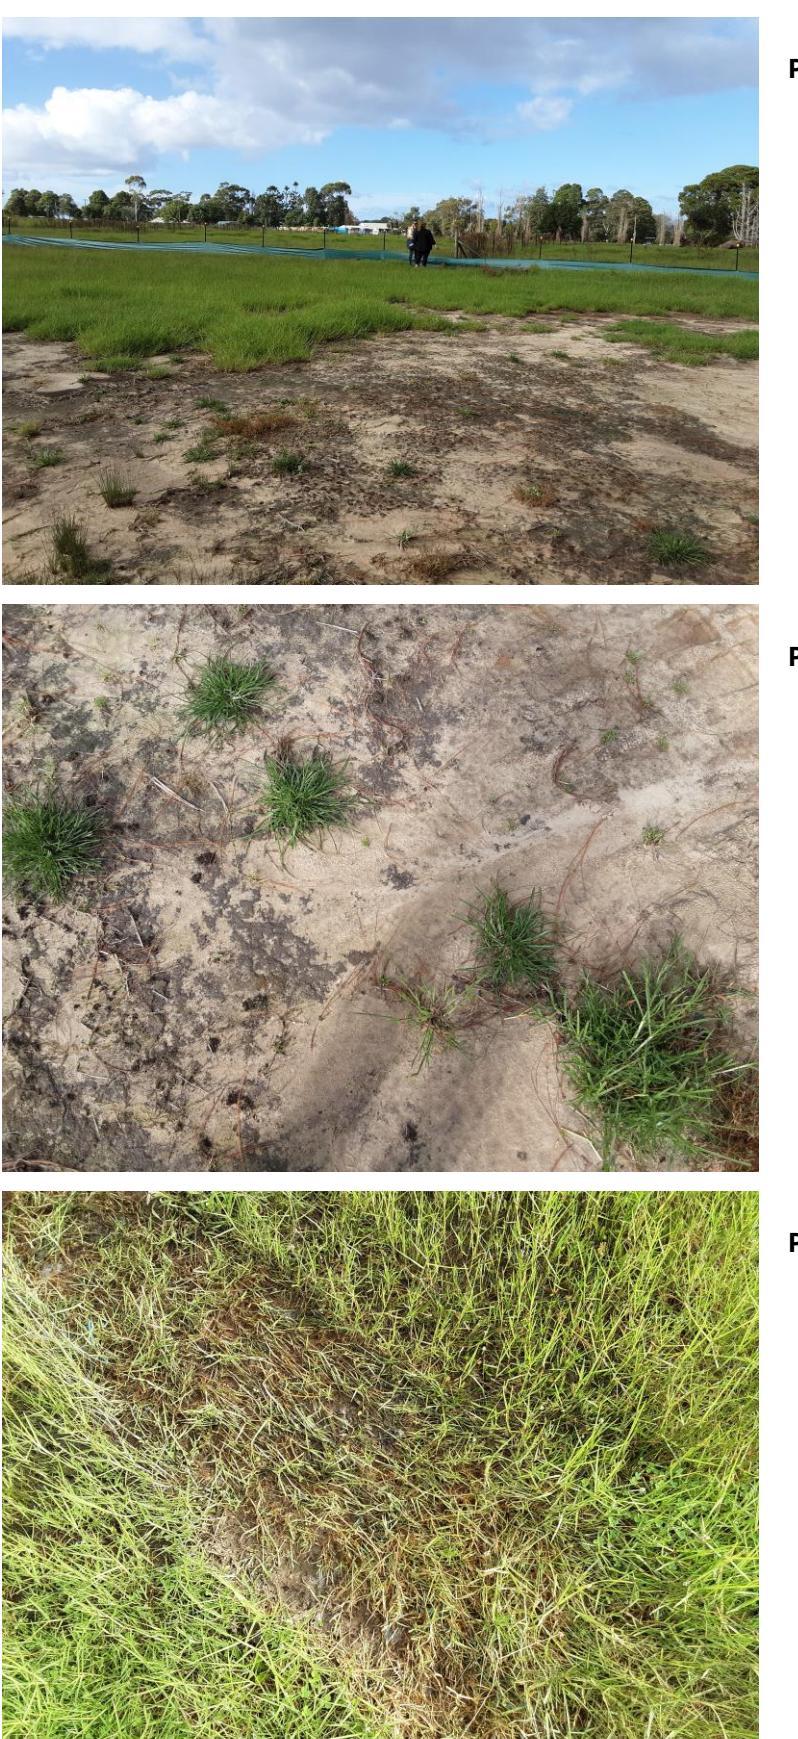
Photo 27 Area of exposure in the northern portion of the study area located to the north of Parklands Road

Photo 28 Area of exposure in the northern portion of the study area located to the north of Parklands Road

Photo 29 Area of exposure in the northern portion of the study area located to the north of Parklands Road due to ground disturbance from vehicles

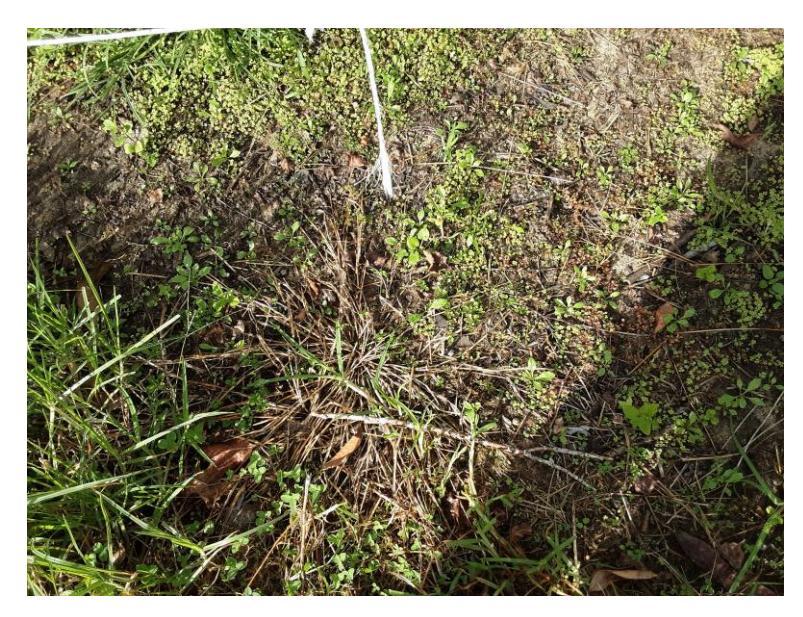
Photo 30 Area of exposure in the northern portion of the study area located to the north of Parklands Road

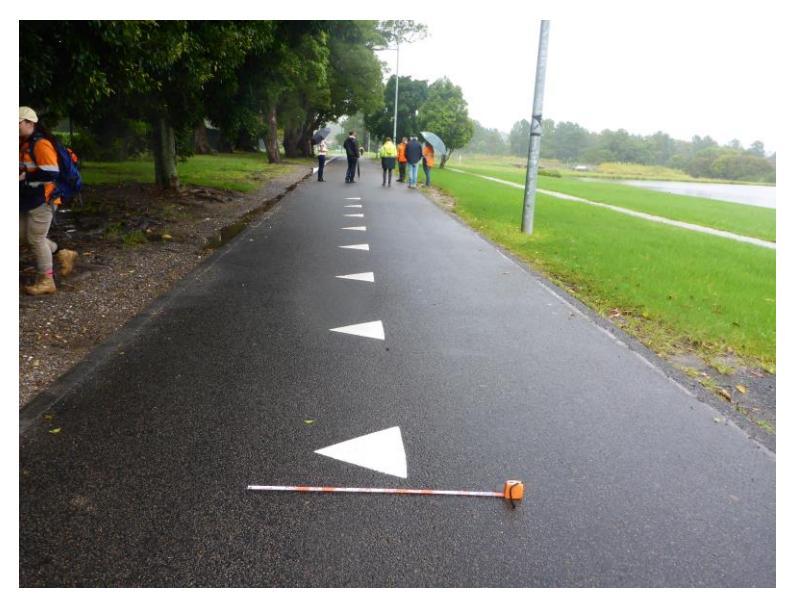
The study area as a whole has been subject to disturbance by human activity. Historic and recent aerials show that the study area has been subject to tree clearing, the development of a boys school in the early 1900s and associated modern subsurface infrastructure and landscaping over the past 60 years. These disturbances were noted during the archaeological survey and are shown in Photo 31, Photo 32, Photo 33, Photo 34, Photo 35, Photo 36 and Photo 37.

Photo 31 Parklands Road, facing south

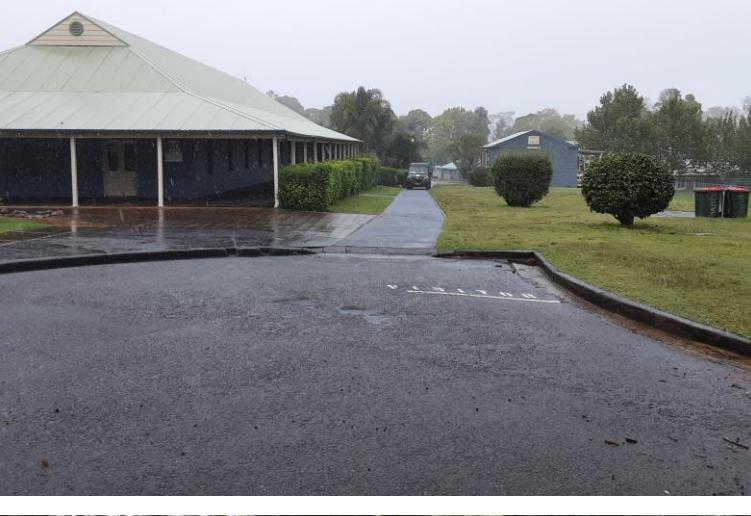
- Photo 34 View of historic paving's associated with the historic boys school, facing east
