Report on Geotechnical Investigation

Proposed Mt Penang Roads Upgrade Baxter Track and Parklands Road, Kariong

Prepared for Hunter and Central Coast Development Corporation

> Project 206464.00 September 2021

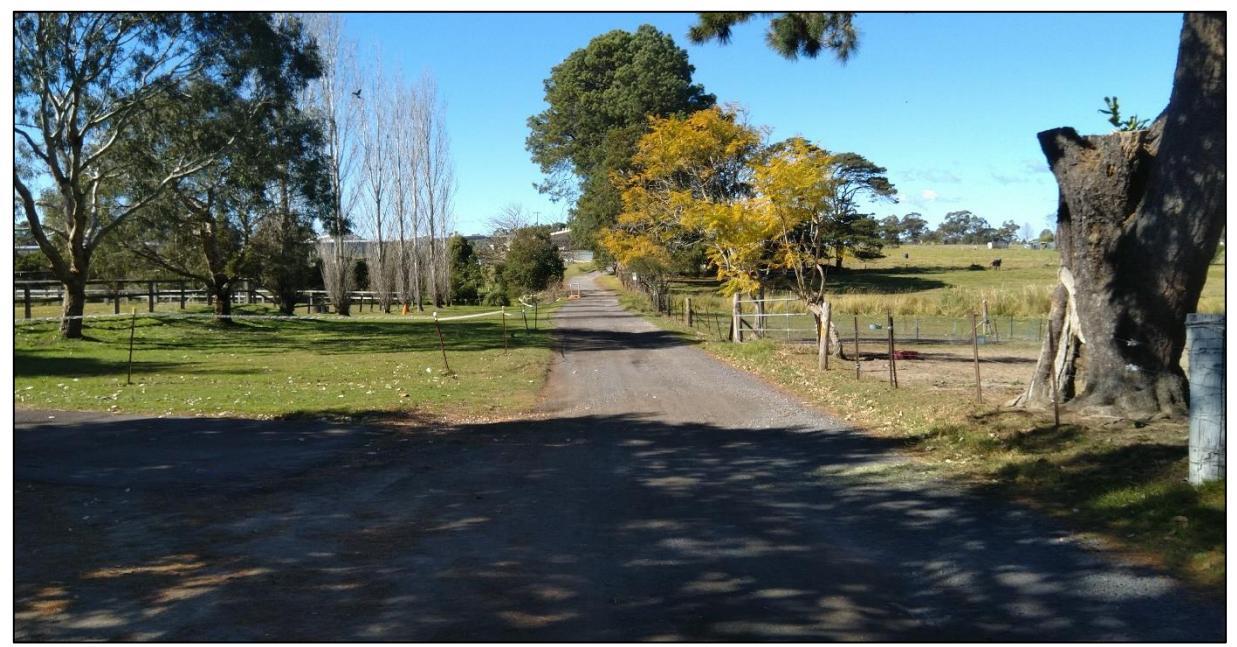
Figure 1: Photograph showing existing Baxter Track, taken from near intersection with Kangoo Road, looking south-west

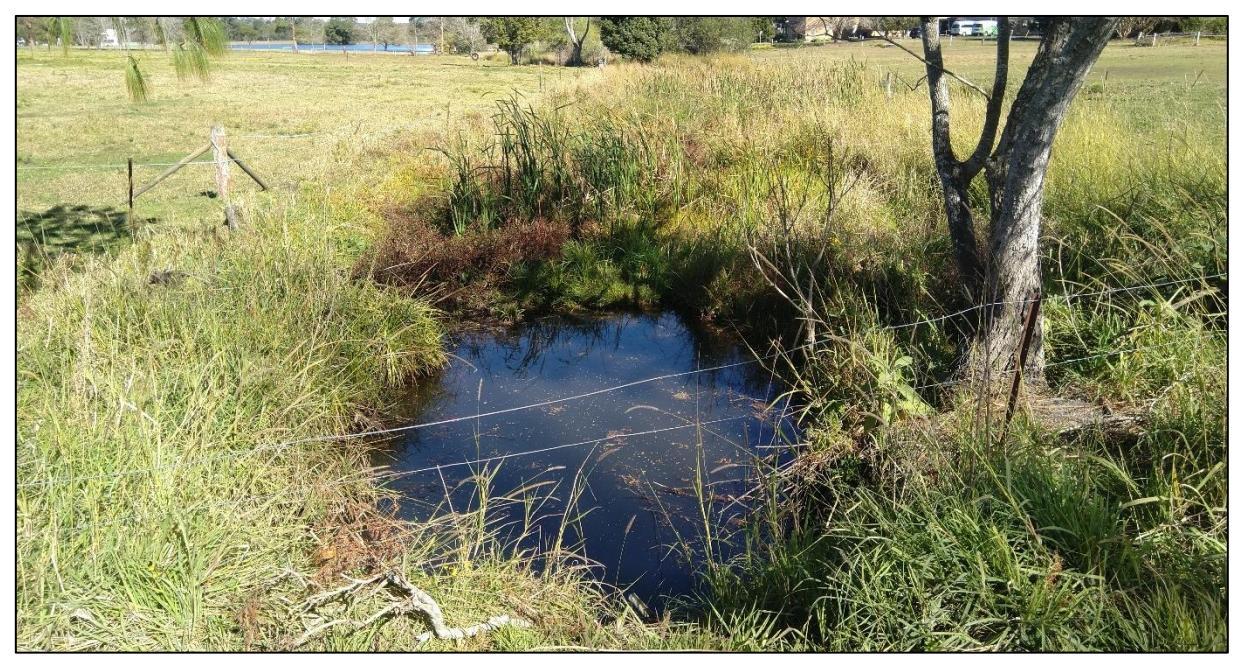
Figure 2: Photograph showing existing drainage line and location of proposed culvert at approximate CH190

Based on the results of the investigation, the conditions encountered at the proposed culvert location comprise soft grey sandy silt to a depth of 0.3 m, overlying firm grey sandy silt to 0.8 m depth, then firm pale grey residual sandy clay.

It is recommended that the culvert be supported within the firm pale grey residual sandy clay as identified below 0.8 m depth in Bore 3.

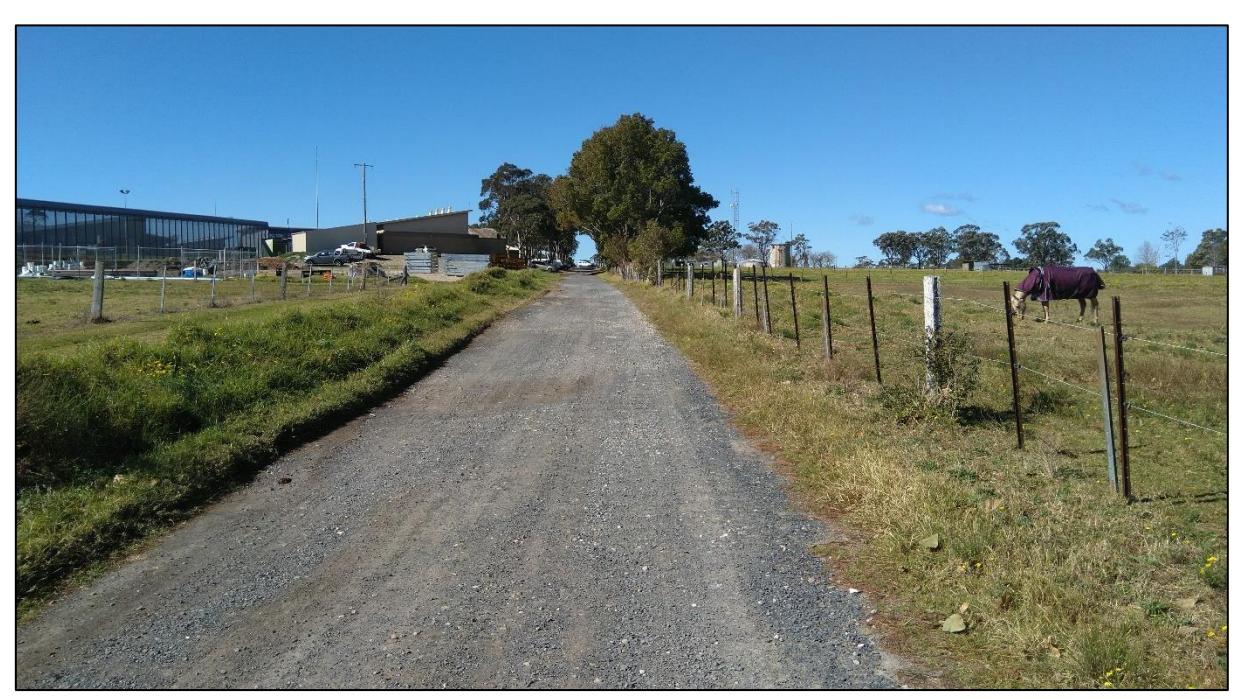
Figure 3: Photograph showing existing Baxter Track, taken from near proposed driveway entrance to Frank Baxter Juvenile Justice Centre, looking south-west

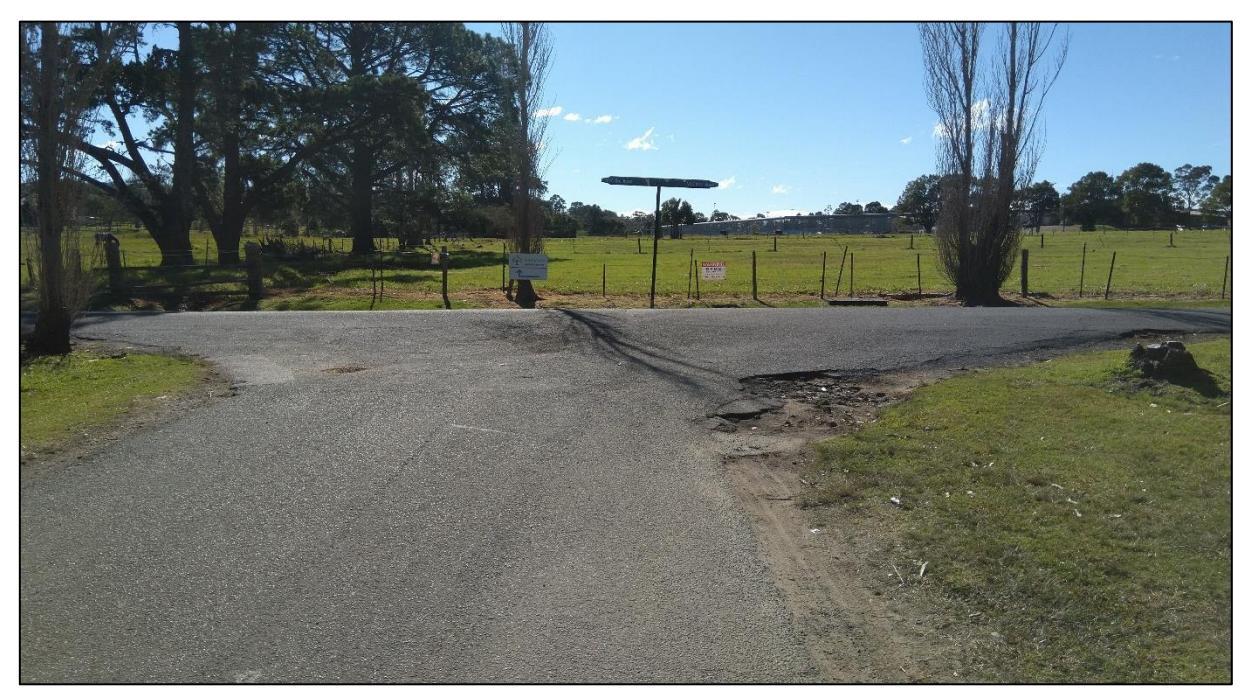
Figure 4: Photograph showing existing intersection of Parklands Road and McCabe Road and location of proposed roundabout and road extension, looking north-east

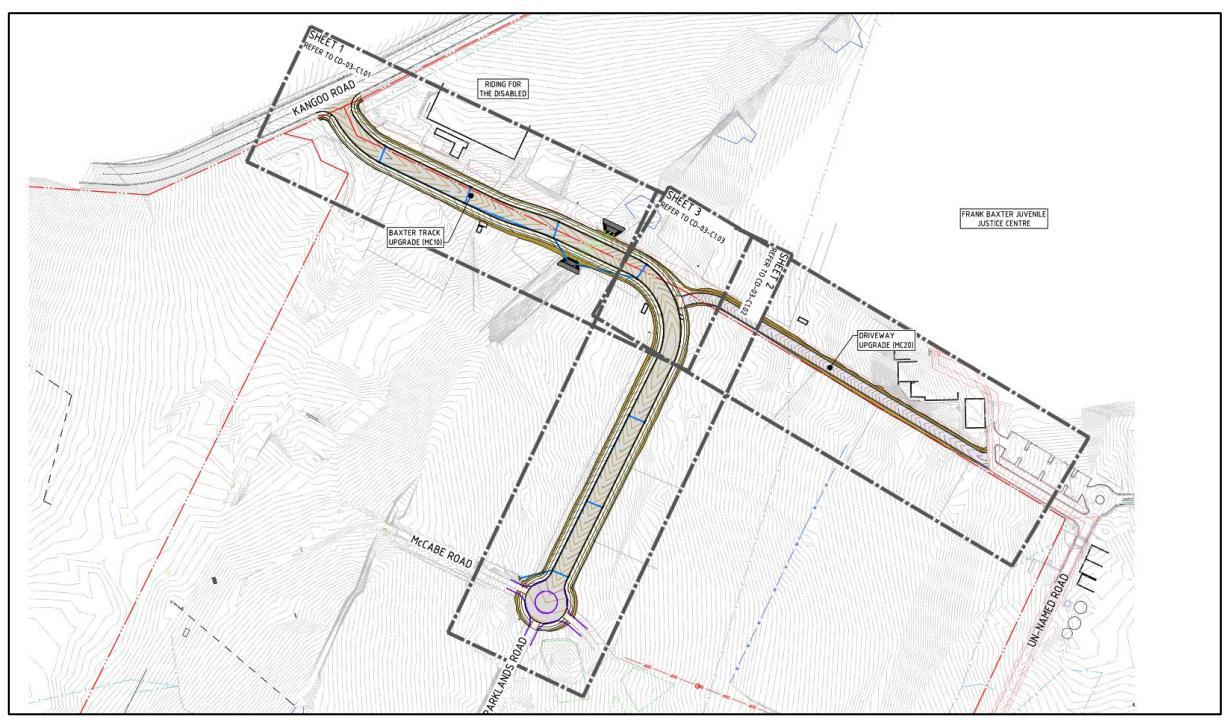
Figure 5: Plan of the proposed roads upgrade

- A sealed at-grade upgrade to the western section of Baxter Track, extending from Kangoo Road to approximately CH260, with a culvert to be constructed at approximately CH190;
- Construction of a new at-grade extension of Parklands Road to the north from approximate CH260 to CH460 to connect with the Baxter Track upgrade;
- A new roundabout at the intersection of Parklands Road and McCabe Road at approximate CH460; and,
- A driveway upgrade to the remaining eastern section of the Baxter Track, with entrance from the new Baxter Track/Parklands Road upgrade to Frank Baxter Juvenile Justice Centre.

A plan of the proposed roads upgrade is shown in Figure 5.

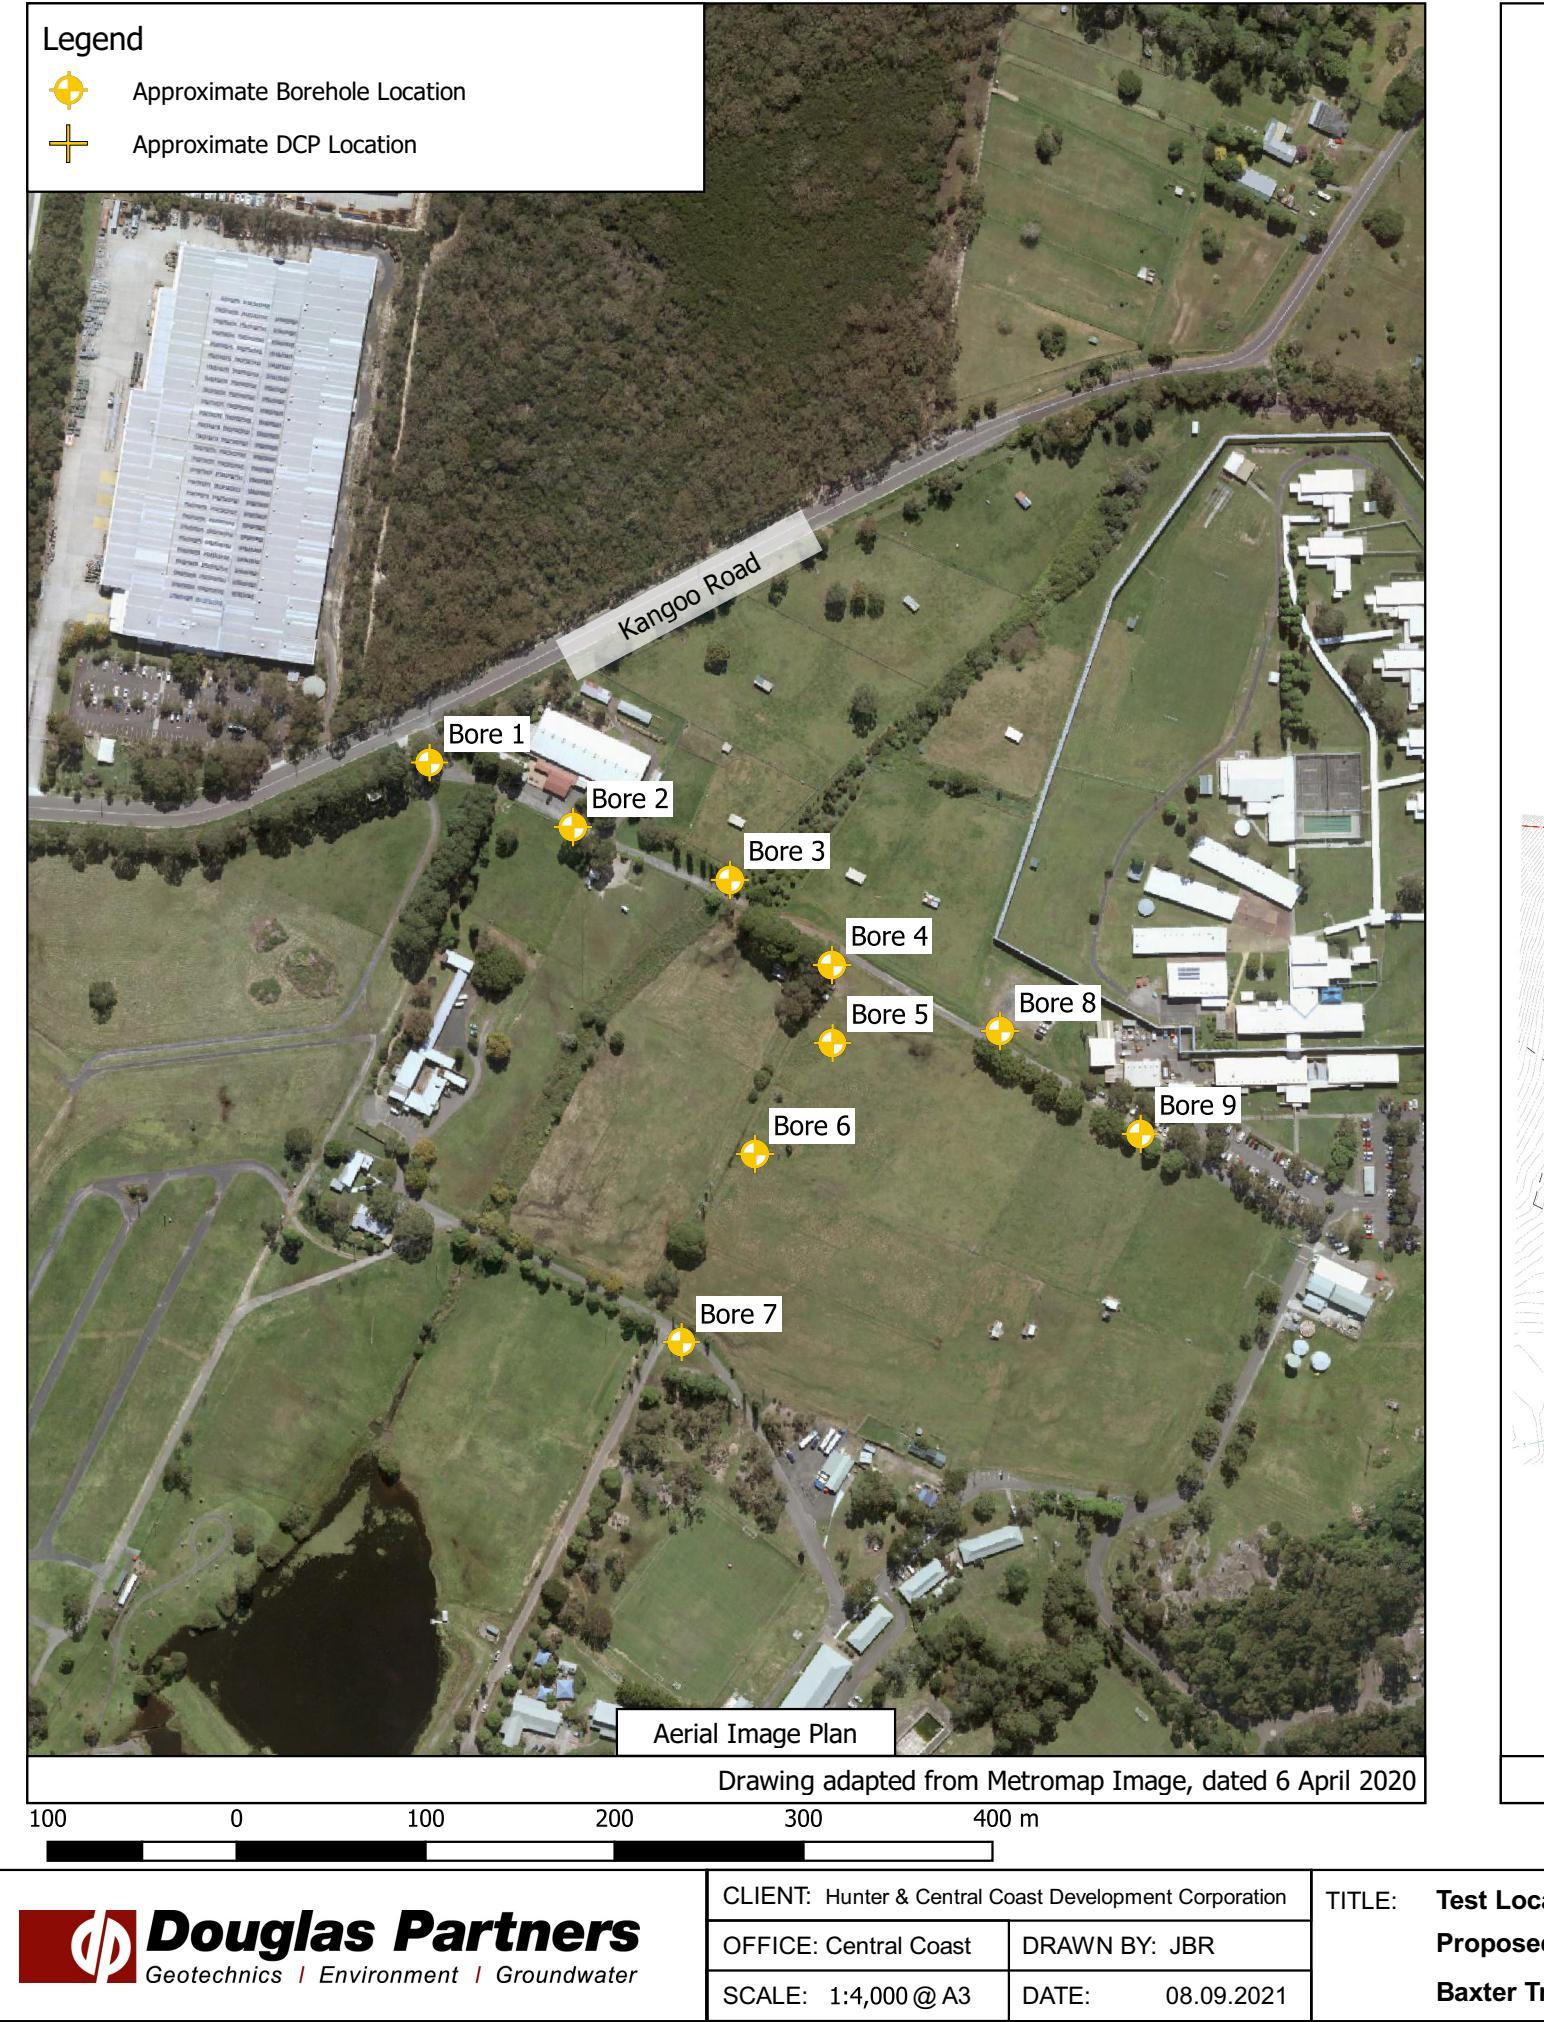
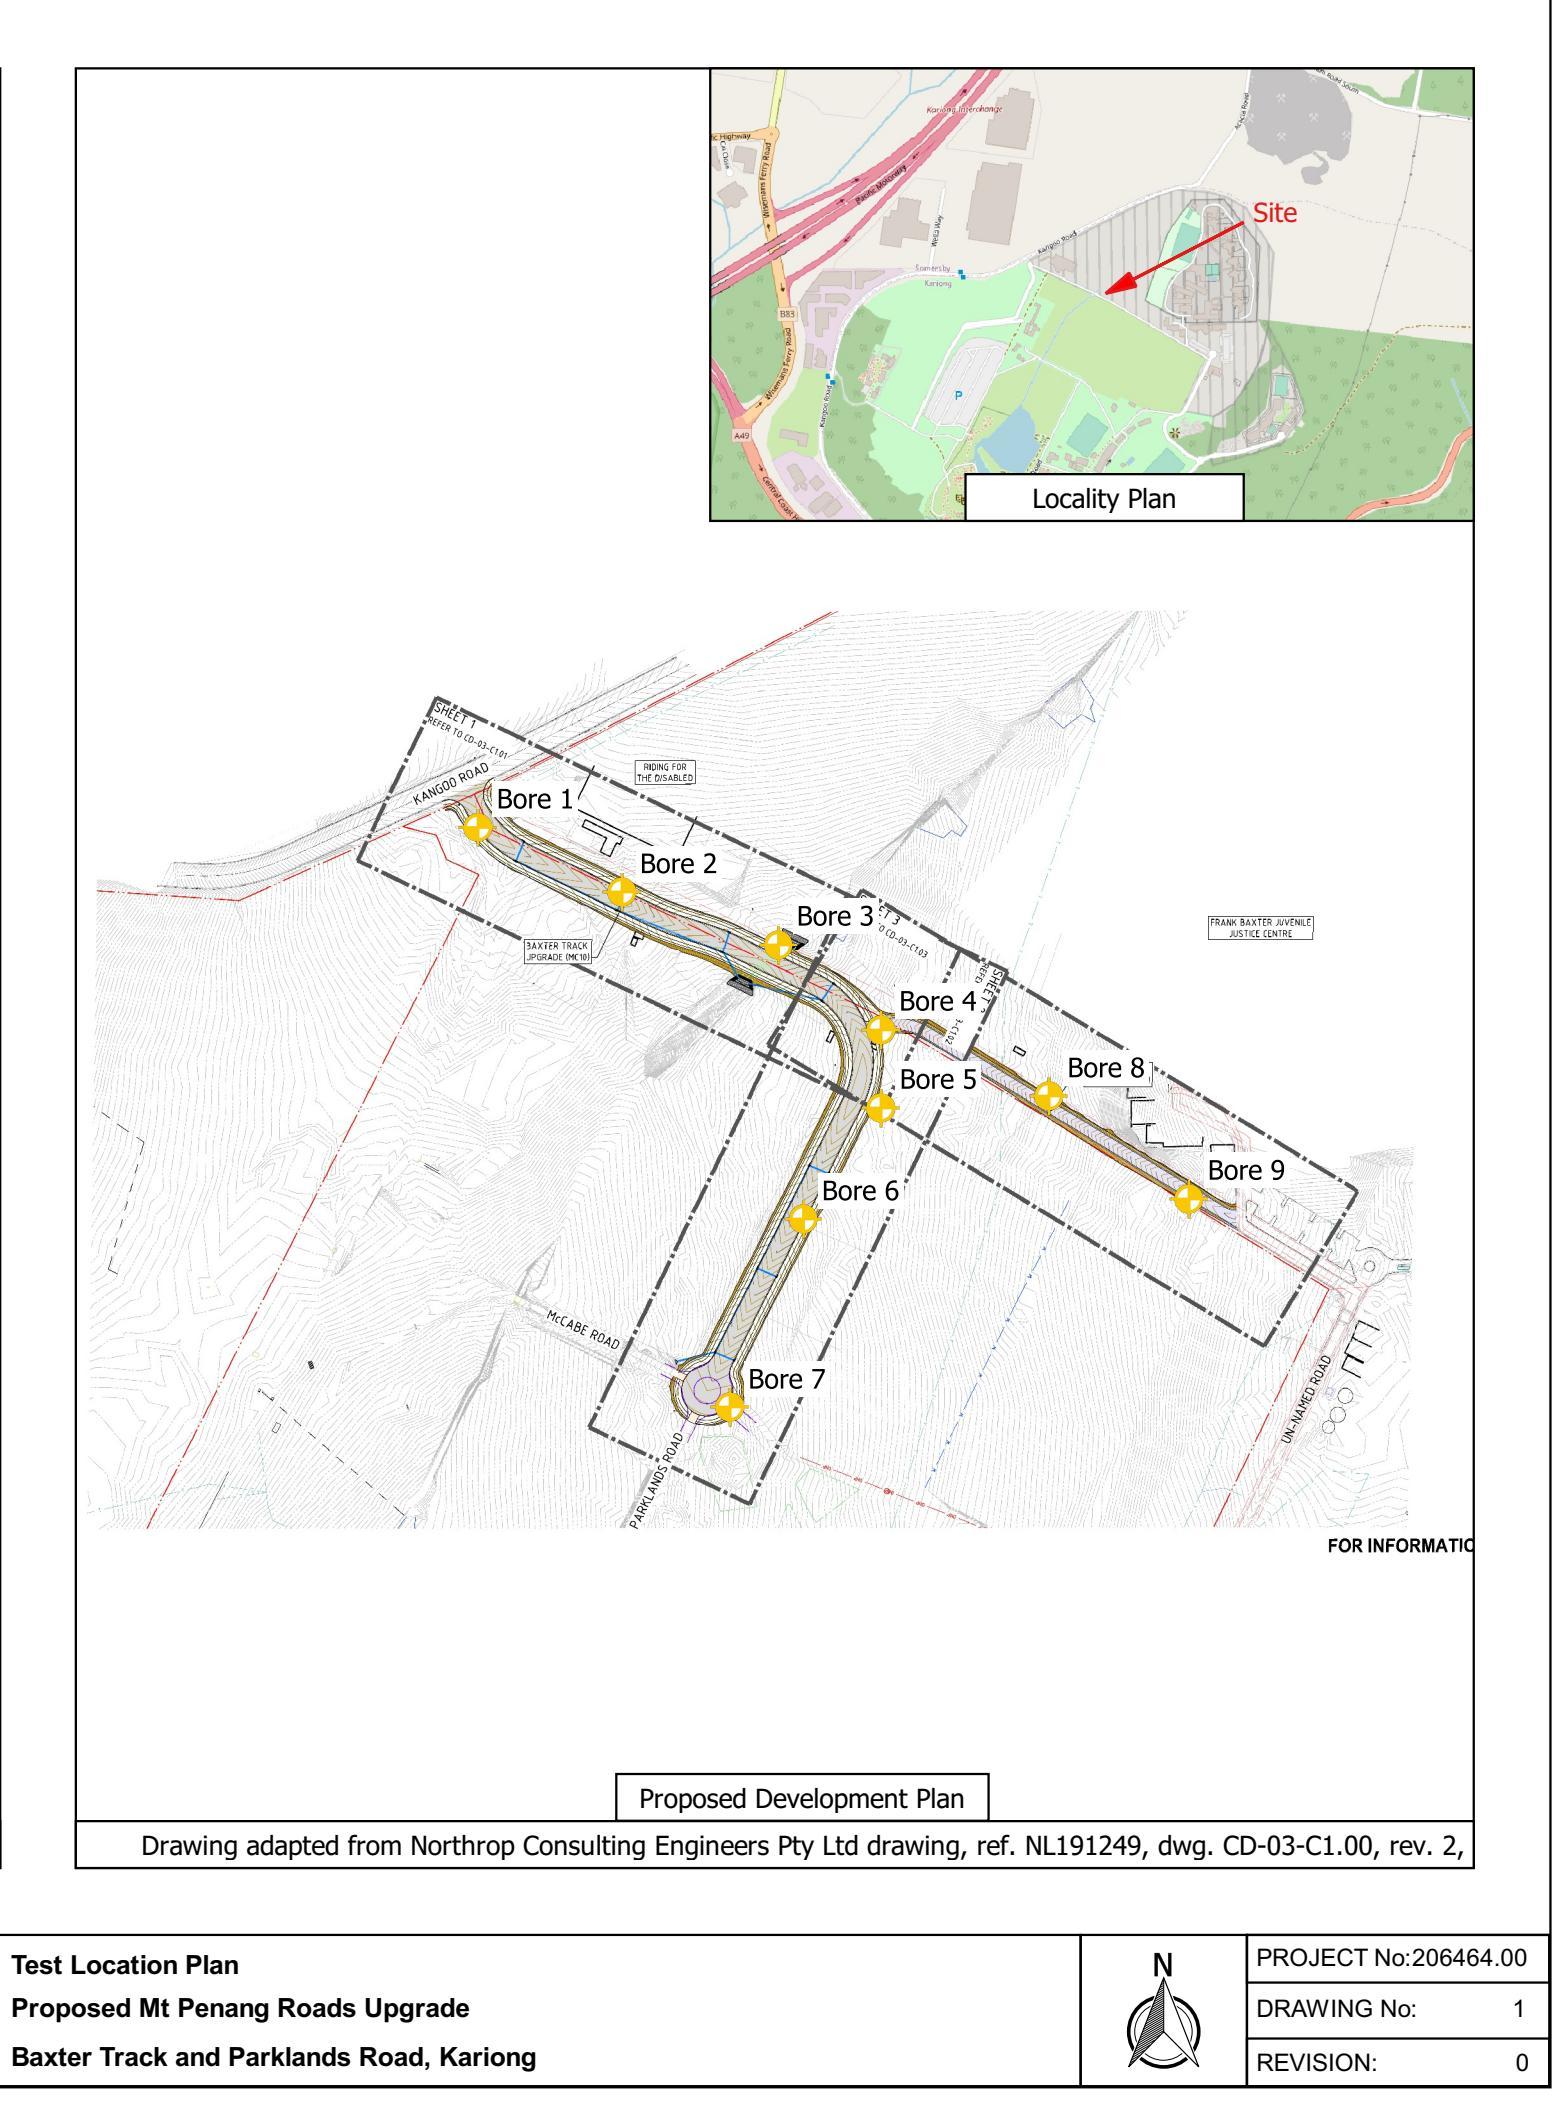
Drawing 1 - Test Location Plan

Proposed Developm
Drawing adapted from Northrop Consulti	ng Engineers Pty Ltd

TITLE: Test Location Plan Proposed Mt Penang Roads Upgrade

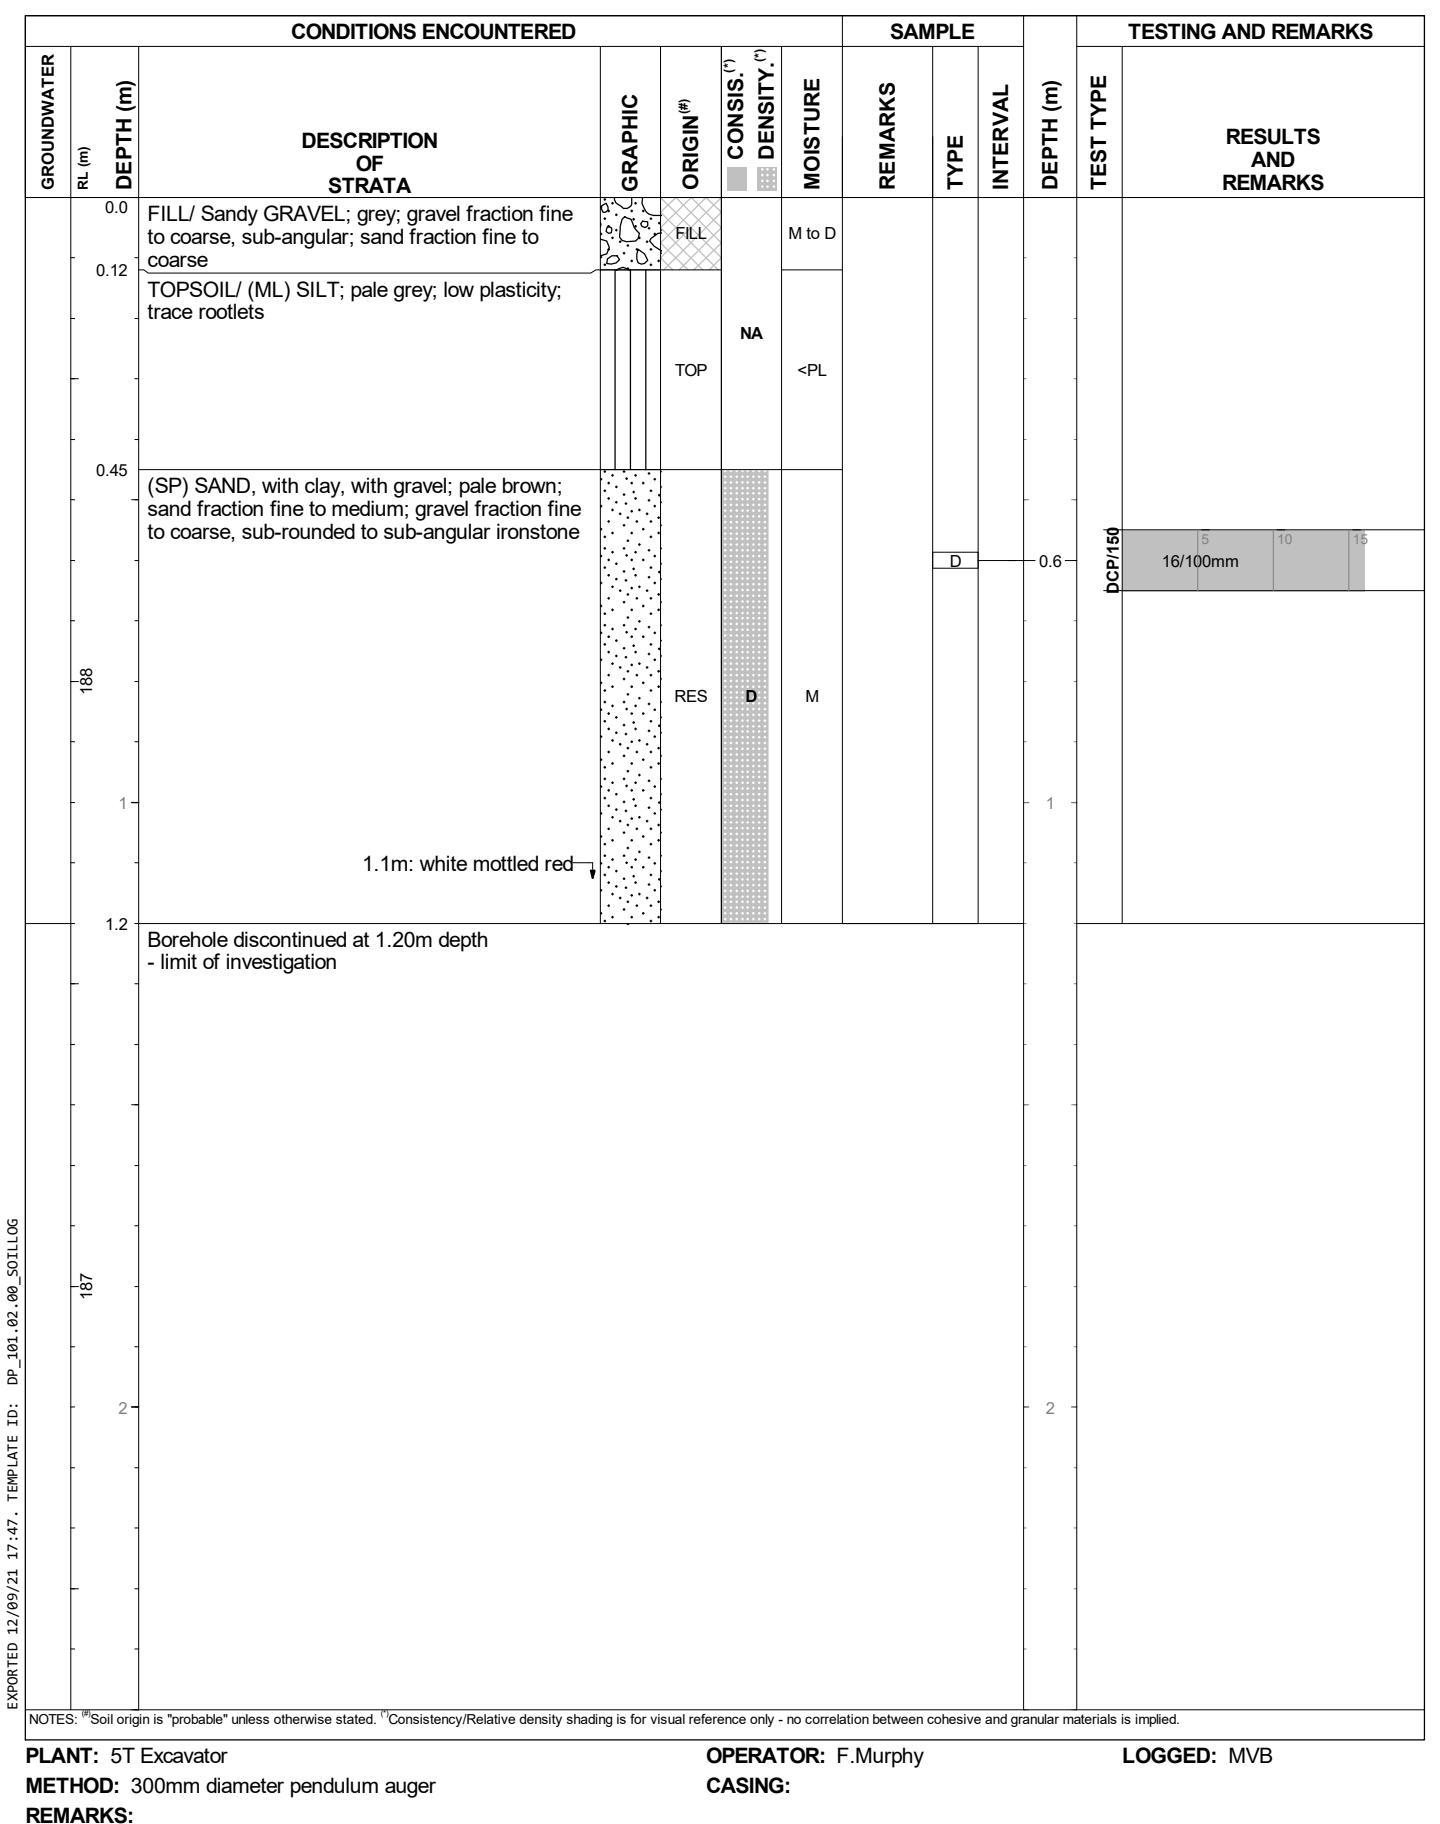
SURFACE LEVEL: 188.8 AHD COORDINATE E:341582.9 N: 6300599.5 DATUM/GRID: MGA94 Zone 56 H DIP/AZIMUTH: 90°/--- LOCATION ID: 1 PROJECT No: 206464.00 DATE: 03/08/21 SHEET: 1 of 1

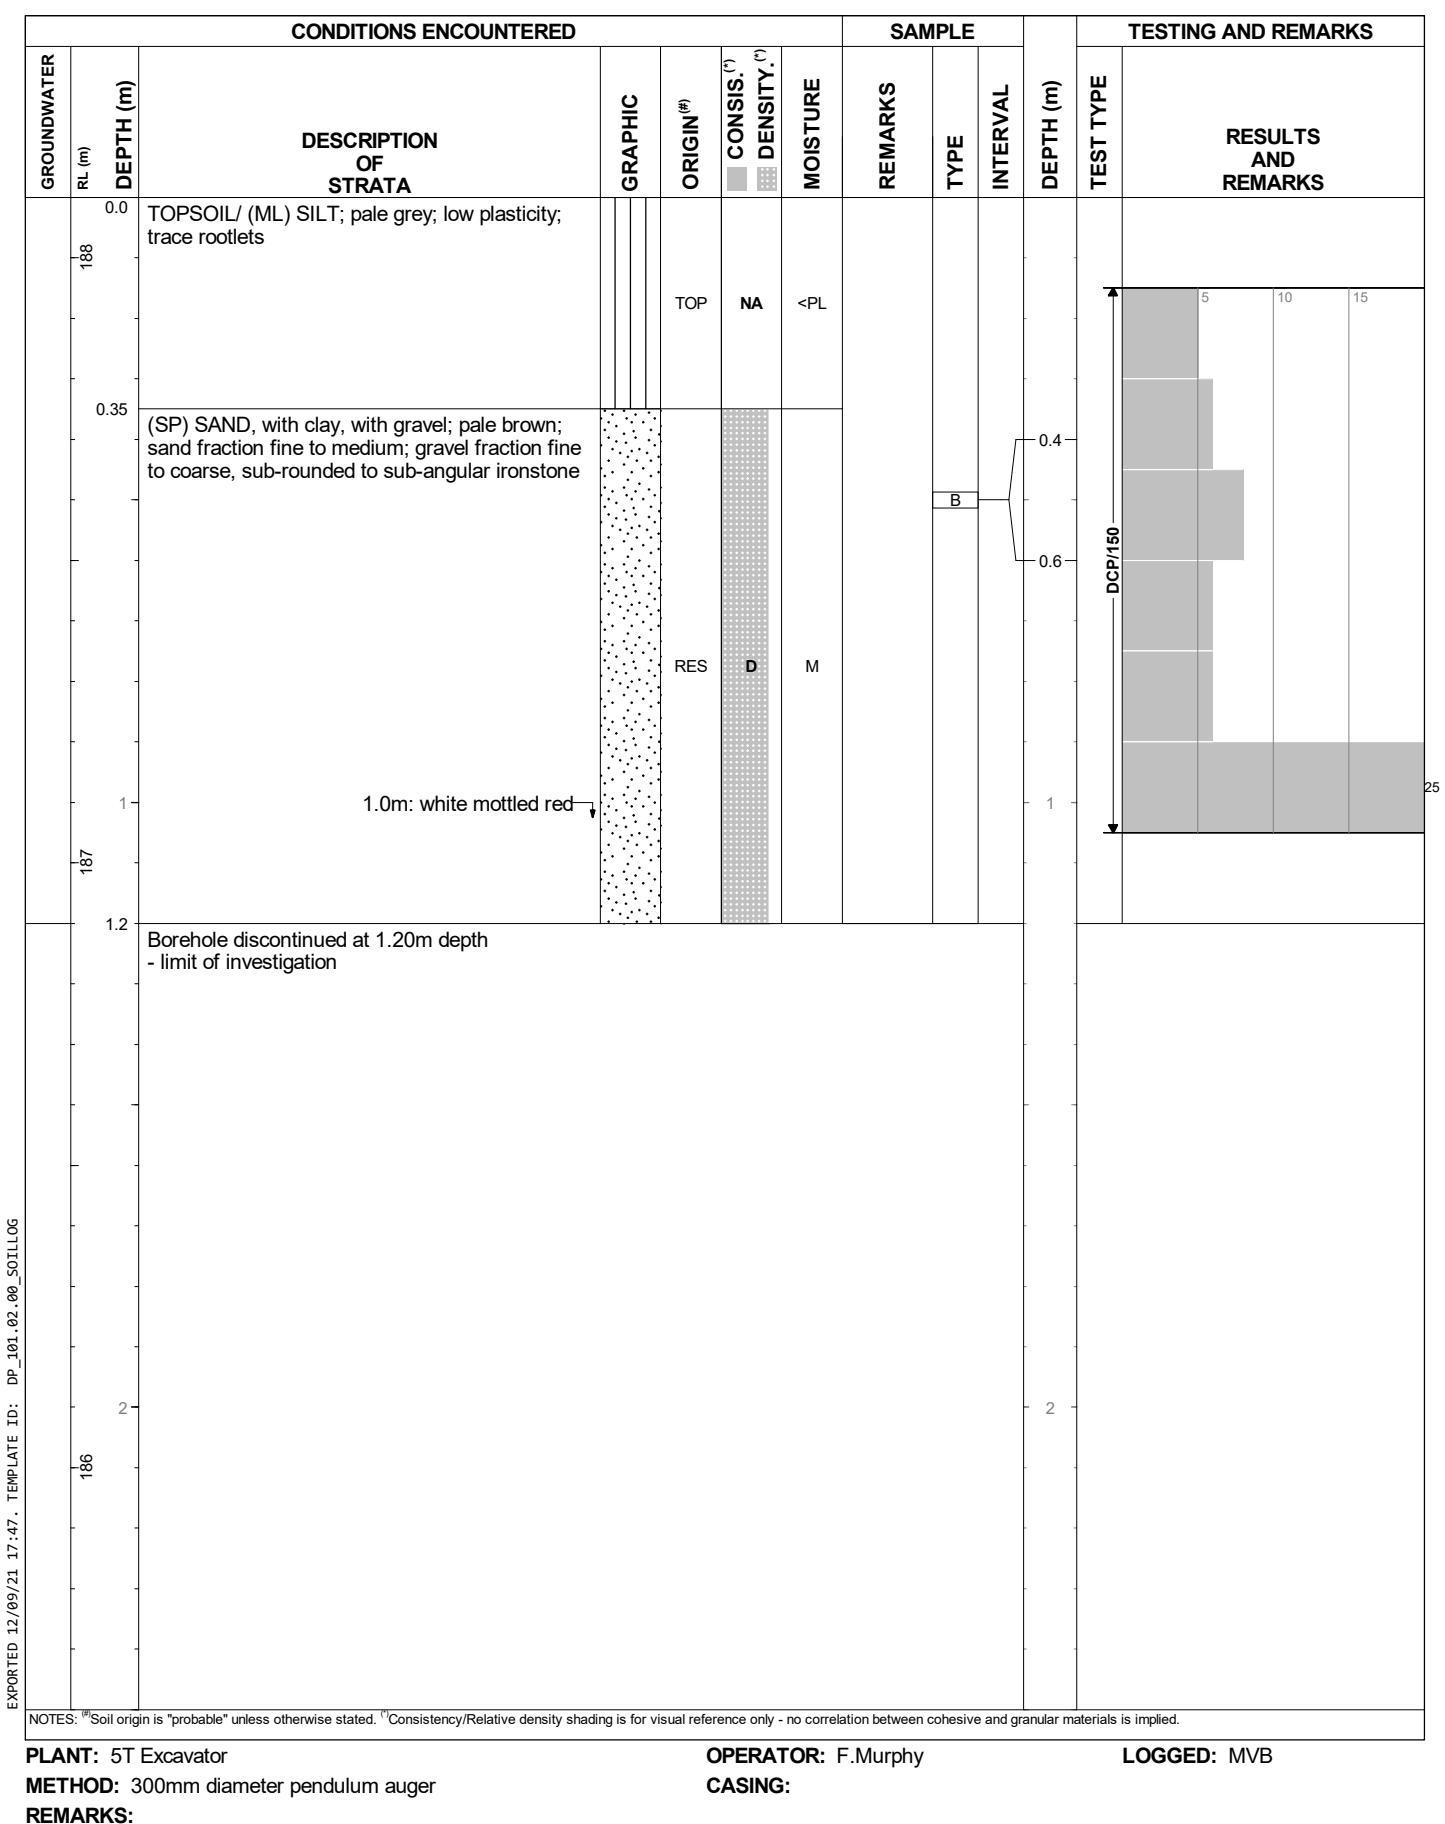
SURFACE LEVEL: 188.1 AHD COORDINATE E:341658.9 N: 6300565.4 DATUM/GRID: MGA94 Zone 56 H DIP/AZIMUTH: 90°/--- LOCATION ID: 2 PROJECT No: 206464.00 DATE: 03/08/21 SHEET: 1 of 1

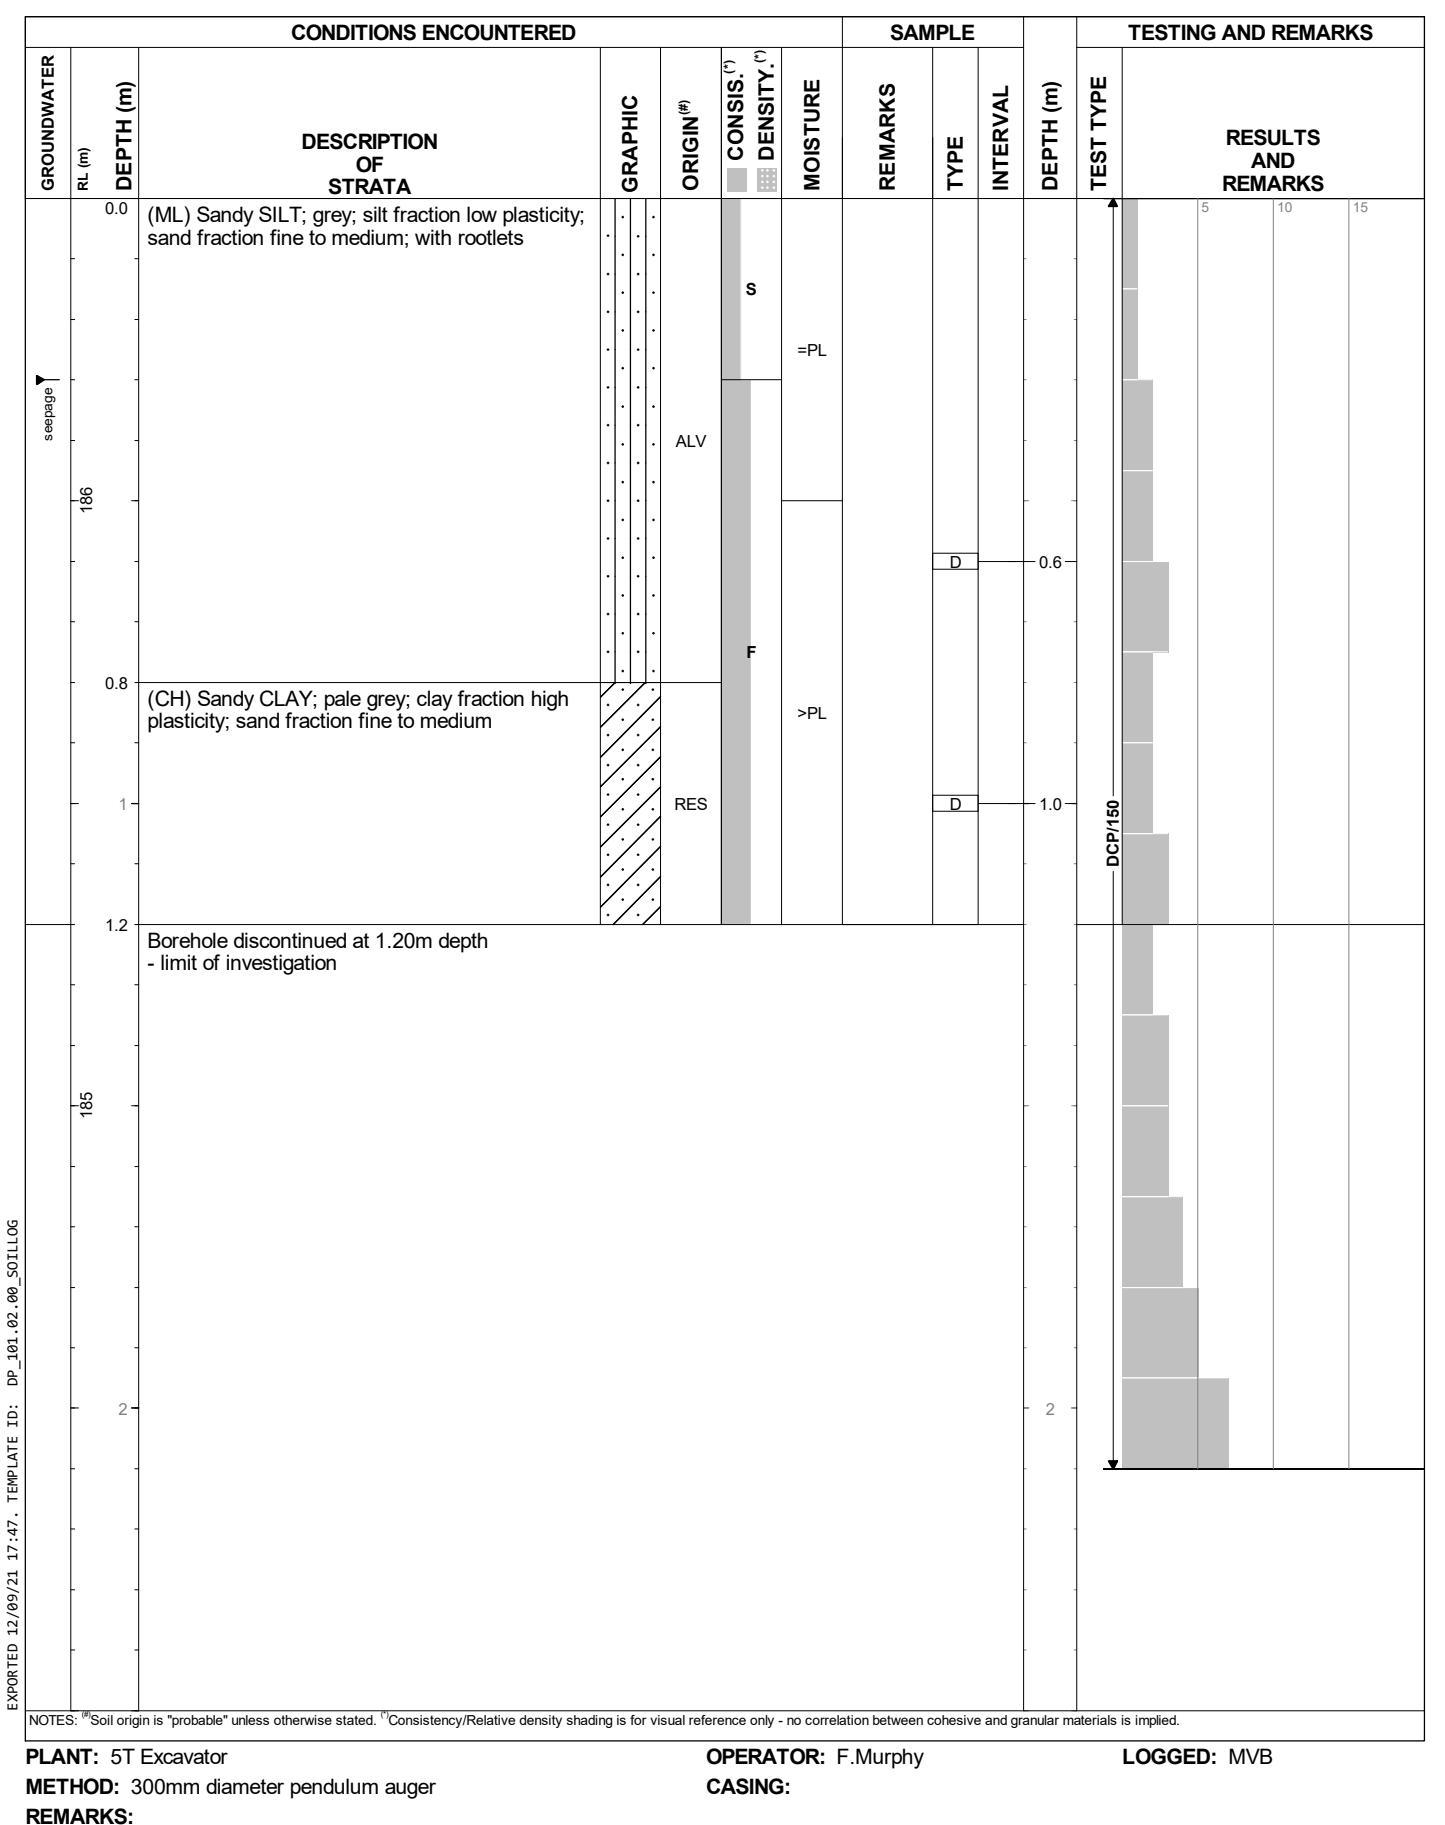
SURFACE LEVEL: 186.5 AHD **COORDINATE E:**341741.8 **N:** 6300537.5 **DATUM/GRID:** MGA94 Zone 56 H **DIP/AZIMUTH:** 90°/--- LOCATION ID: 3 PROJECT No: 206464.00 DATE: 03/08/21 SHEET: 1 of 1

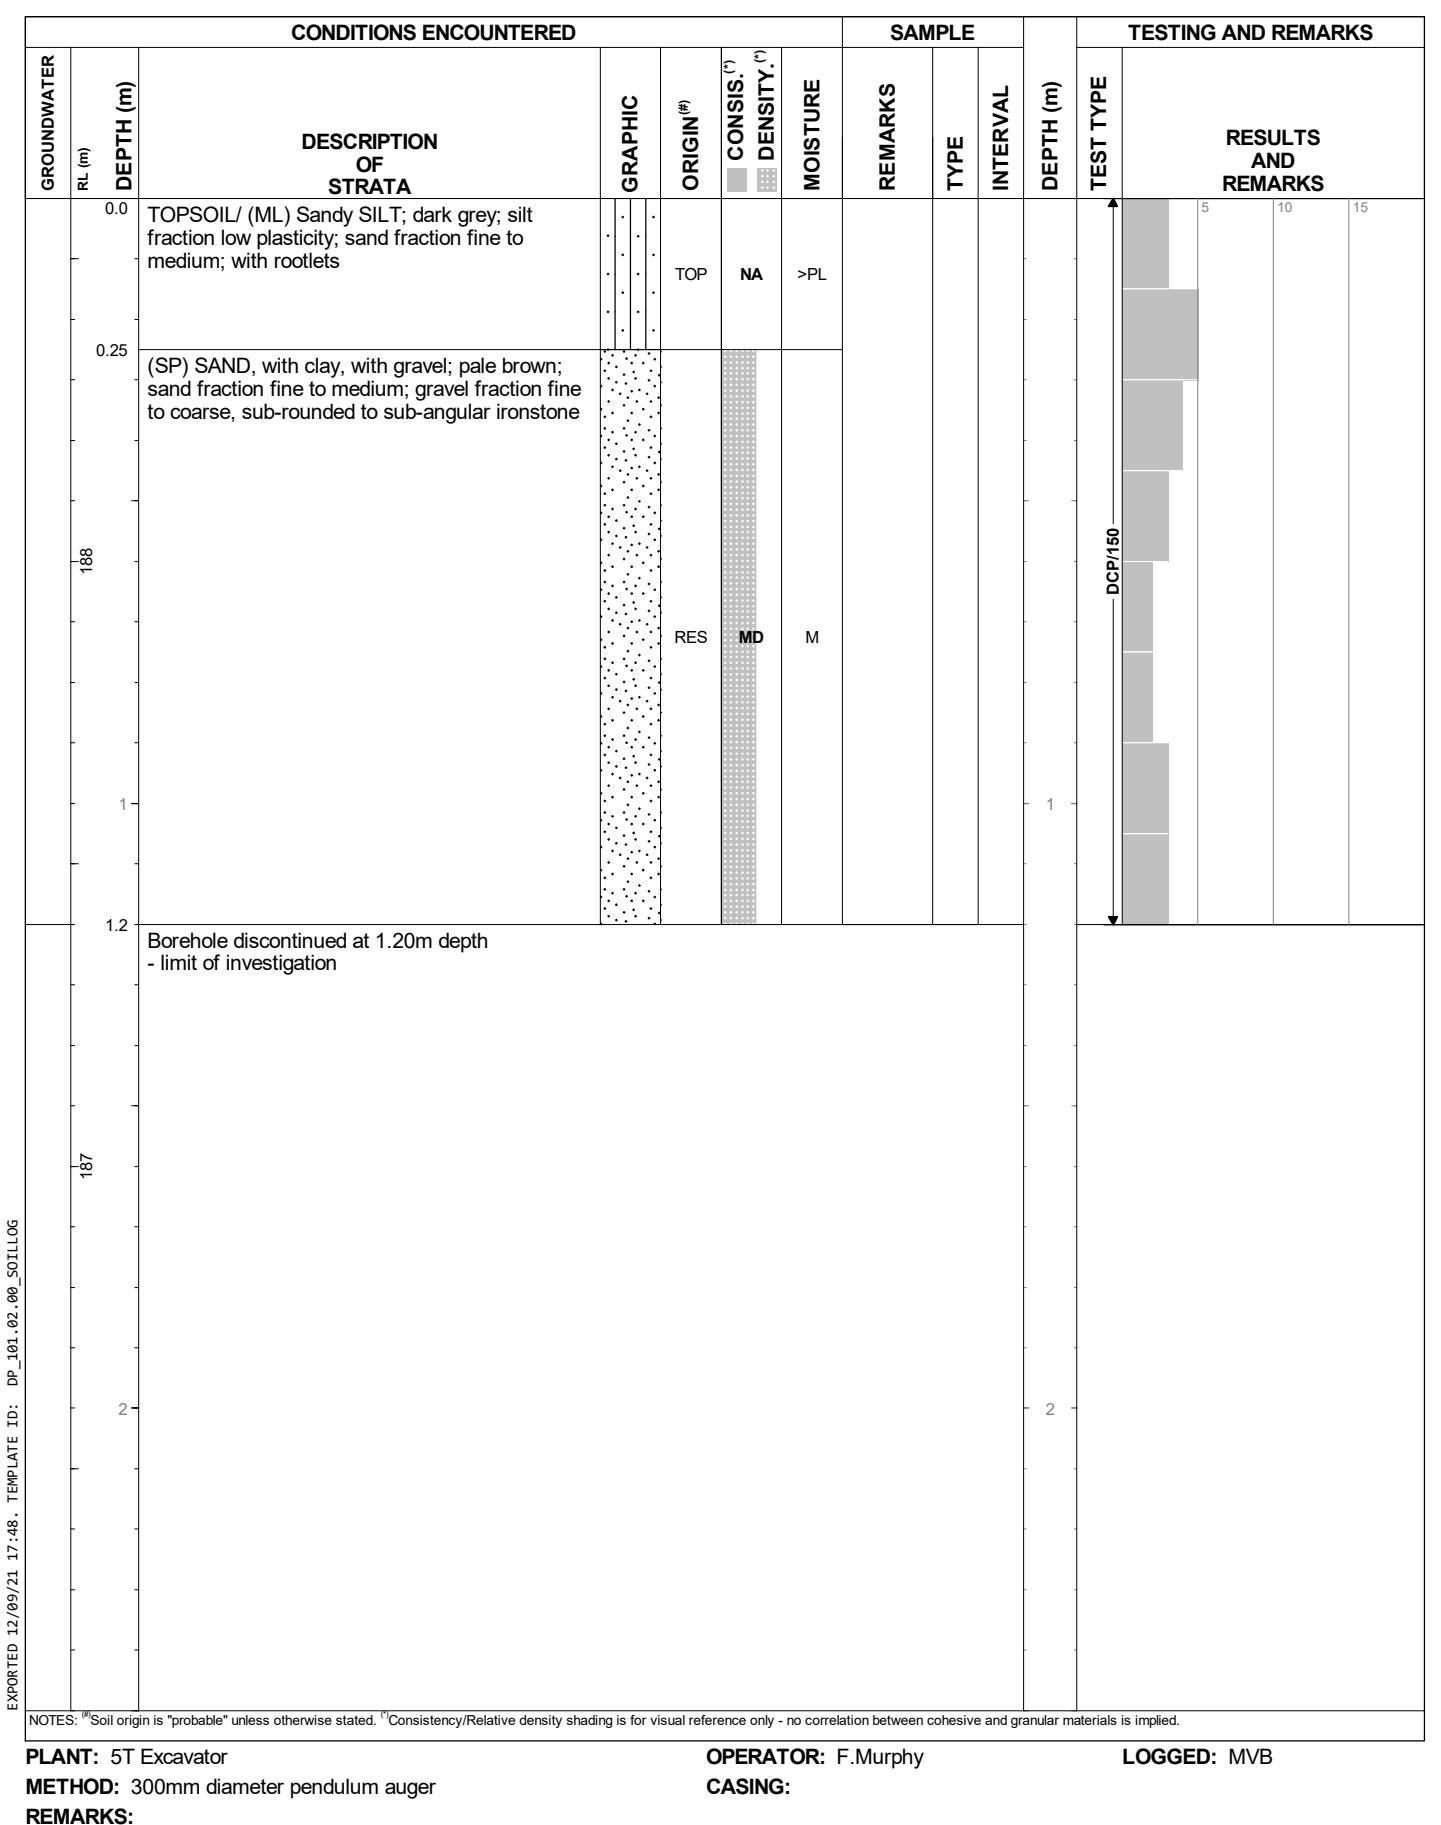
SURFACE LEVEL: 188.6 AHD COORDINATE E:341796.1 N: 6300492.5 DATUM/GRID: MGA94 Zone 56 H DIP/AZIMUTH: 90°/--- LOCATION ID: 4 PROJECT No: 206464.00 DATE: 03/08/21 SHEET: 1 of 1
