Report on Geotechnical Investigation

Proposed Mt Penang Roads Upgrade Baxter Track and Parklands Road, Kariong

Prepared for Hunter and Central Coast Development Corporation

> Project 206464.00 September 2021

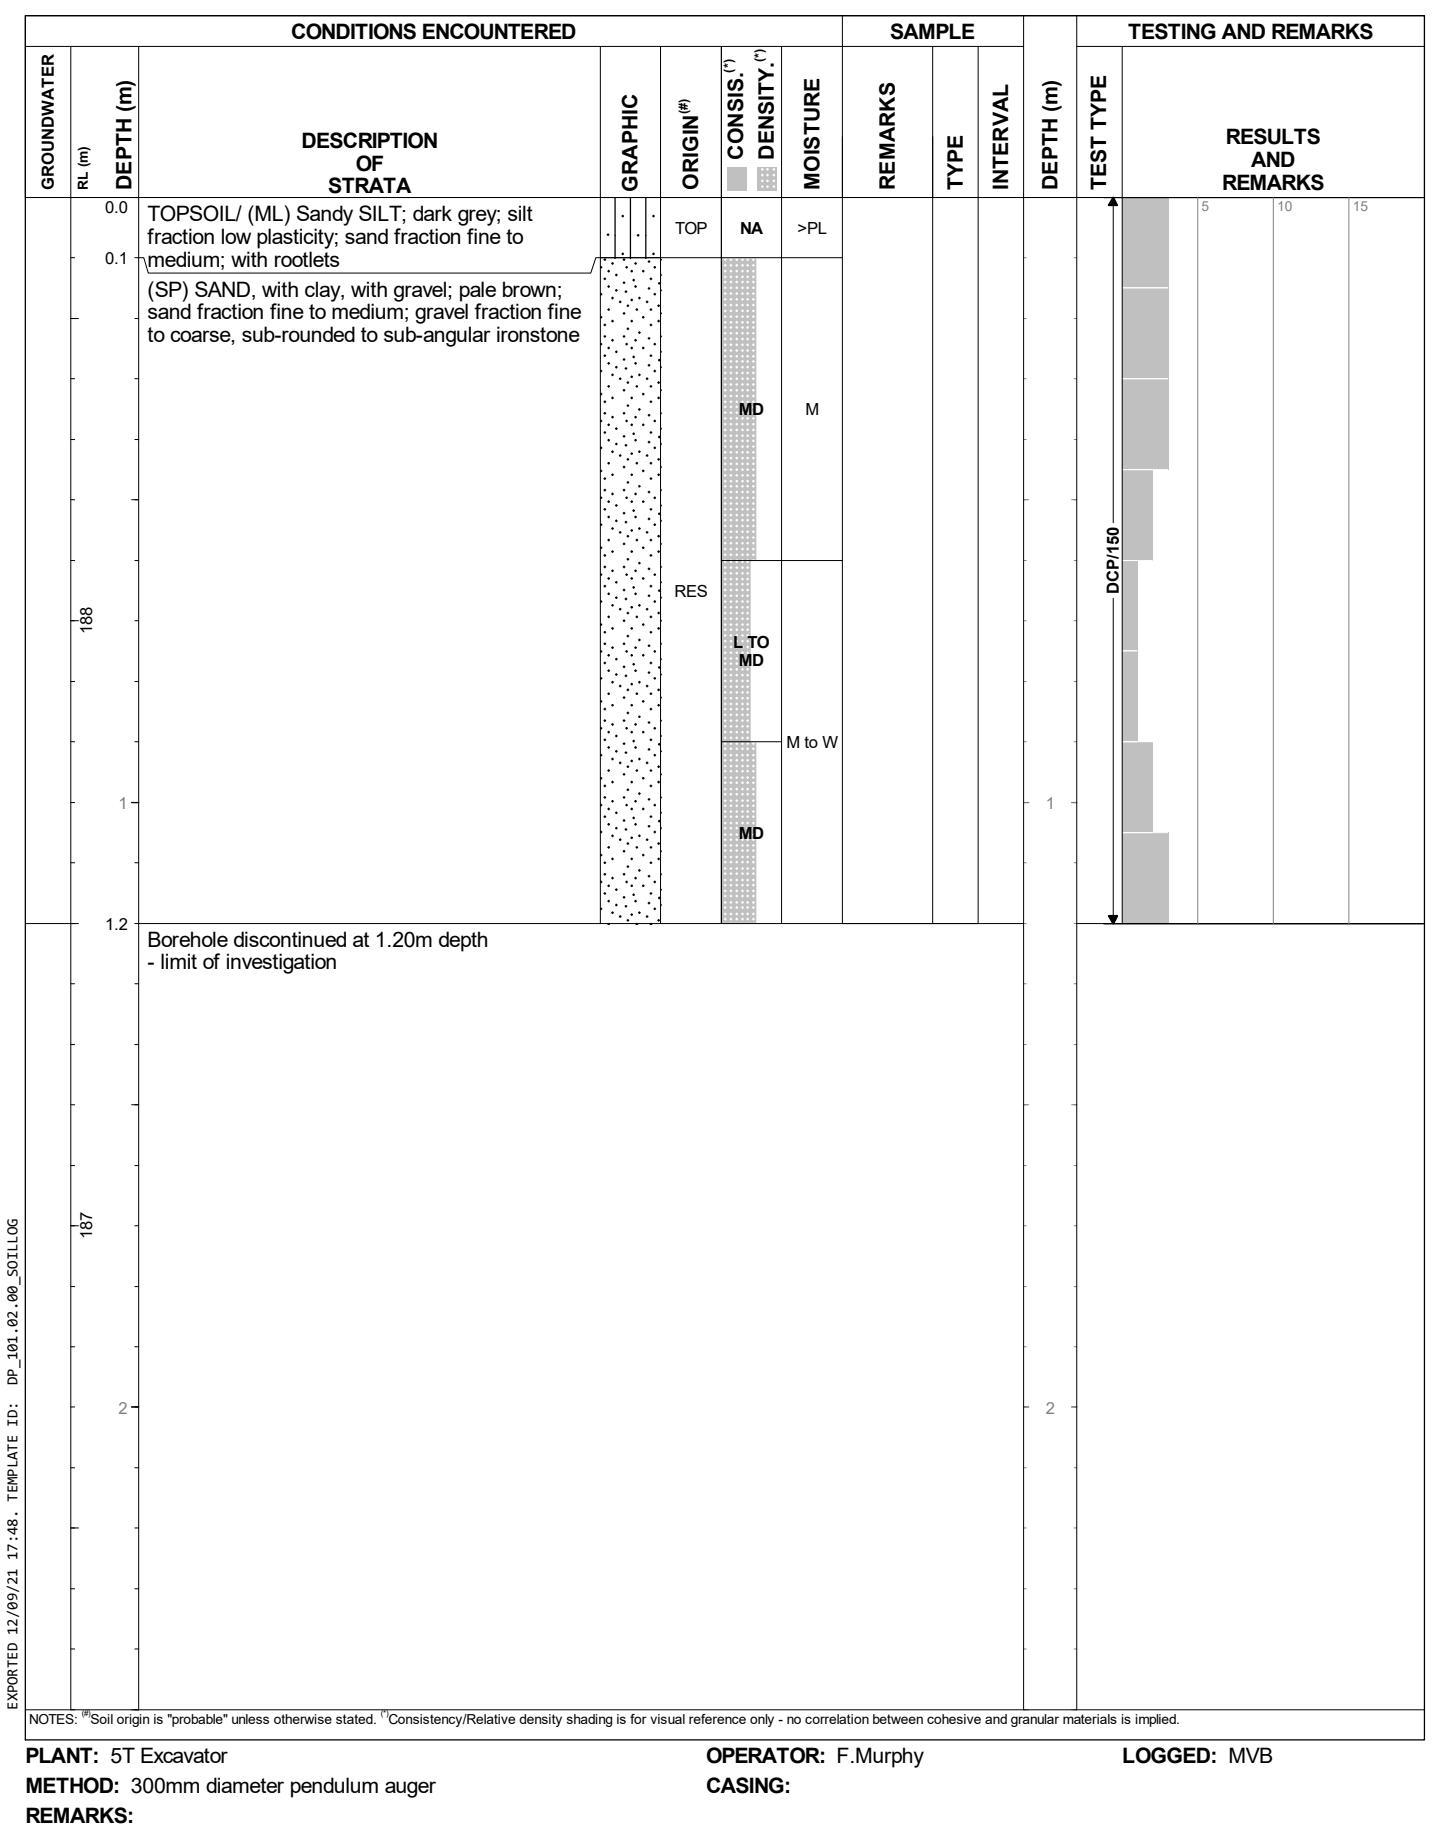
SURFACE LEVEL: 188.7 AHD COORDINATE E:341796.2 N: 6300451.2 DATUM/GRID: MGA94 Zone 56 H DIP/AZIMUTH: 90°/--- LOCATION ID: 5 PROJECT No: 206464.00 DATE: 03/08/21 SHEET: 1 of 1

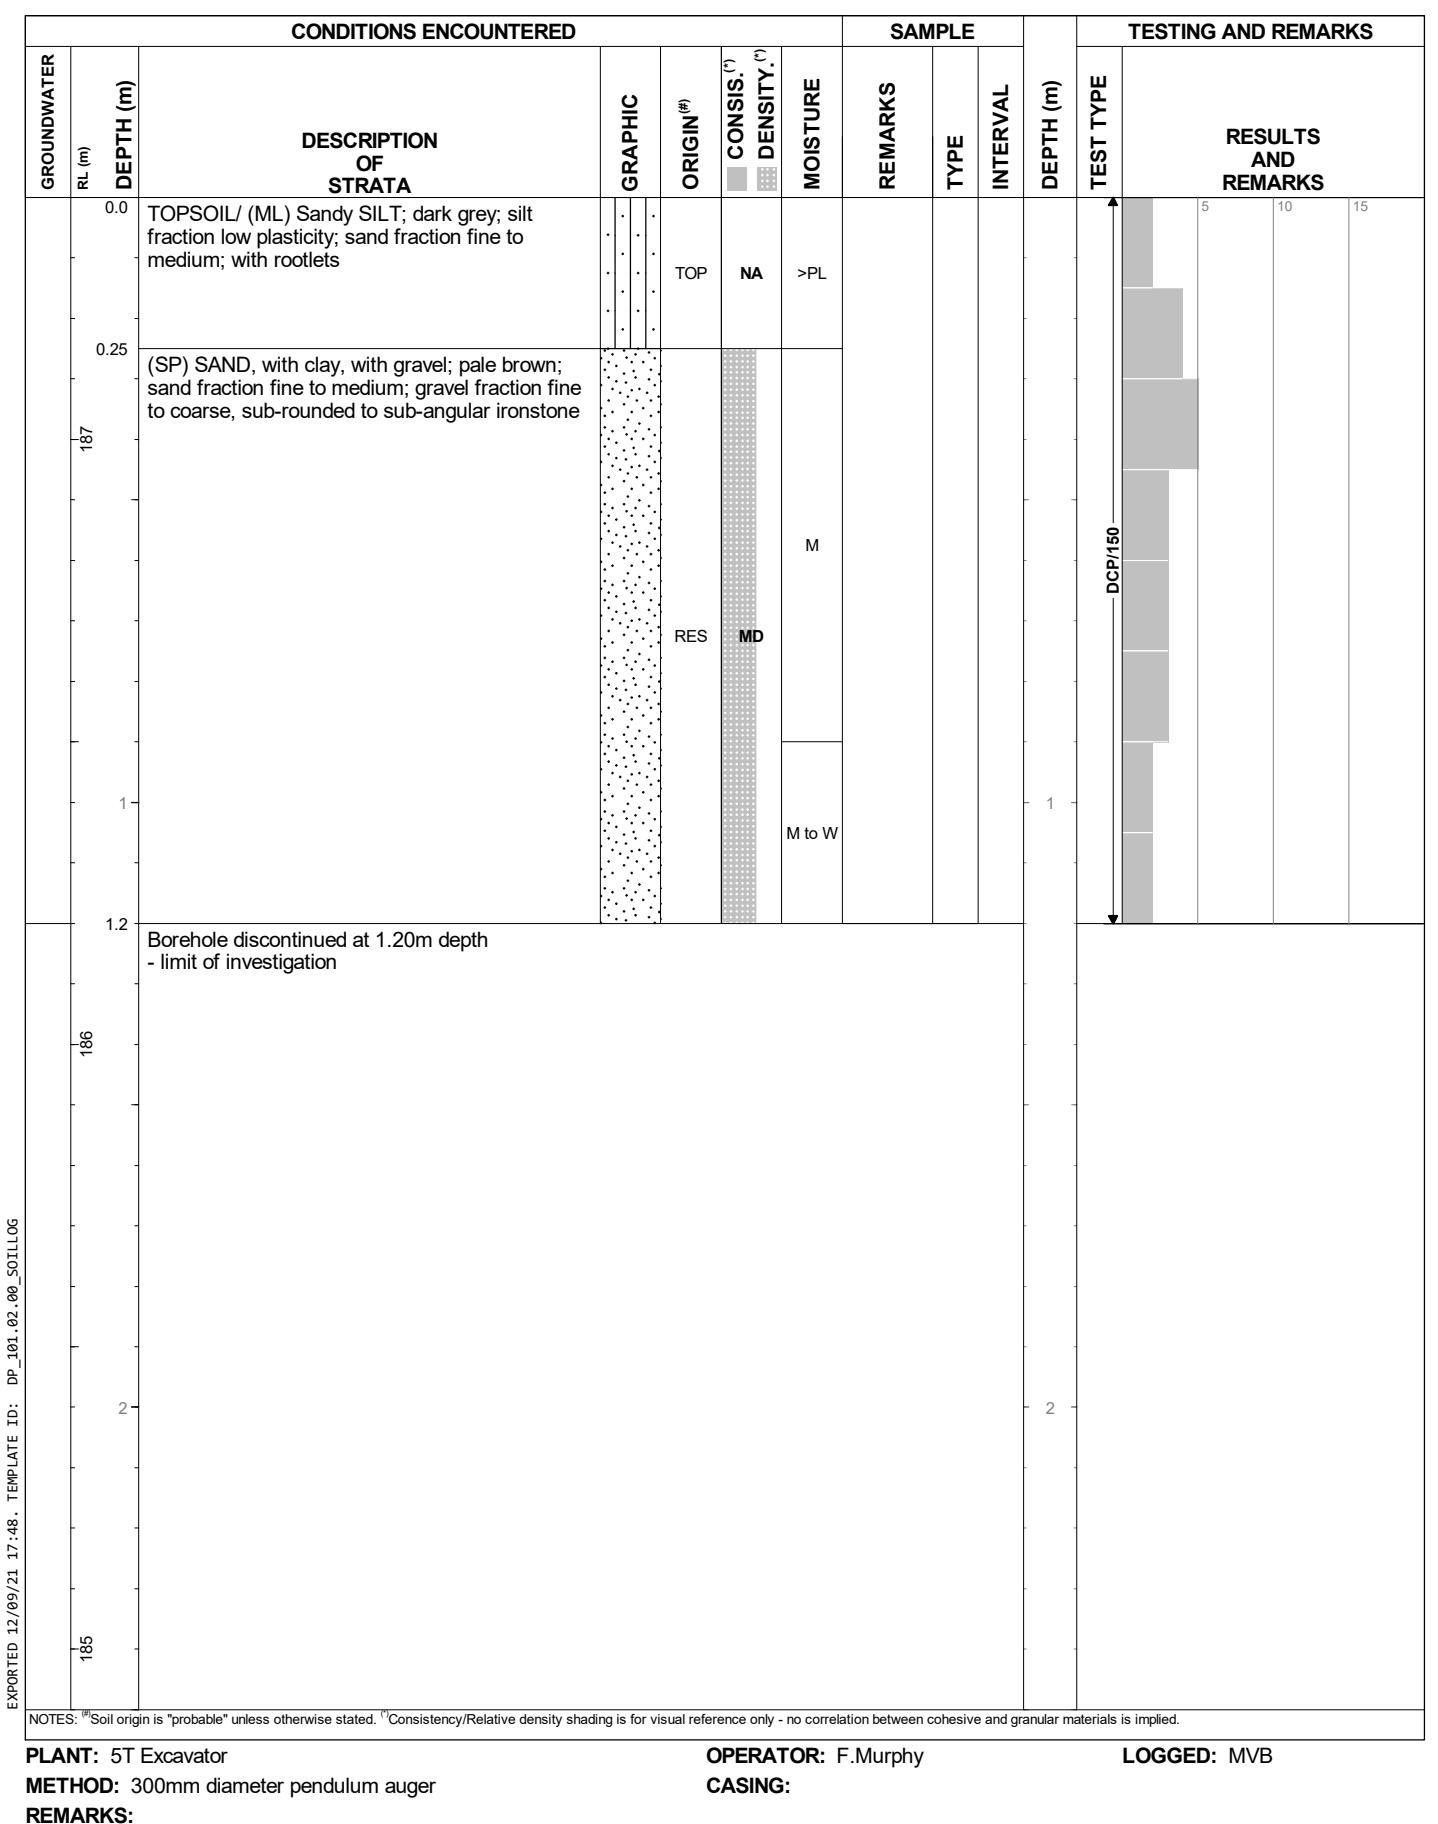
SURFACE LEVEL: 187.4 AHD COORDINATE E:341755.1 N: 6300392.2 DATUM/GRID: MGA94 Zone 56 H DIP/AZIMUTH: 90°/--- LOCATION ID: 6 PROJECT No: 206464.00 DATE: 03/08/21 SHEET: 1 of 1

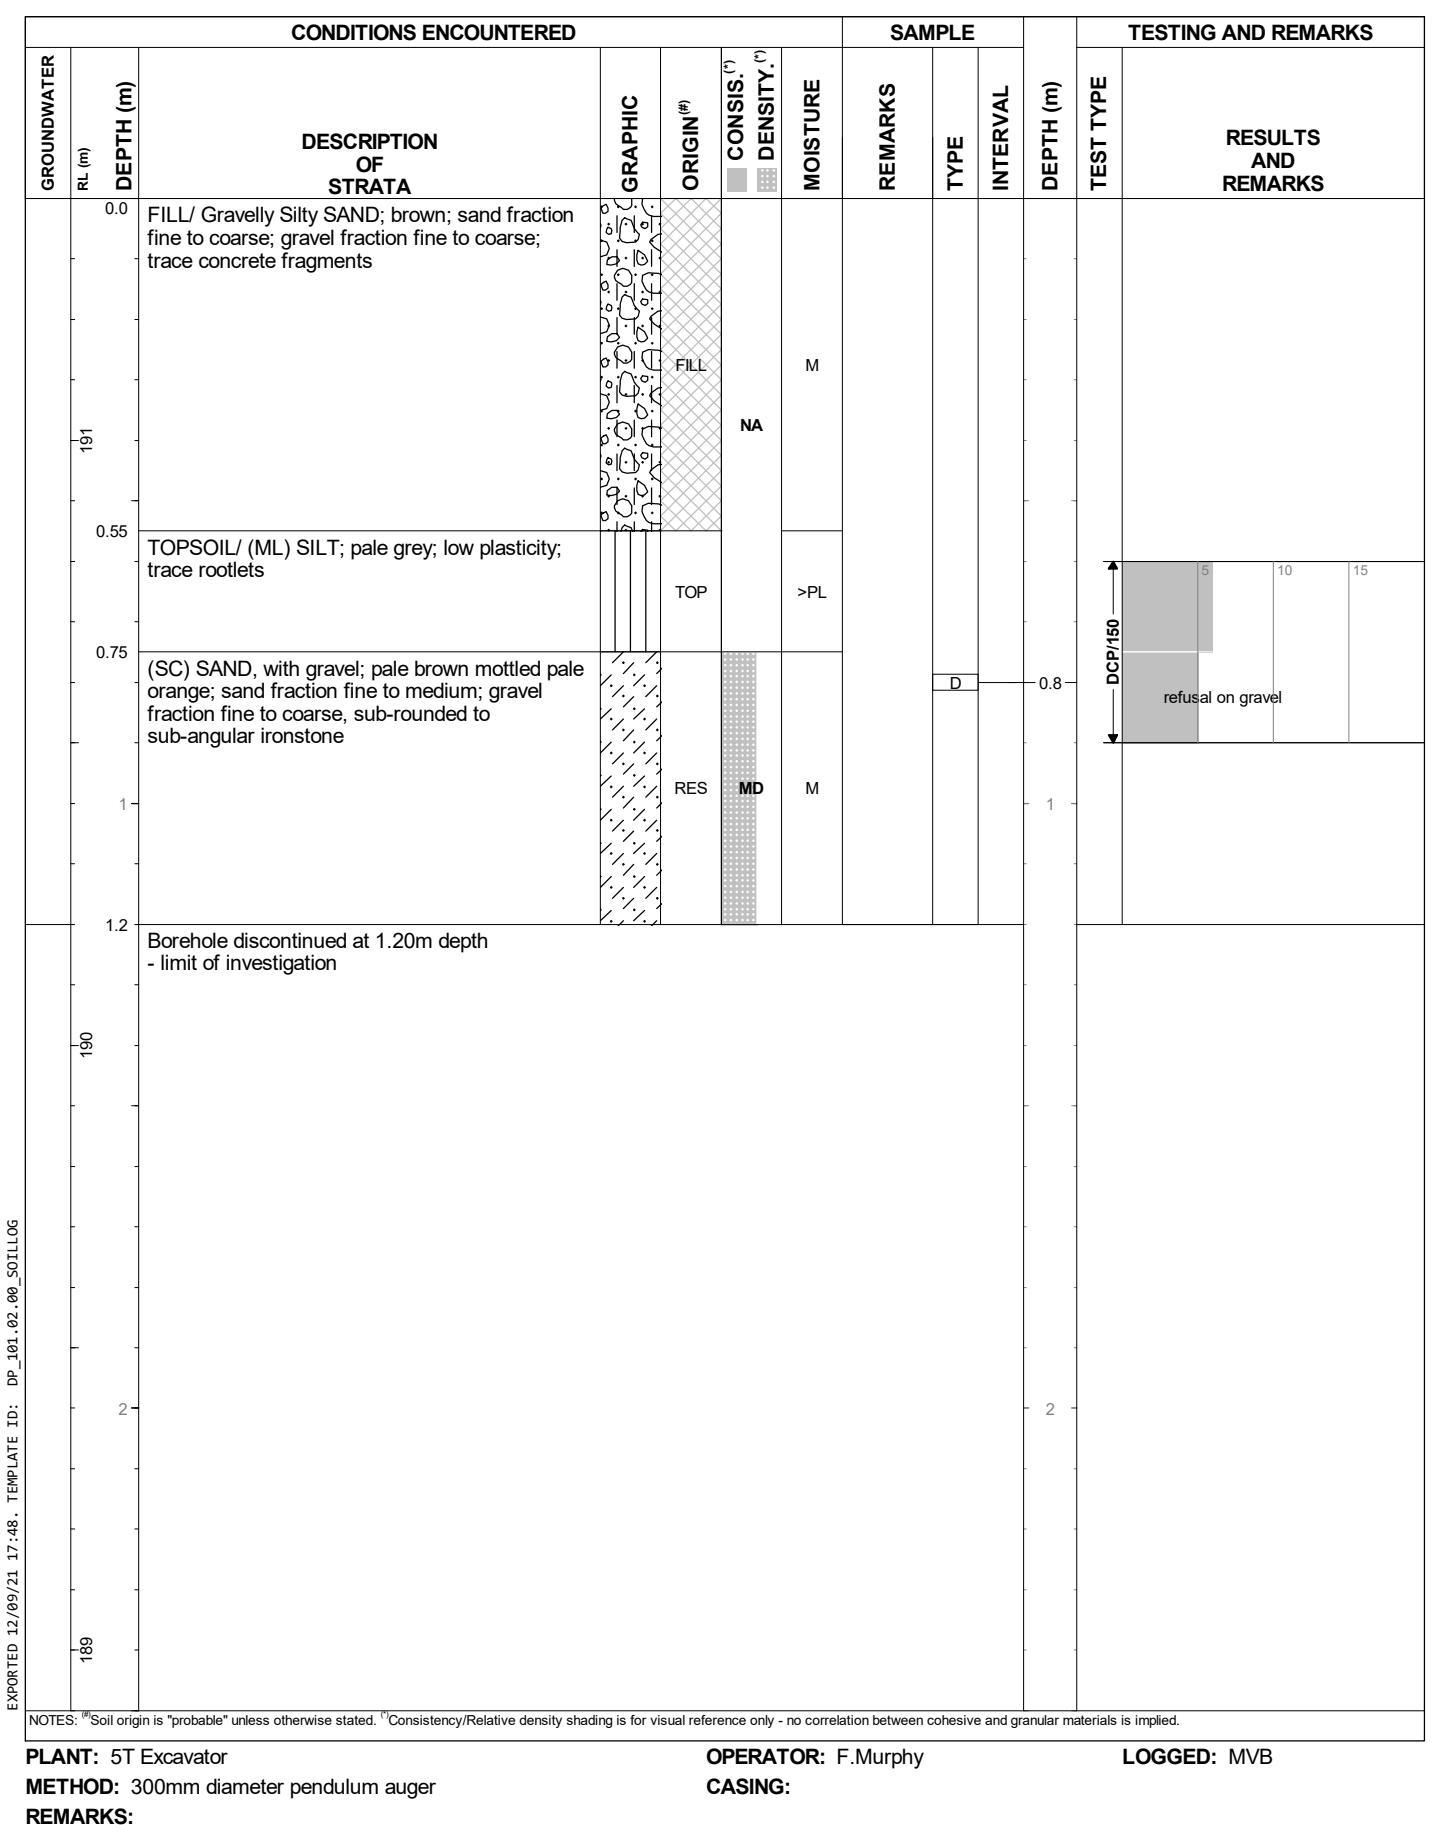
SURFACE LEVEL: 191.4 AHD COORDINATE E:341884.9 N: 6300457.3 DATUM/GRID: MGA94 Zone 56 H DIP/AZIMUTH: 90°/--- LOCATION ID: 8 PROJECT No: 206464.00 DATE: 03/08/21 SHEET: 1 of 1

- Where required, strip existing vegetation, fill, topsoils and other deleterious material. It is noted that in the location of Bore 8, gravelly silty sand fill and topsoil will need to be removed to a depth of approximately 0.75 m;

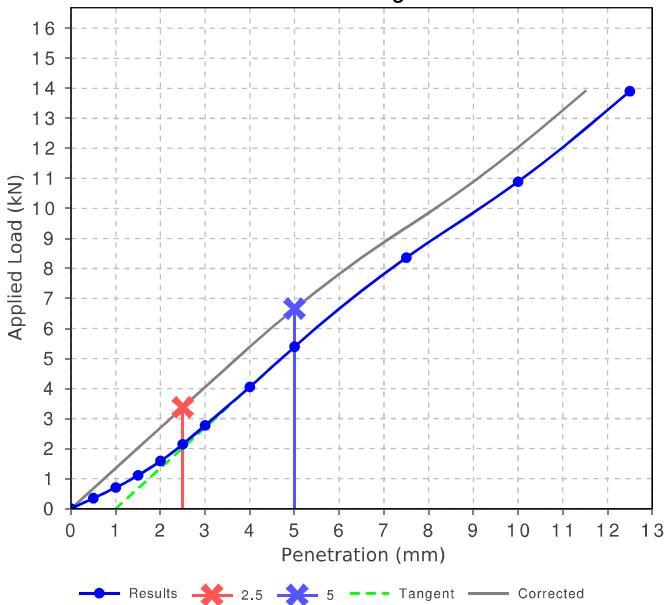
California Bearing Ratio (AS 1289 6.1.1 & 2.	.1.1)	Min	Max
CBR taken at	5 mm		
CBR %	35		
Method of Compactive Effort	Stan	dard	
Method used to Determine MDD	AS 1289 5.	1.1 & 2	.1.1
Method used to Determine Plasticity	Visual As	sessme	ent
Maximum Dry Density (t/m ³)	2.11		
Optimum Moisture Content (%)	10.0		
Laboratory Density Ratio (%)	99.5		
Laboratory Moisture Ratio (%)	101.5		
Dry Density after Soaking (t/m ³)	2.11		
Field Moisture Content (%)	8.3		
Moisture Content at Placement (%)	10.0		
Moisture Content Top 30mm (%)	9.8		
Moisture Content Rest of Sample (%)	9.4		
Mass Surcharge (kg)	4.5		
Soaking Period (days)	4		
Curing Hours	72.7		
Swell (%)	-0.5		
Oversize Material (mm)	19		
Oversize Material Included	Excluded		
Oversize Material (%)	0.0
